Village of Shoreland, Wisconsin

**Pedestrian/Bicycle Safety
Intersection Review**

December 2005

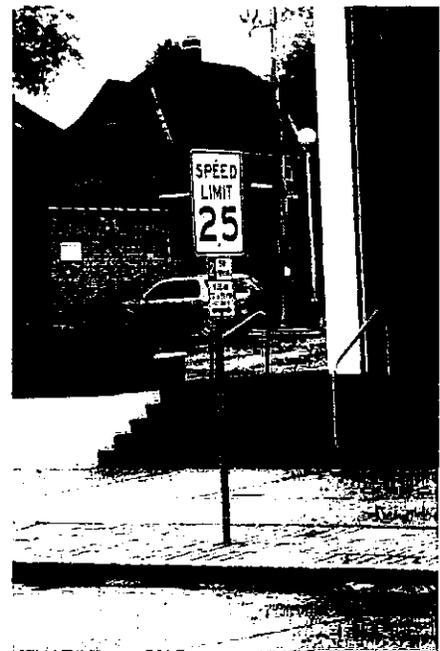
*1) Excessive Speed. Many vehicles drive over the posted speed limit of 25 mph on North Oakland Avenue and there are too few speed limit signs on North Lake Drive.

Picture 1 – 25 mph Speed Limit on Oakland

Solution: Install additional speed limit signs on North Oakland Avenue and North Lake Drive. There are currently only 2 to 3 speed limit signs in each direction along Oakland, one of which is shown in Picture 1.

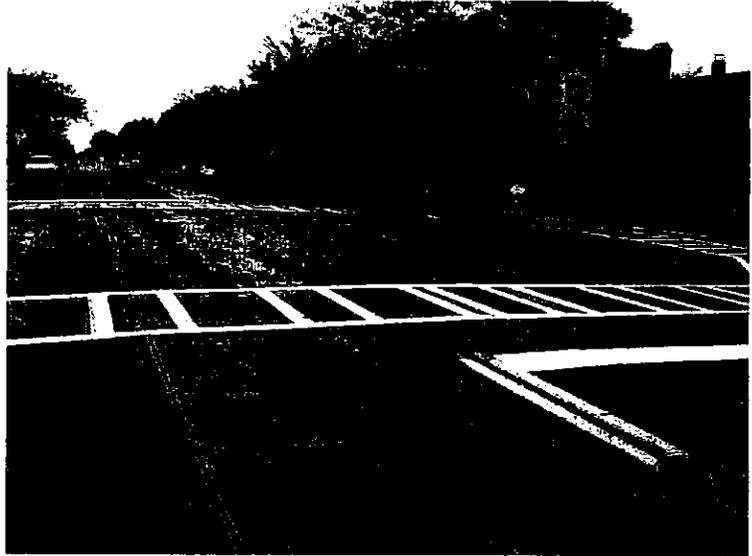
from paying attention to their surroundings. Picture 6 shows the crosswalk pavement markings at North Oakland Avenue and East Kenmore Place. The widths between the white markings are not consistent and the style of the pavement markings is not consistent with the MUTCD.

Picture 6 – Crosswalk at Oakland and Kenmore

Solution: Re-mark the substandard crosswalks in accordance with the MUTCD standard and re-mark the substandard parking lines in accordance with State laws throughout the Village. Replace the existing crosswalks, and parking markings with highly reflective pavement markings, such as paint or thermoplastic with glass beads to make all pavement markings more visible. When future maintenance is required on other pavement markings, replace them with highly reflective pavement markings.

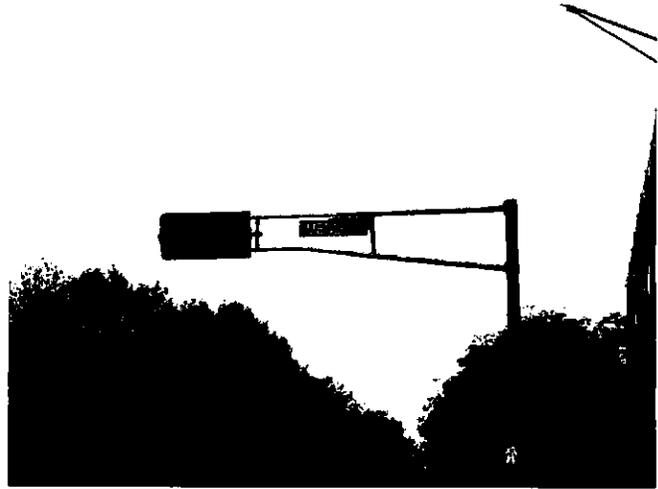
*3) Street Name Signs. The street name signs along North Oakland Avenue and East Capitol Drive are very small as can be seen in Picture 8, which make them difficult for drivers to read as they approach an intersection. This takes drivers' attention away from the road and from pedestrians and bicyclists.

Picture 8– Hard to read overhead street sign

Solution: Replace the existing street signs with larger, more reflective signs. The Manual on Uniform Traffic Control Devices recommends a minimum letter height of 6-inch upper case and 4 ½" lower case letters for ground mounted signs, and 12-inch upper case and 9" lower case letters for overhead mounted street name signs (such as the one shown in Picture 8); and the signs shall be retro reflective or illuminated to show the same shape and similar color both day and night. Replacing the existing street signs would cost approximately \$1000 - \$1500 per intersection.

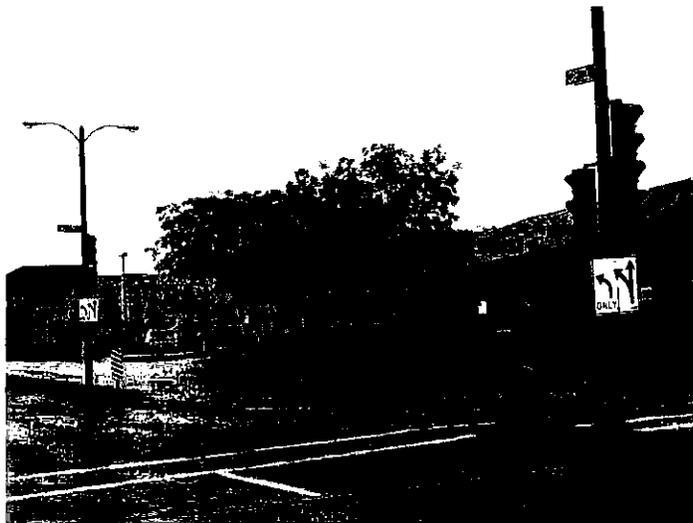
b) The sign shown in Picture 12 shows that the inside eastbound through lane is designated for both through and left turning traffic. However, there are no pavement markings for eastbound traffic that indicate this lane configuration, which causes confusion over whether vehicles are continuing straight through the intersection or turning left.

Solution: After reviewing the capacity analysis, one dedicated left turn lane is not sufficient to service the left turn demand alone. Therefore, the shared through/left lane should remain. Install pavement markings for eastbound East Capitol Drive that delineate the lane assignments as indicated on the existing signs.

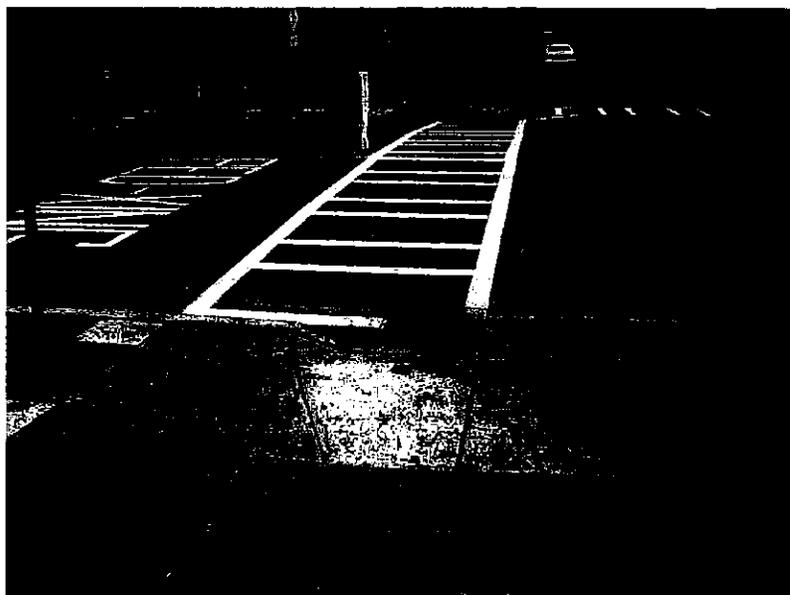
Picture 13 shows the intersection of Oakland and Elmdale, which is near the intersection of Oakland and Kenmore. The depressed curb opening is not in alignment with the painted crosswalk and the storm sewer inlet creates a trip hazard for wheelchairs and pedestrians with adaptive equipment.

Picture 13 – Crosswalk at Oakland & Elmdale

Solution: Reconstruct the depressed curb opening so that it is in alignment with the crosswalk and so pedestrians or wheelchairs do not have to cross over the storm sewer inlet in order to cross the street.

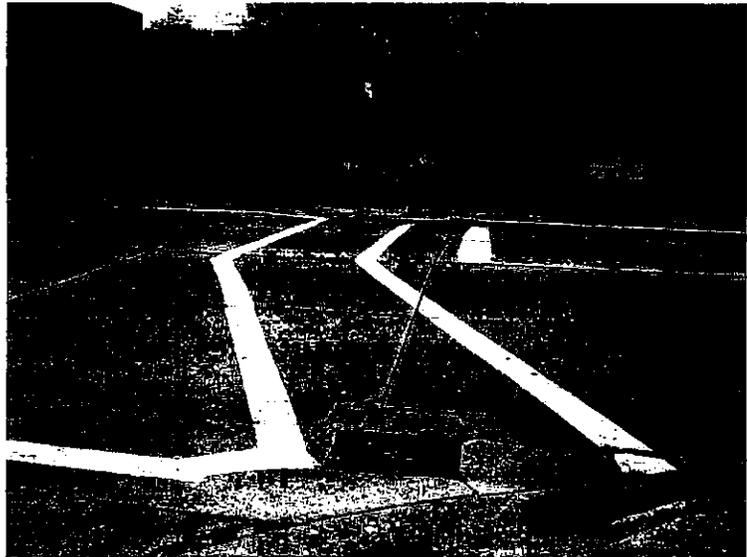
d. The crosswalk across North Oakland Avenue has a “kink” as can be seen in Picture 14. This is a safety concern because visually impaired pedestrians may not realize the crosswalk does not continue in a straight line and may walk into opposing lanes of traffic on East Shorewood Boulevard. Additionally, the kinked sidewalk results in a longer crosswalk length which increases the potential for an accident because pedestrians may underestimate the time necessary to cross the road.

Picture 14– “Kinked” Crosswalk @ Oakland & Shorewood Elmdale

Solution: Repaint the crosswalk so that it is in a straight line. The stop bar may then need to be repainted so that it is a minimum of 4' behind the crosswalk.

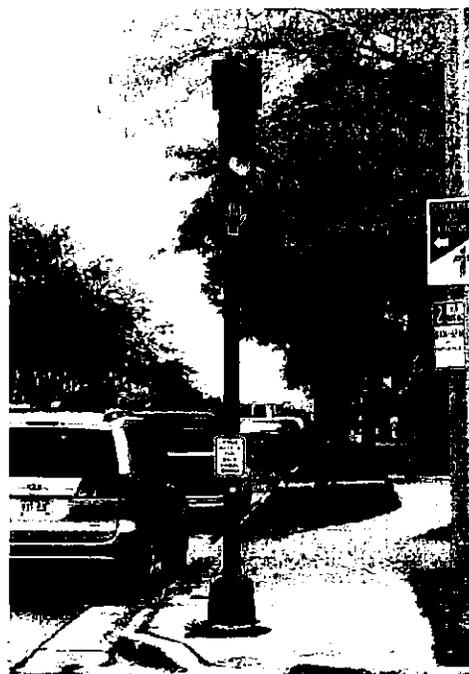
Picture 15 – 8" vs. 12" Signal Heads

Solution: Consider upgrading all traffic signals to 12" LED traffic signals on trombone arms as the budget permits. The cost of replacing existing traffic signal heads with 12" LED signal heads is approximately \$10,000 - \$12,000 per intersection. Further engineering is required to determine the cost of replacing the existing signal posts with trombone arms but the range of cost is likely an additional \$50,000 - \$100,000 per intersection depending upon the amount of signal equipment that could be salvaged. WisDOT may upgrade the traffic signal equipment along Capitol Drive, as described above, when Capitol Drive is improved.
