Village of Shorewood

Village Hall and Public Works Department
Facilities Condition Assessment

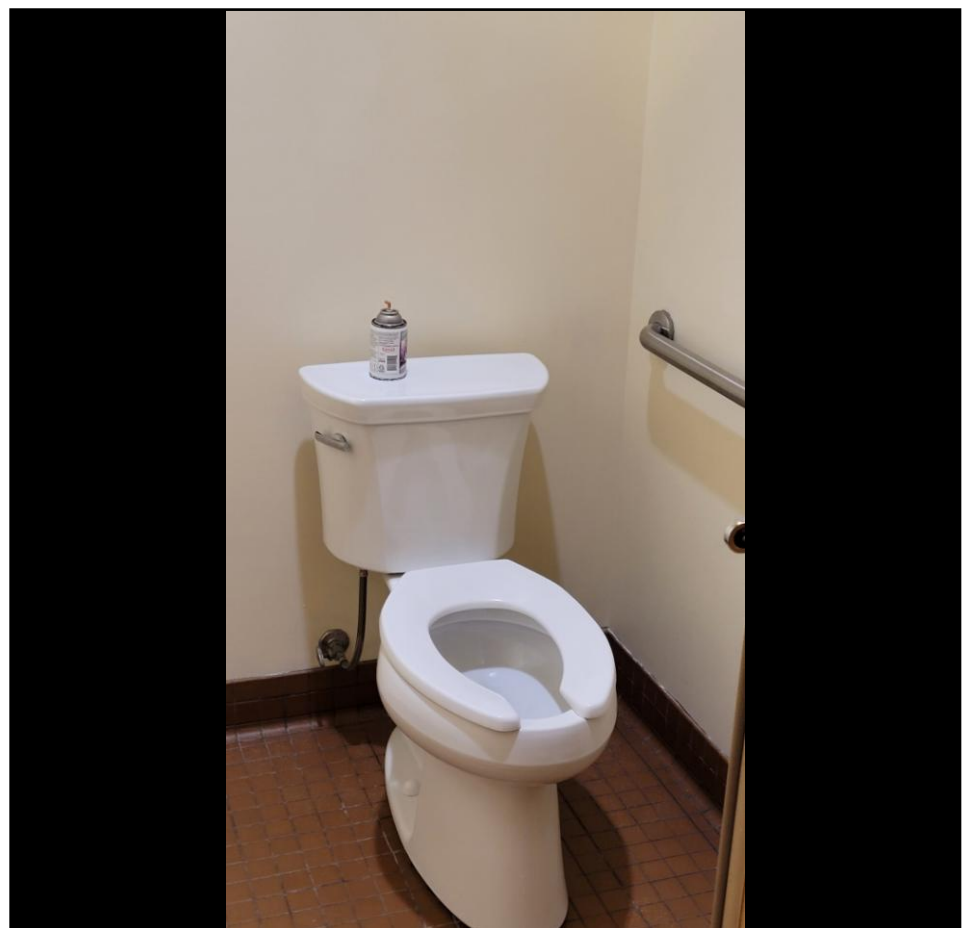
50

ADA requirements

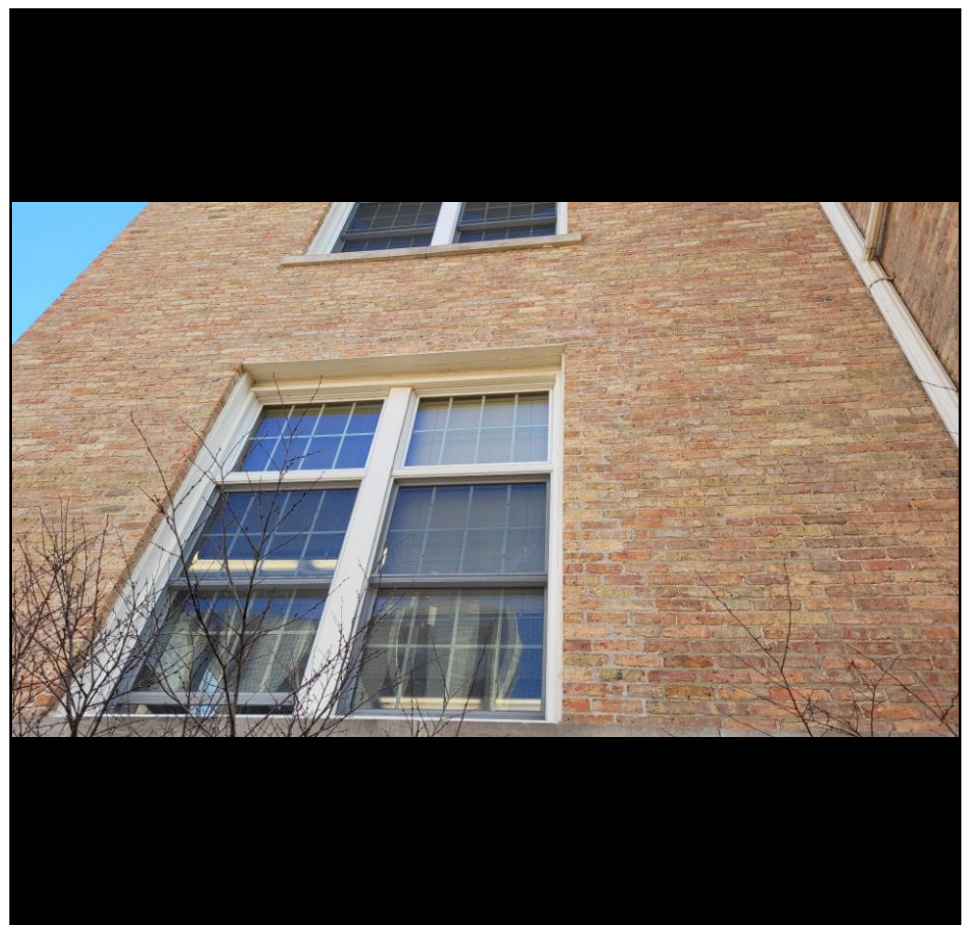
58

Exterior Windows

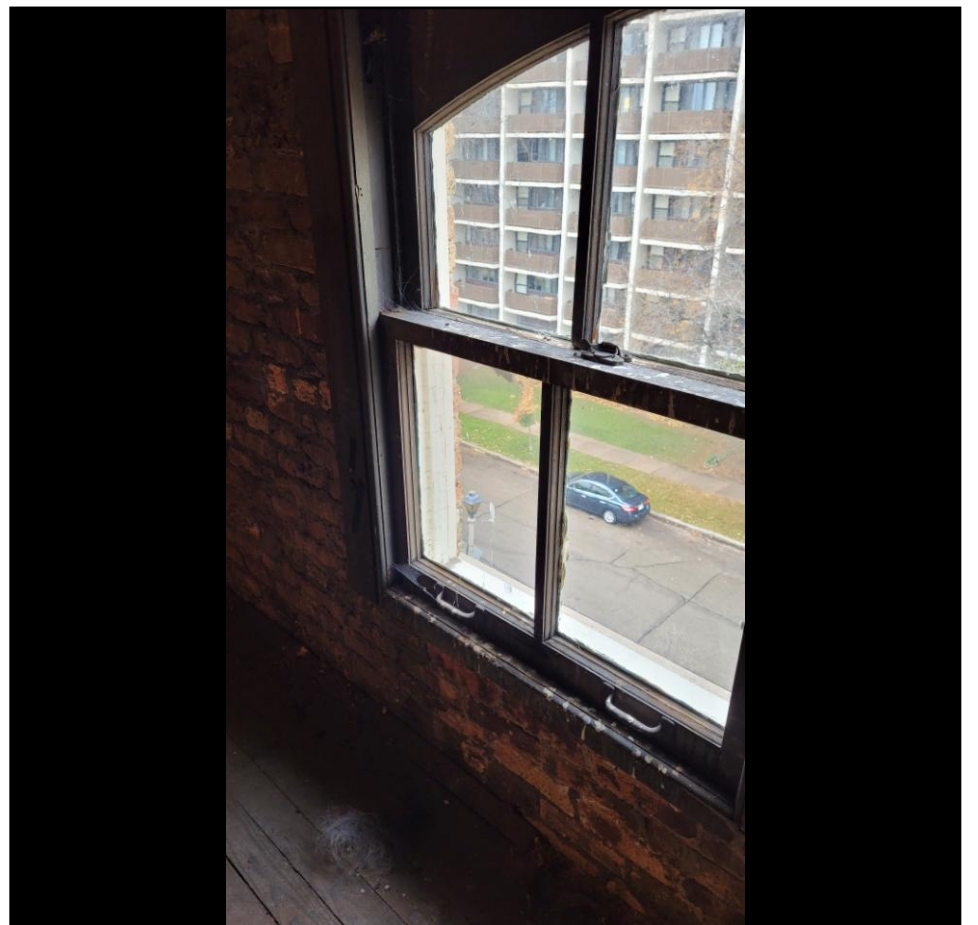
61

Exterior Windows

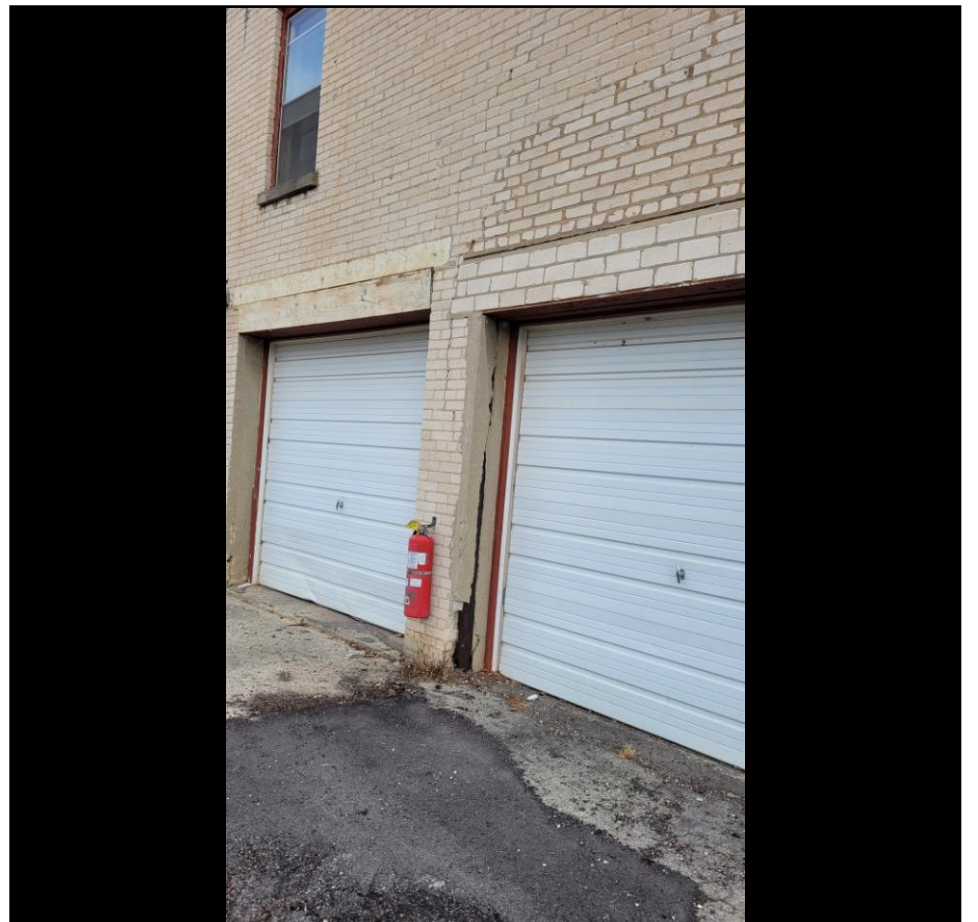
65

Exterior Doors

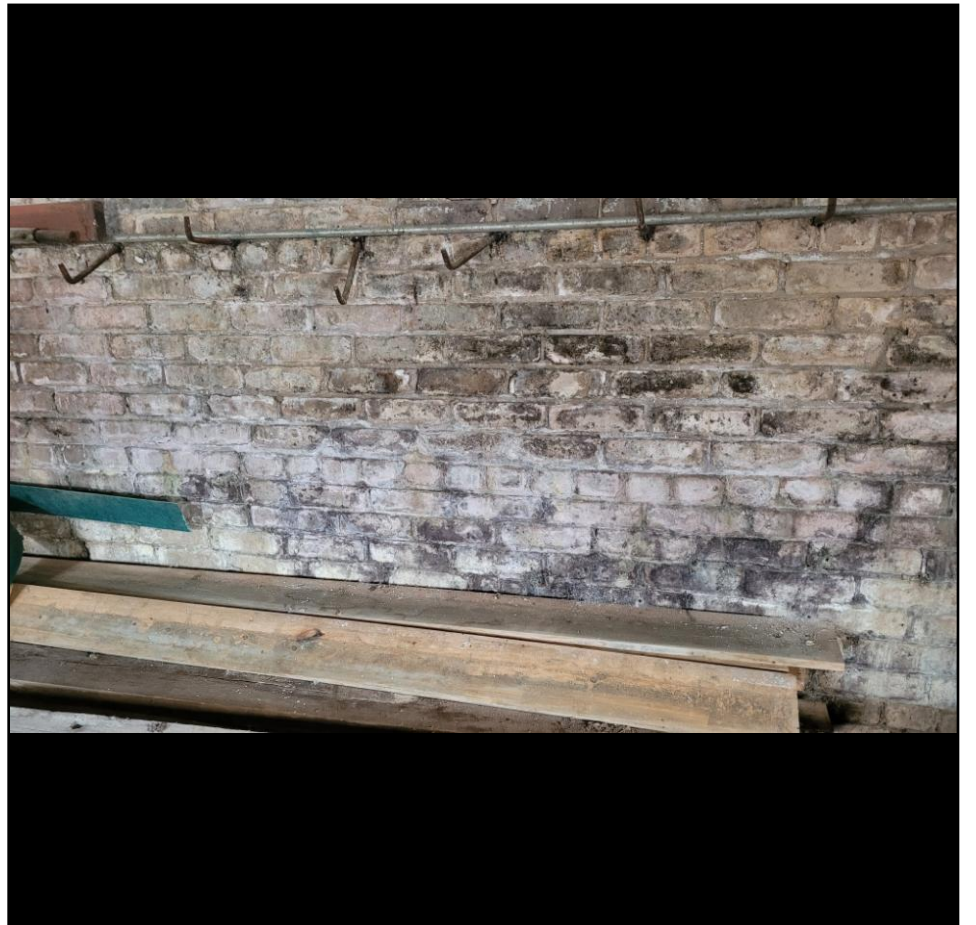
59

Foundation

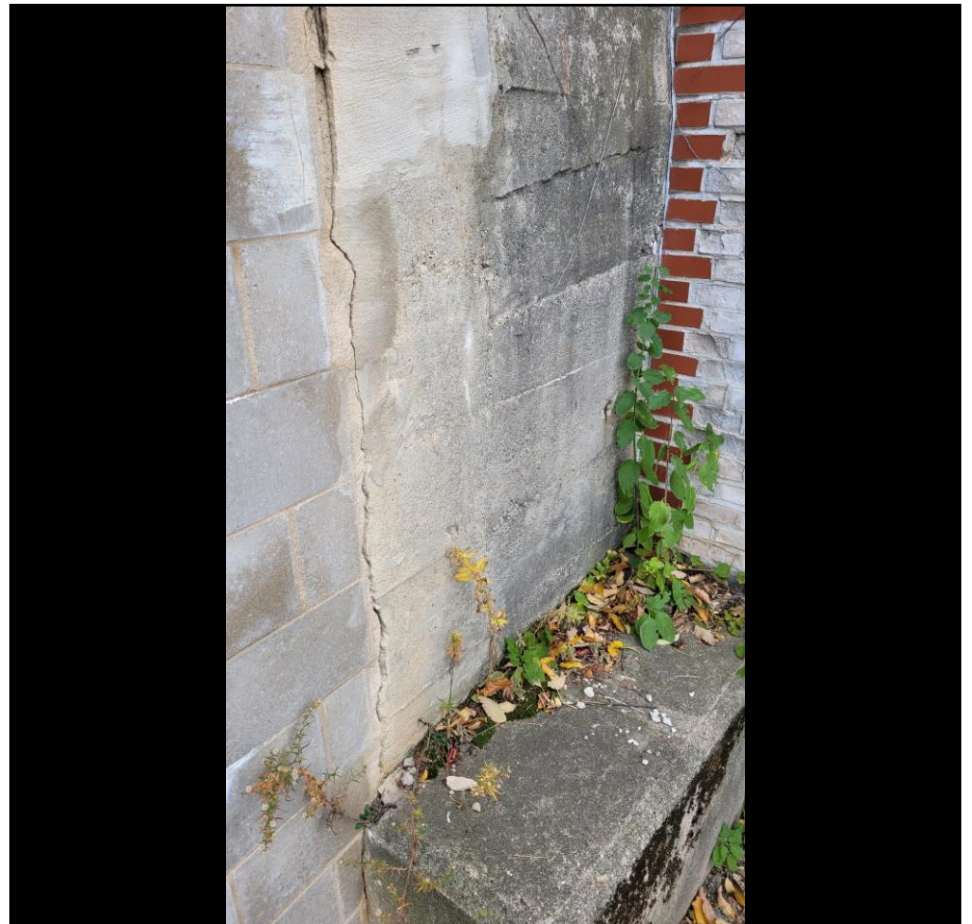
58

Foundation

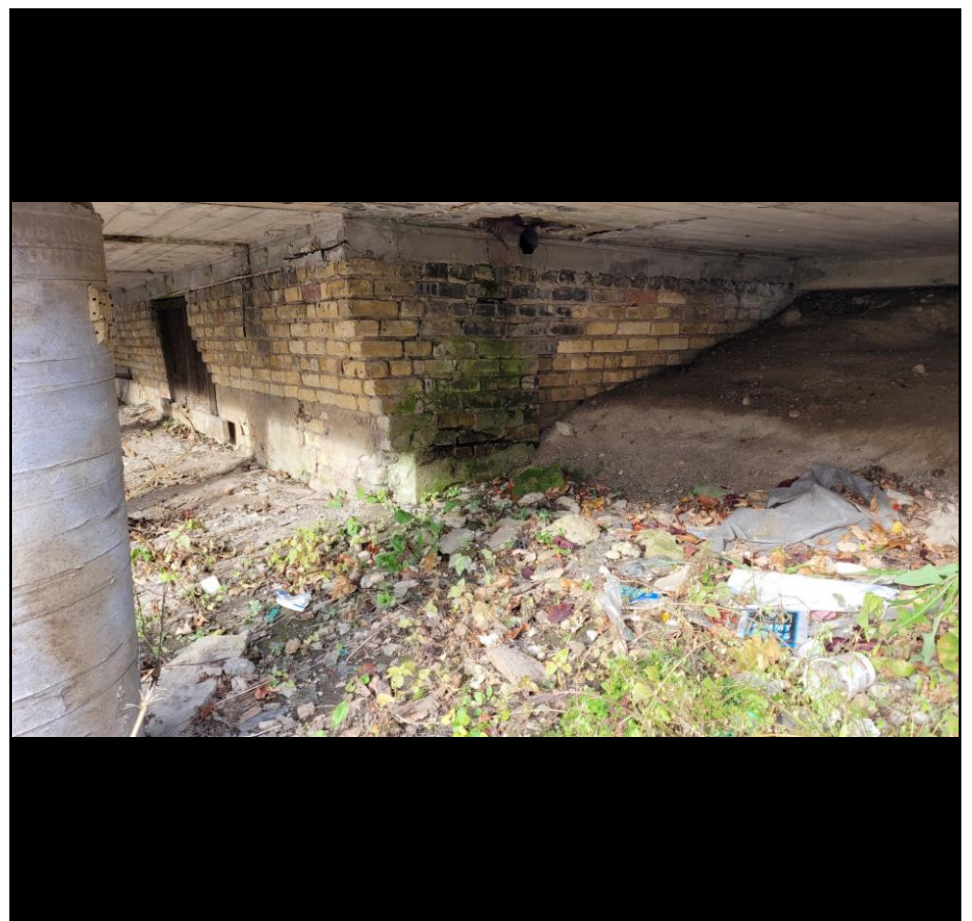
60

Foundation

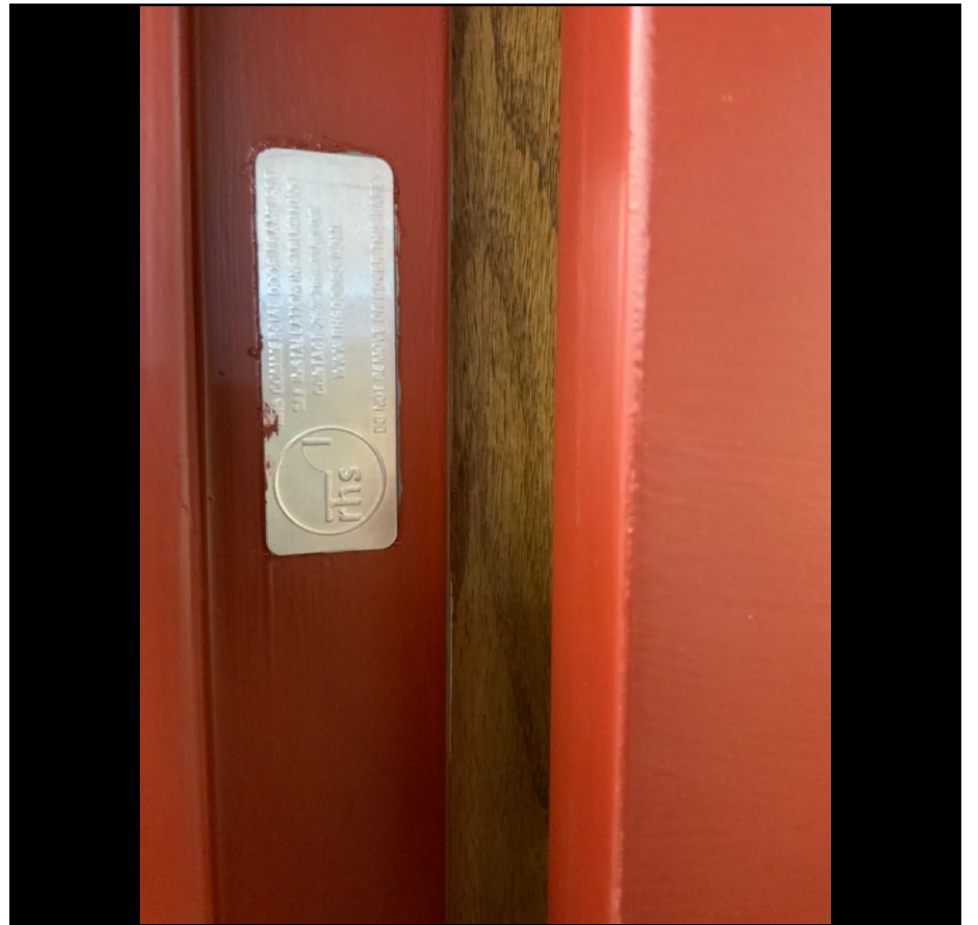
5

Doors

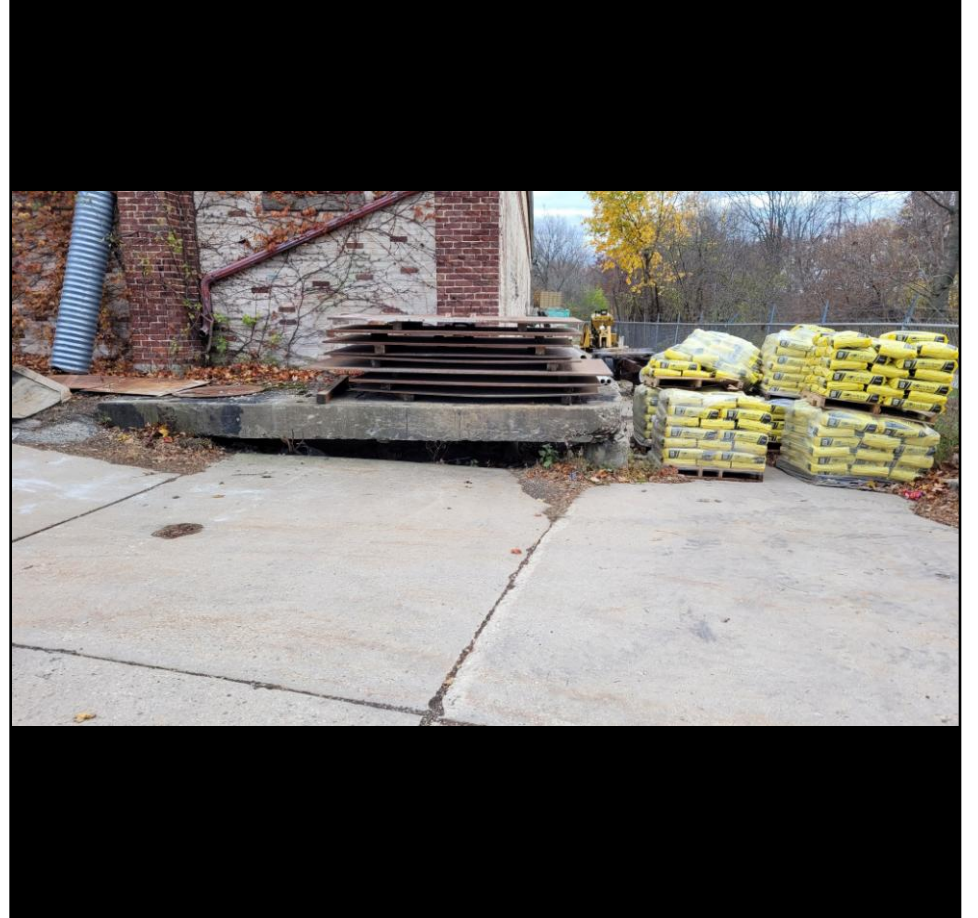
67

Foundation

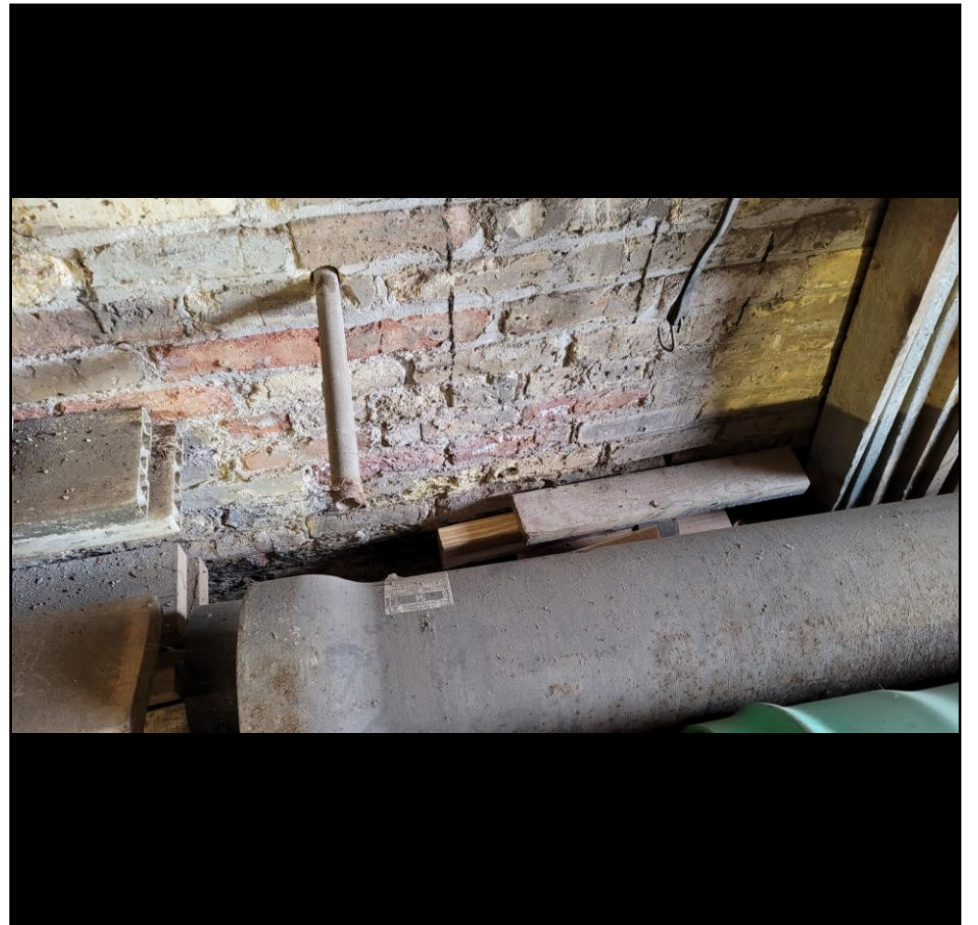
33

Foundation

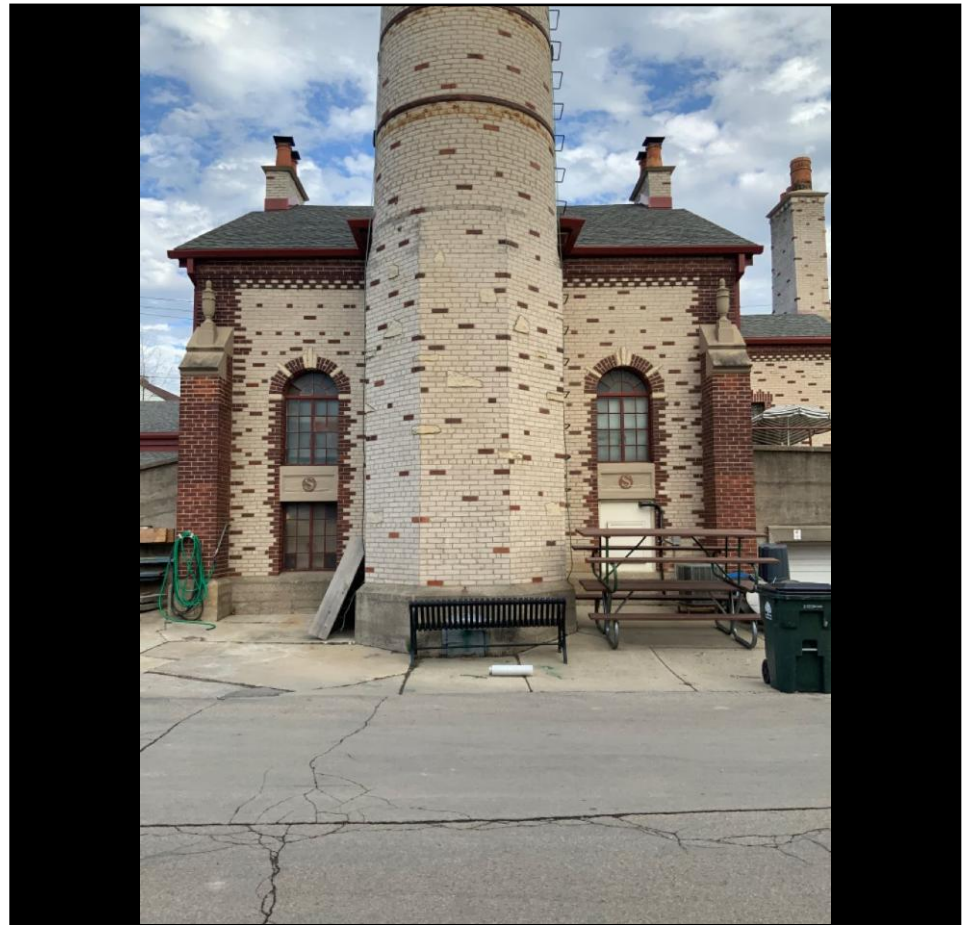
Walls
36

46	Walls	Priority 3	Category 3	Spalling on Brick Walls	\$2,000

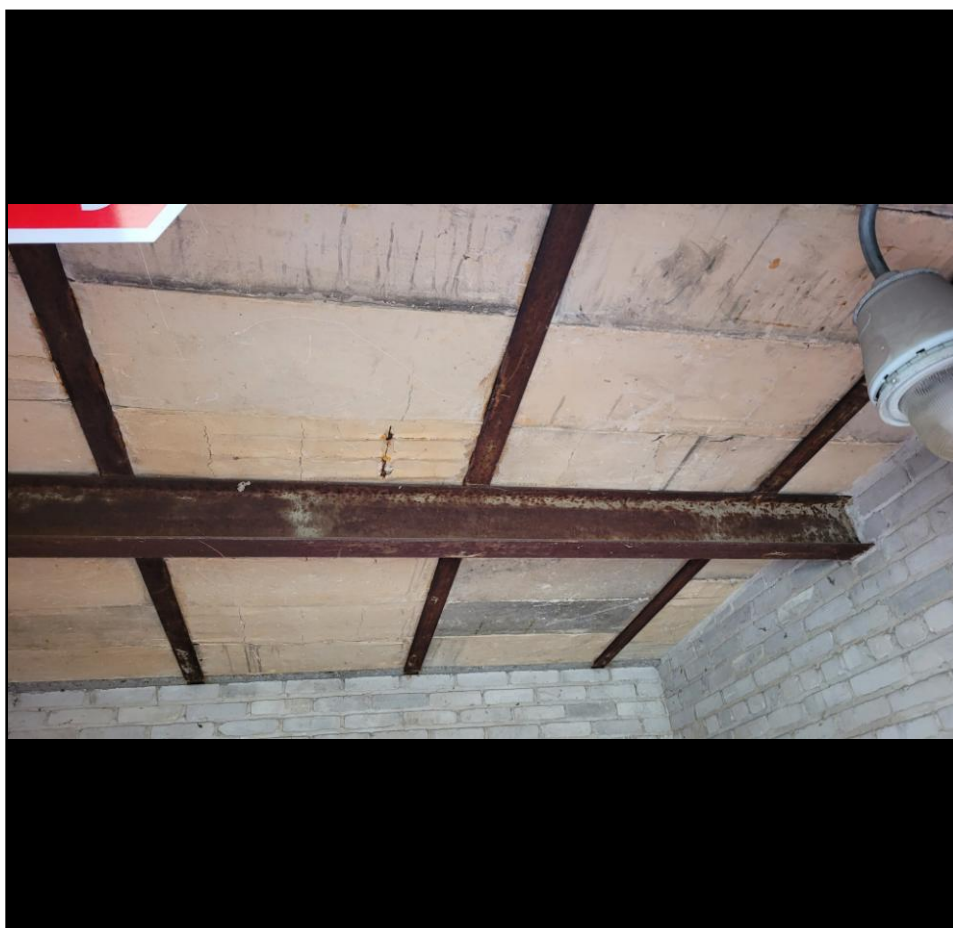
40

Foundation
