Re: Department of Public Works (DPW) Warehouse Building Condition Assessment  
Village of Shorewood, Wisconsin

Department of Public Works Warehouse Building  
Condition Assessment

January 2025

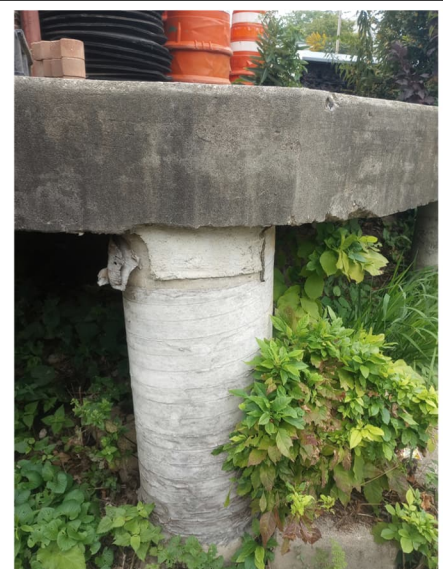
**Figure 13 Current Circular Concrete Piers at West Shipping Platform**

The 1936 drawings indicate the west edge of the shipping platform was to be supported on 10- by 12-inch rectangular piers, as shown on Figure 12. However, it was observed on-site that the west edge of this platform is currently supported on approximately 12-inch-diameter concrete piers, as shown on Figure 13. This indicates the original support piers in these locations were likely replaced with circular concrete piers at some time in the past.

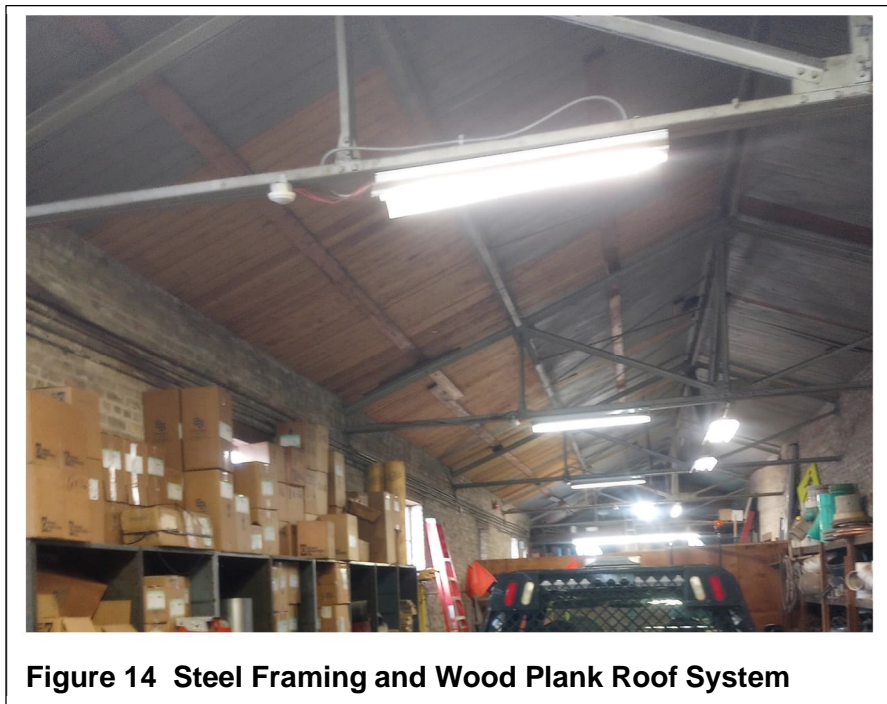
**Figure 14 Steel Framing and Wood Plank Roof System**

The roof framing system was observed from the floor level inside the building. The following observations are considered general in nature as in-depth inspections (including the use of aerial lifts to provide detailed observations) were not included. The steel roof trusses and steel joists generally appear to be in fair condition, with localized areas of corrosion visible on the steel. Significant portions of the original wood planking roof system have been replaced since original construction, as shown in Figure 14. The current system appears to be in fair condition. It is recommended that localized corrosion present on areas of the steel framing systems be prepared and recoated with an epoxy paint system to prevent further corrosion and deterioration. The wood plank roof system should continue to be monitored and routine maintenance and deteriorated wood replacement be performed.

The Village has indicated that the existing asphalt shingle roofing system is approximately 20 to 30 years old. The asphalt shingle roof is at the end of its useful life and should be replaced.

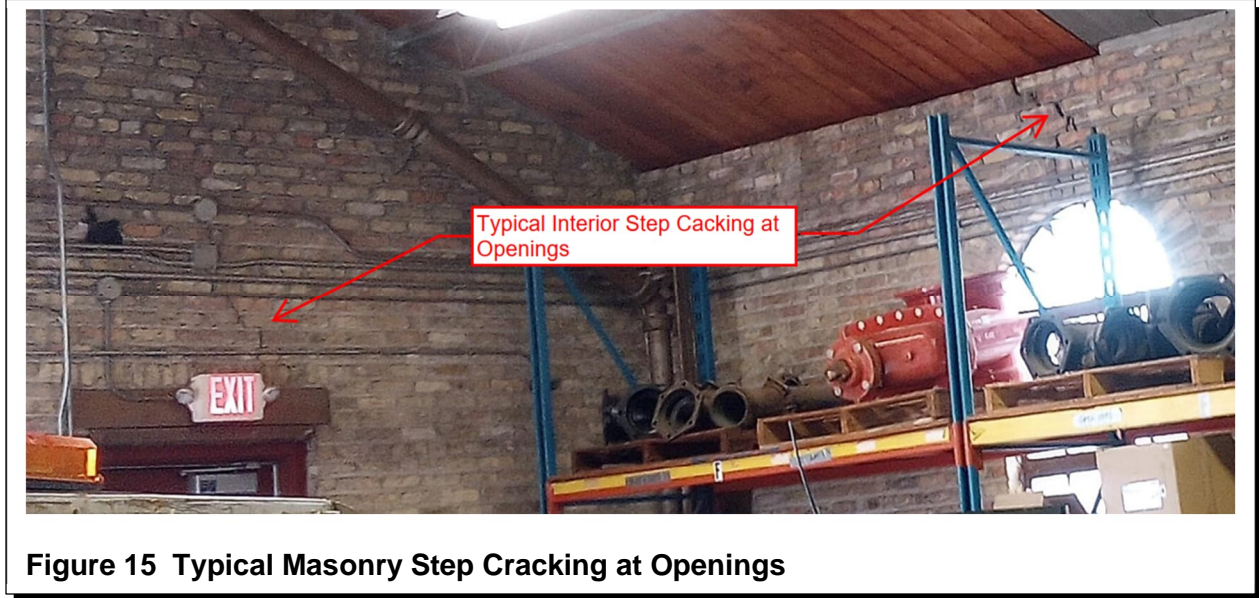
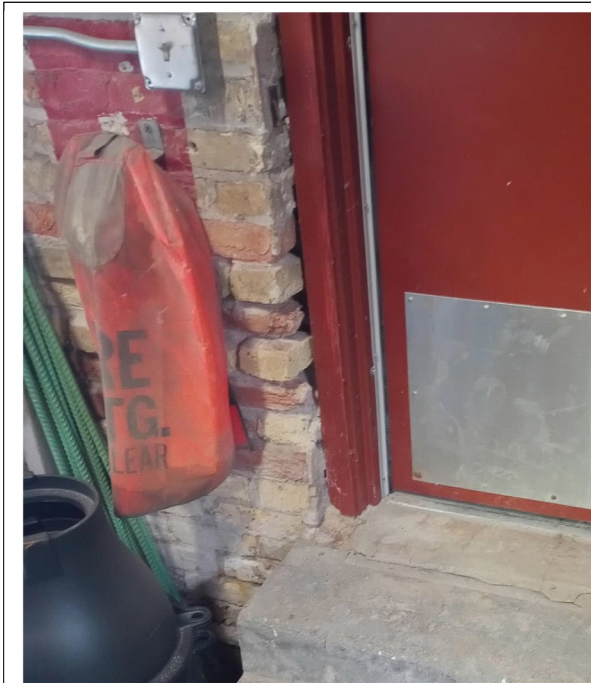
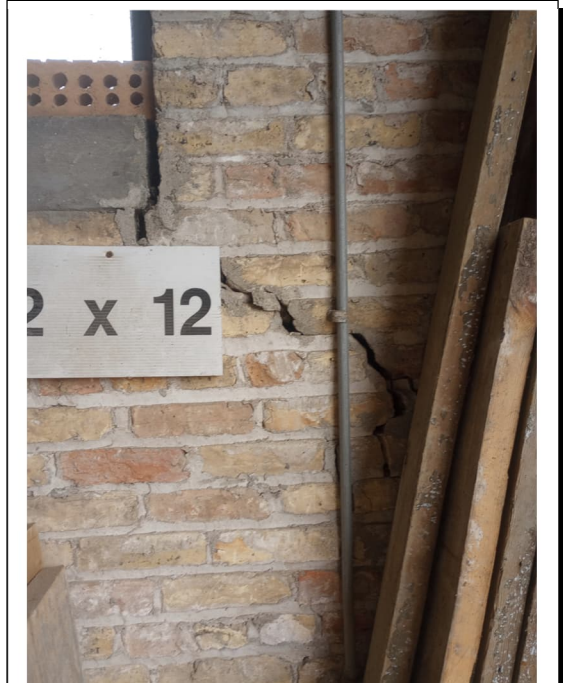
Interior brick walls are generally in fair condition with select areas in poor condition. There are areas of step cracking at openings and mortar bed deterioration at doors, as shown on Figures 15 and 16. There is significant wall cracking at the northeast corner of the building, as shown on Figure 17. This damage appears to have been caused by settlement of the foundation system in this corner of the building, and previous repairs to the walls and lintels over the door openings were observed. It is unclear whether the settlement is continuing or if it has stopped. See the Overall Site and General Observations subsection for additional commentary regarding this area of the building.

It is recommended the interior portions of the masonry walls be tuckpointed to repair all cracks and deteriorated mortar joints. Additionally, it is recommended the northeast corner of the building have crack gauges installed to monitor whether or not the building is still settling or moving in this corner.

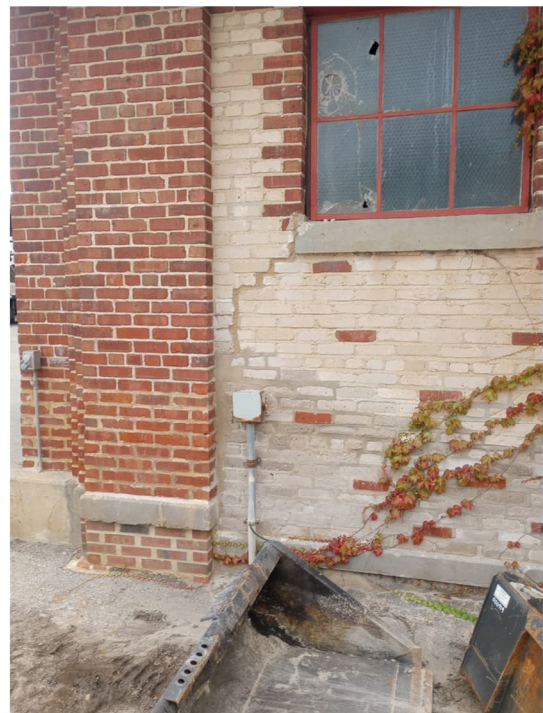
**Figure 18 Previous Exterior Repairs at Northeast Building Corner**

The exterior brick walls are generally in fair condition with select areas in poor condition. As previously noted, the northeast corner of the building has undergone settlement and has previously been repaired, as shown on Figure 18. However, portions of the repairs were completed using caulk, which is an inappropriate repair material and method for masonry. Original door and window openings located on the west side of the building have previously been infilled with masonry. Additionally, portions of the west wall have undergone significant deterioration of the brick and mortar joints, as show on Figure 19.

It is recommended the exterior portions of the masonry walls be tuckpointed to repair all cracks and deteriorated mortar joints. Additionally, deteriorated and broken brick should be removed and replaced with new brick throughout. All previous repairs that were completed using caulking materials should have caulk removed and the joints repaired with mortar materials.

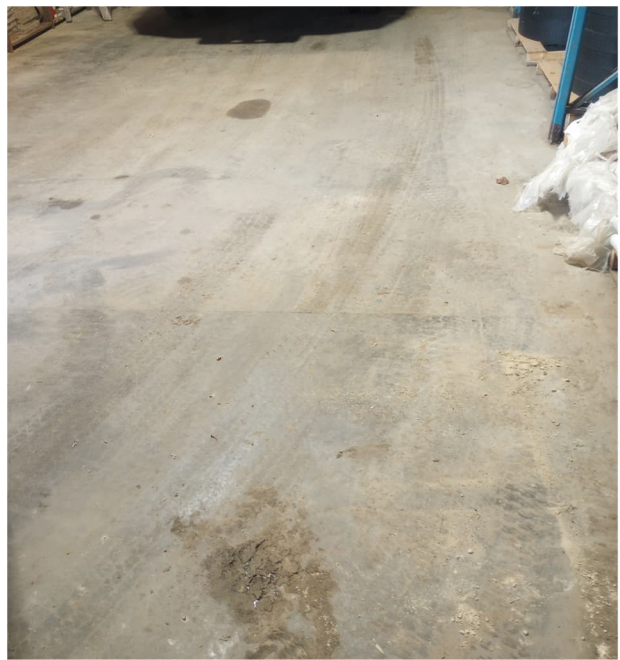
**Figure 20** Typical Interior Concrete Slab in Main East-West Portion of the Building

The interior concrete slab located along the main east-west long axis of the building is in fair condition with minor hairline cracking, as show on Figure 20. This type of cracking is typical of concrete construction and does not represent a significant structural concern. The interior concrete slab located in the northeast extension of the building is in poor condition, as show on Figure 21. It is recommended that this area of the interior slab have concrete repair work performed to restore the concrete. While this area of the interior concrete slab was originally designed as an elevated slab with a void space below according to the original 1936 drawings, it is unclear whether this area has been replaced in the past with a concrete slab on grade over fill materials. Additional investigation will be required, such as concrete coring, in order to determine the existing construction conditions and appropriate repair methods developed.

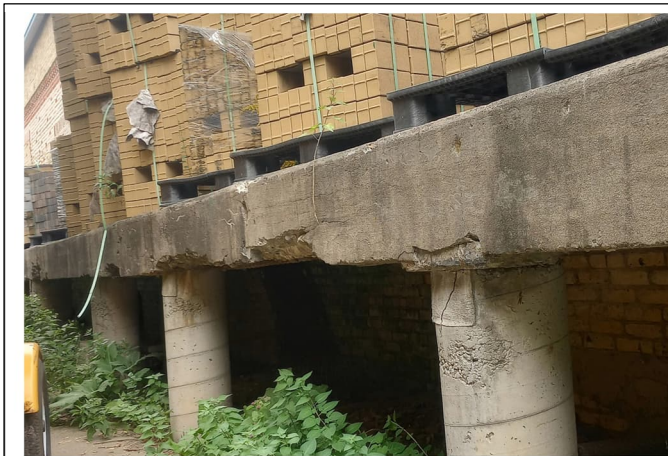
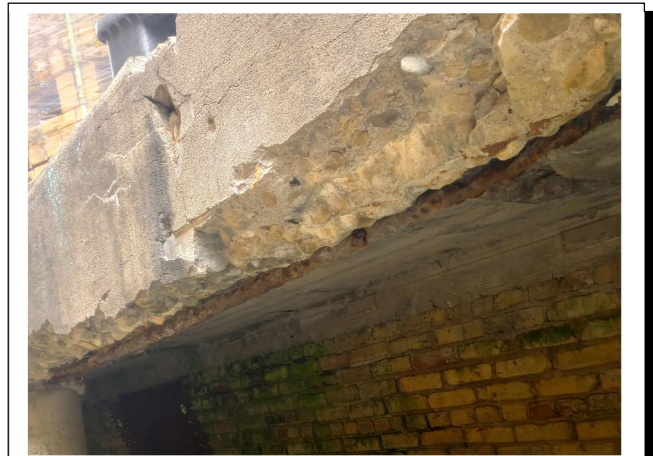
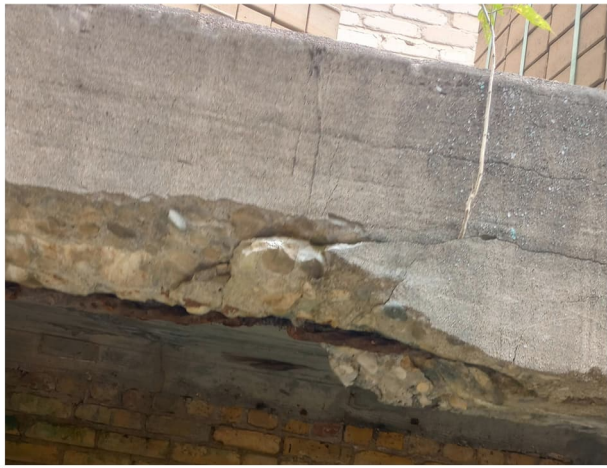
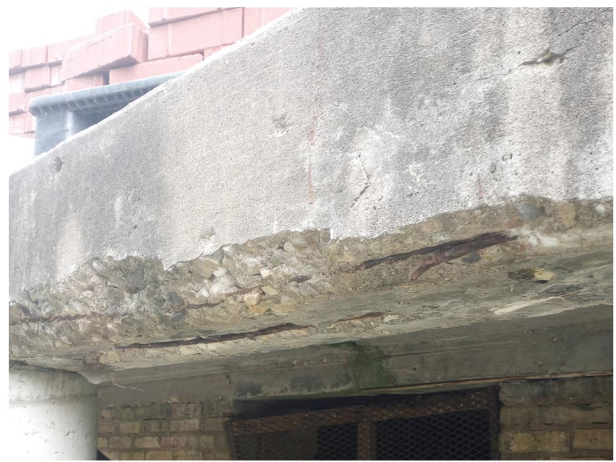
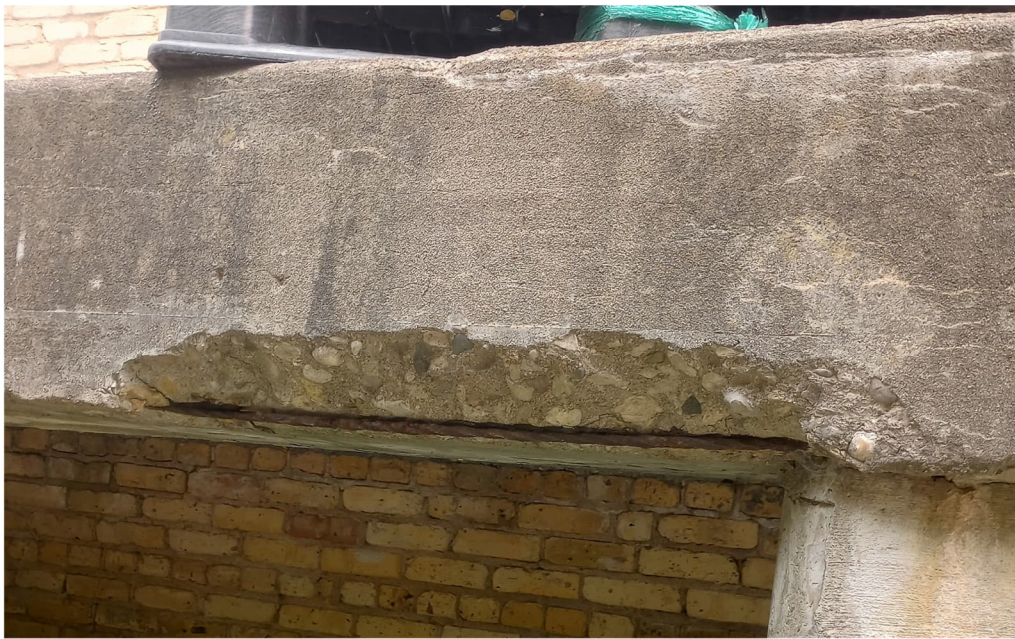
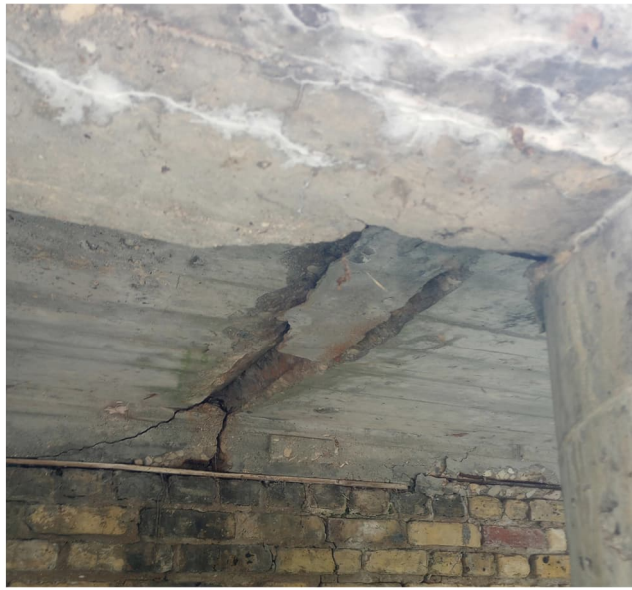
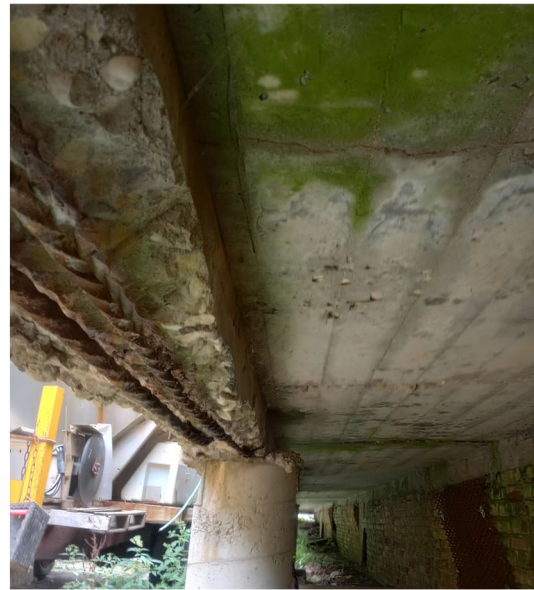
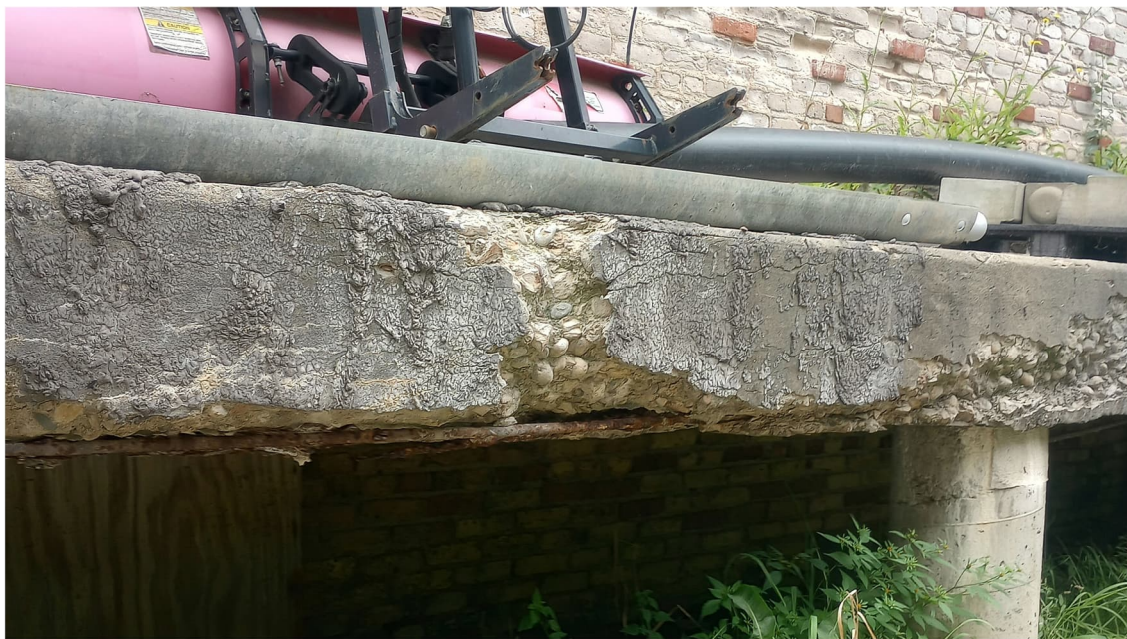
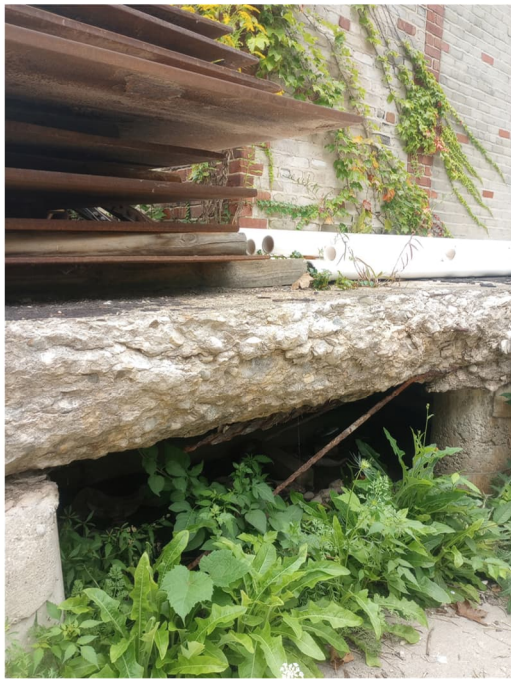
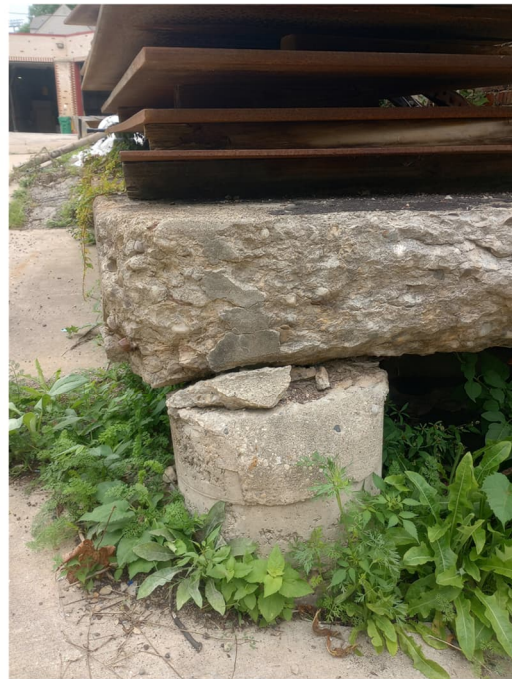
The exterior concrete platform is in poor condition and requires significant concrete and reinforcing repairs. The concrete has undergone significant cracking, spalling, delamination, and deterioration. The steel reinforcing bars that were embedded in the concrete during original construction have become exposed in numerous locations, have experienced significant corrosion, and have completely corroded away in some locations. See Figures 22 through 31 for typical deterioration of these areas.

It is recommended that all loose and delaminated concrete be removed down to sound concrete. Existing exposed steel reinforcing bars that are still intact should be cleaned and prepared for embedment in newly placed concrete repair materials. Where reinforcing bars have completely corroded away, they should be replaced with new reinforcing bars doweled into existing sound concrete with epoxy adhesive or mechanically spliced onto the ends of existing reinforcing. All reinforcing steel should then be embedded in new concrete repair materials installed throughout the platform areas on both the top side and underside. The intention of repair work is to restore the platform to its original construction conditions.

Currently, the Village is using the platform for storage of various materials including pallets of bricks. Due to the compromised nature of the existing platform and concrete and steel reinforcing deterioration that has occurred, it is recommended that the Village remove all storage materials from the platform until repairs are completed.

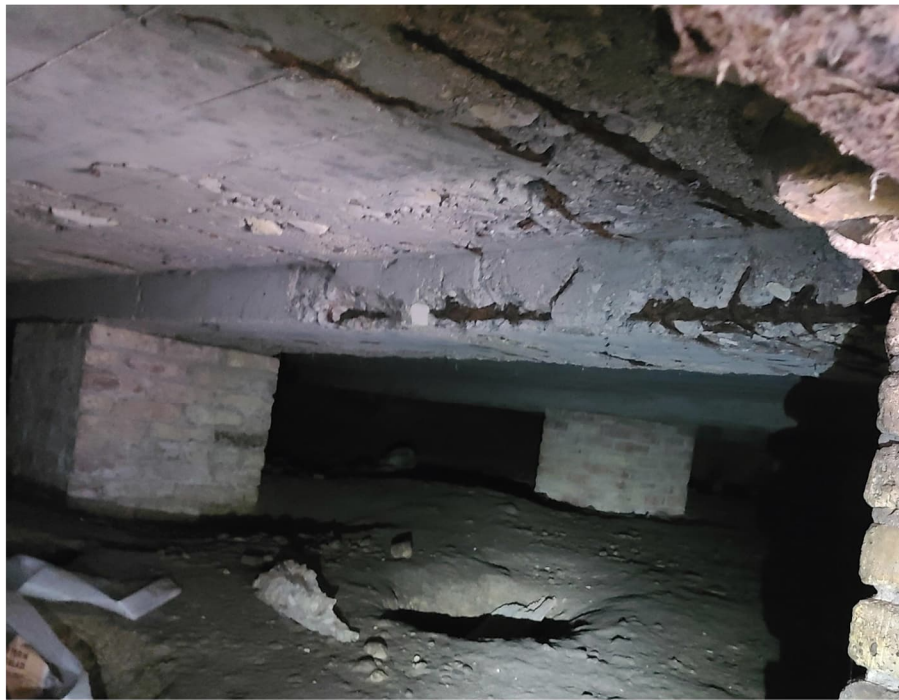
Along the west foundation wall, there are access openings in the brick foundation wall below the platform slab that allow access to the crawl space located below the elevated concrete building slab. The northernmost opening allowed for visual observation of the interior brick foundation piers as well as the underside of the building slab and concrete girders. The underside of these concrete elements were observed to be in poor-to-fair condition. Concrete spalling has occurred, exposing the steel reinforcing bars that were originally embedded in concrete. The exposed reinforcing bars have undergone corrosion. The steel beam lintel that frames the access opening in the brick foundation wall has also experienced significant corrosion. See Figures 32 and 33 for typical deterioration of these areas.

**Figure 32 Concrete Delamination and Reinforcing Bar Corrosion on Underside of Building Slab**

Similar to the concrete platform repairs, it is recommended that all loose and delaminated concrete be removed down to sound concrete. Existing exposed steel reinforcing bars that are still intact should be cleaned and prepared for embedment in newly placed concrete repair materials. Where reinforcing bars have completely corroded away, they should be replaced with new reinforcing bars doweled into existing sound concrete with epoxy adhesive or mechanically spliced onto the ends of existing reinforcing. All reinforcing steel should then be embedded in new concrete repair materials installed throughout the concrete deterioration areas. The intention of repair work is to restore the concrete and steel reinforcing bars to their original construction conditions. The corroded steel beam lintels should be prepared and coated with a new epoxy paint system.

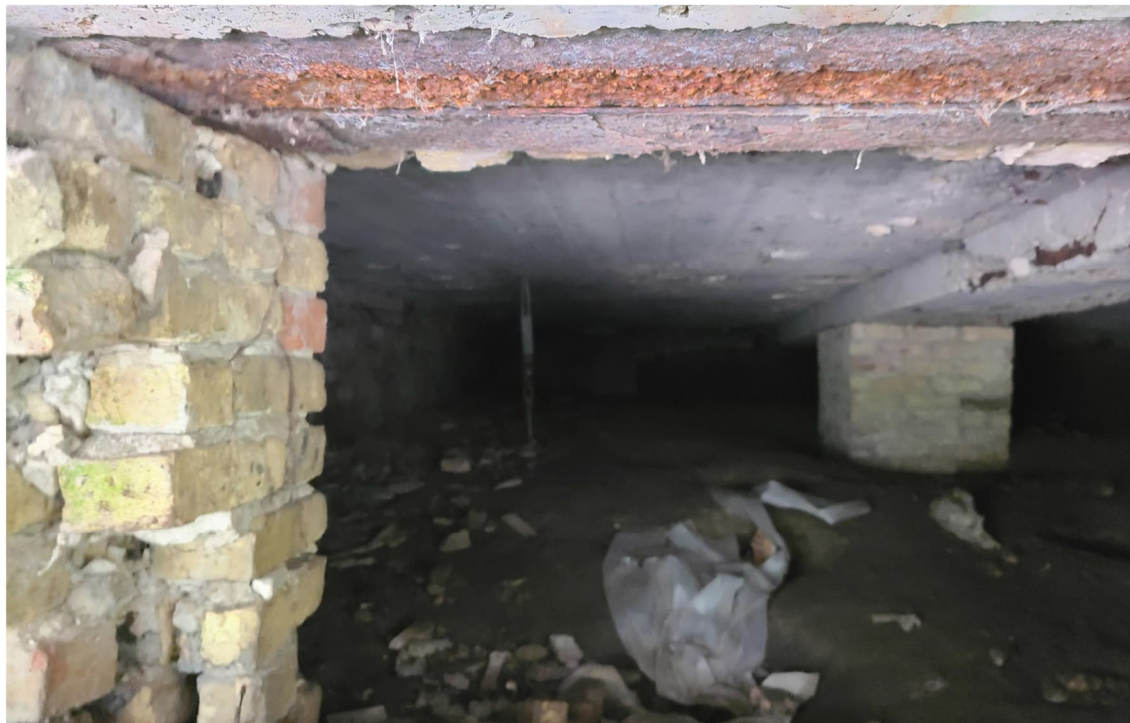
**Figure 33 Corroded Steel Beam Lintel Above Access Opening**

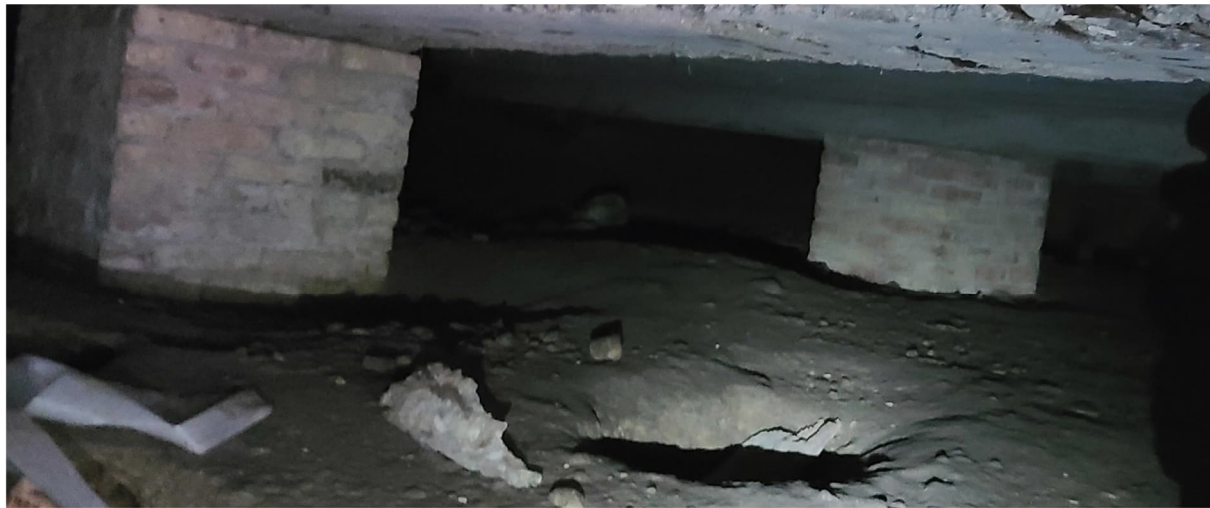
**Figure 34 Brick Pier Foundations Below Interior Building Slab**

The observable brick foundation piers supporting the interior portions of the concrete building slab appear to be in fair condition, as shown on Figure 34. The brick foundation wall along the west side of the building was observable below the platform slab. Approximately 25 percent of this foundation wall is in poor condition with the remaining portions in fair condition, as shown on Figures 35 and 36. It is recommended the brick foundation wall be rebuilt in areas where it has collapsed and the entire wall system undergo tuckpointing to repair masonry joints and all broken or deteriorated brick be replaced.

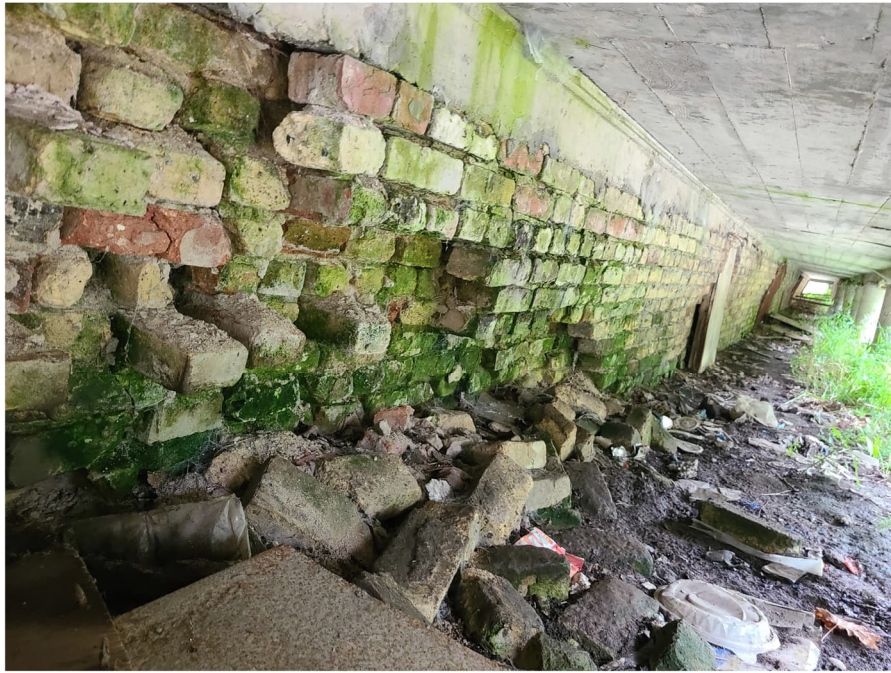
**Figure 35 Collapsed Brick Foundation Wall Along West Wall**

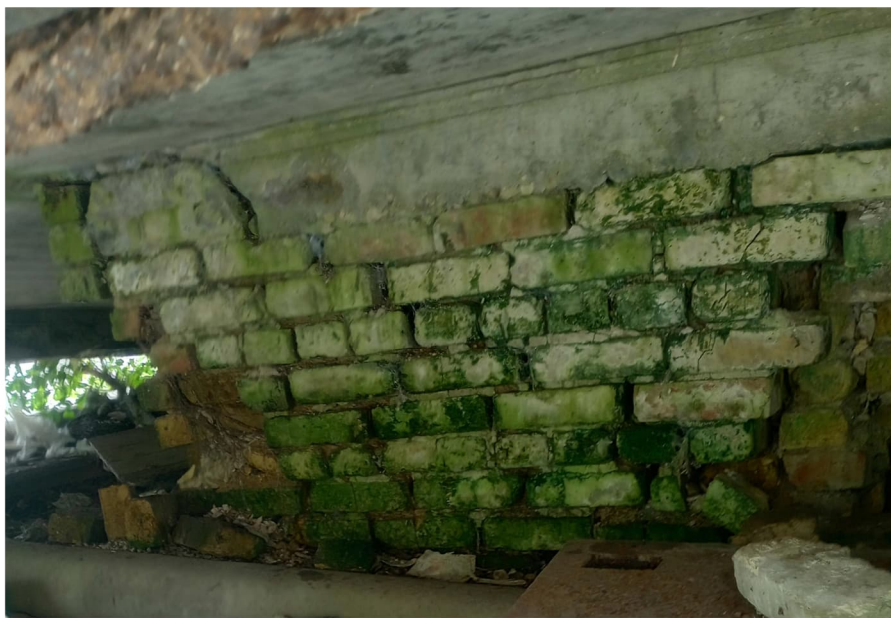
**Figure 36 Collapsed Brick Foundation Wall at Northwest Corner**
