Strand Associates, Inc.[®]
126 North Jefferson Street, Suite 350
Milwaukee, WI 53202
(P) 414.271.0771
www.strand.com

February 18, 2025

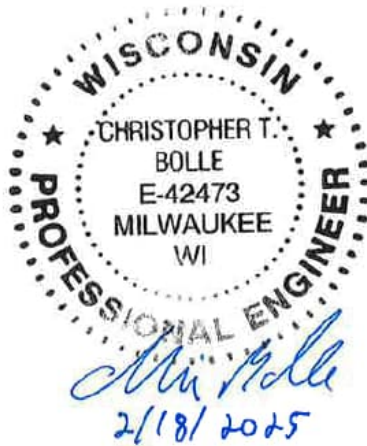
Department of Public Works Warehouse Building Condition Assessment

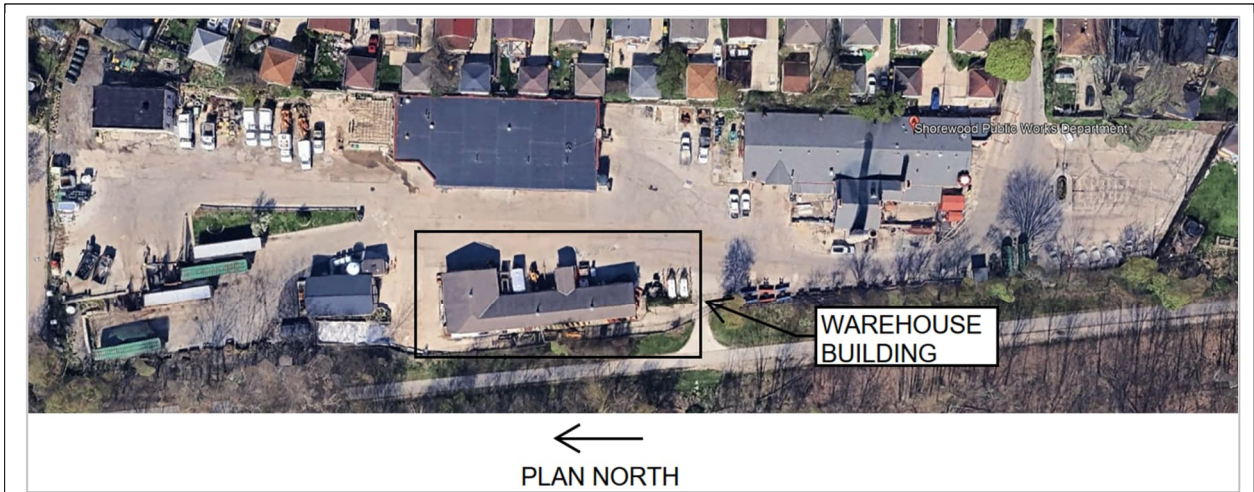
Aerial Source: Google Earth

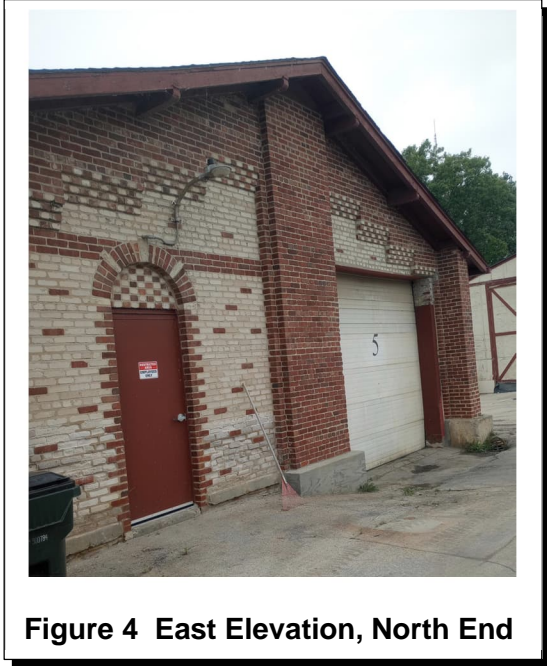
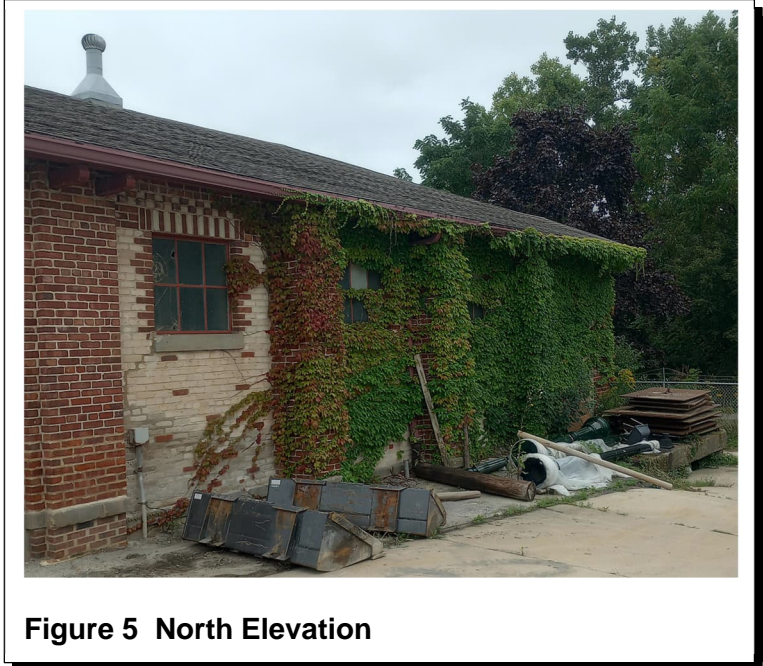
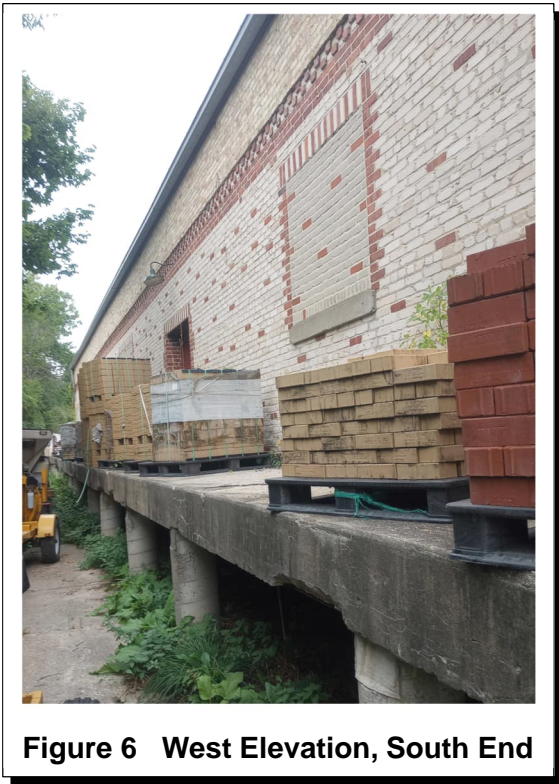
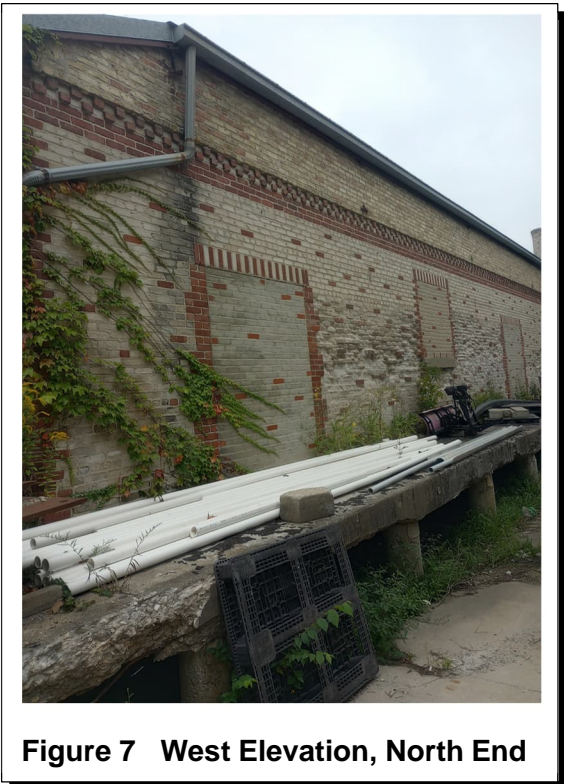
The Warehouse Building includes approximately 4,000 square feet (sf) of single-story, enclosed space and an approximately 700-sf continuous platform located on the west side of the building. The drawings indicate the original use of the interior spaces include storage space, electrical storage, and landscape materials storage. The platform located on the west side of the building is labeled as a shipping platform. The roof framing consists of 2- by 6-inch wood planking on steel purlins. The purlins span between steel trusses. The steel trusses clear span approximately 37 feet and are supported by the perimeter masonry walls.

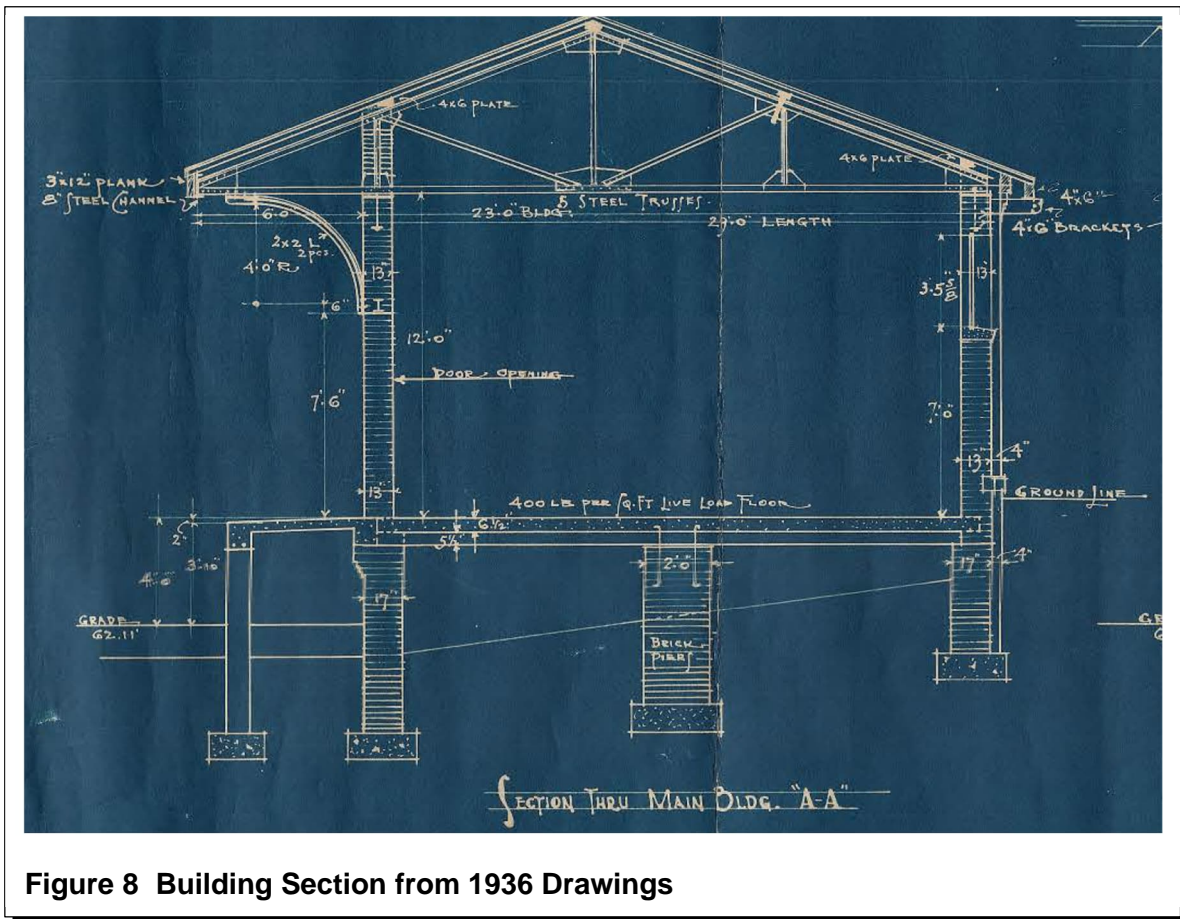
Figure 8 Building Section from 1936 Drawings

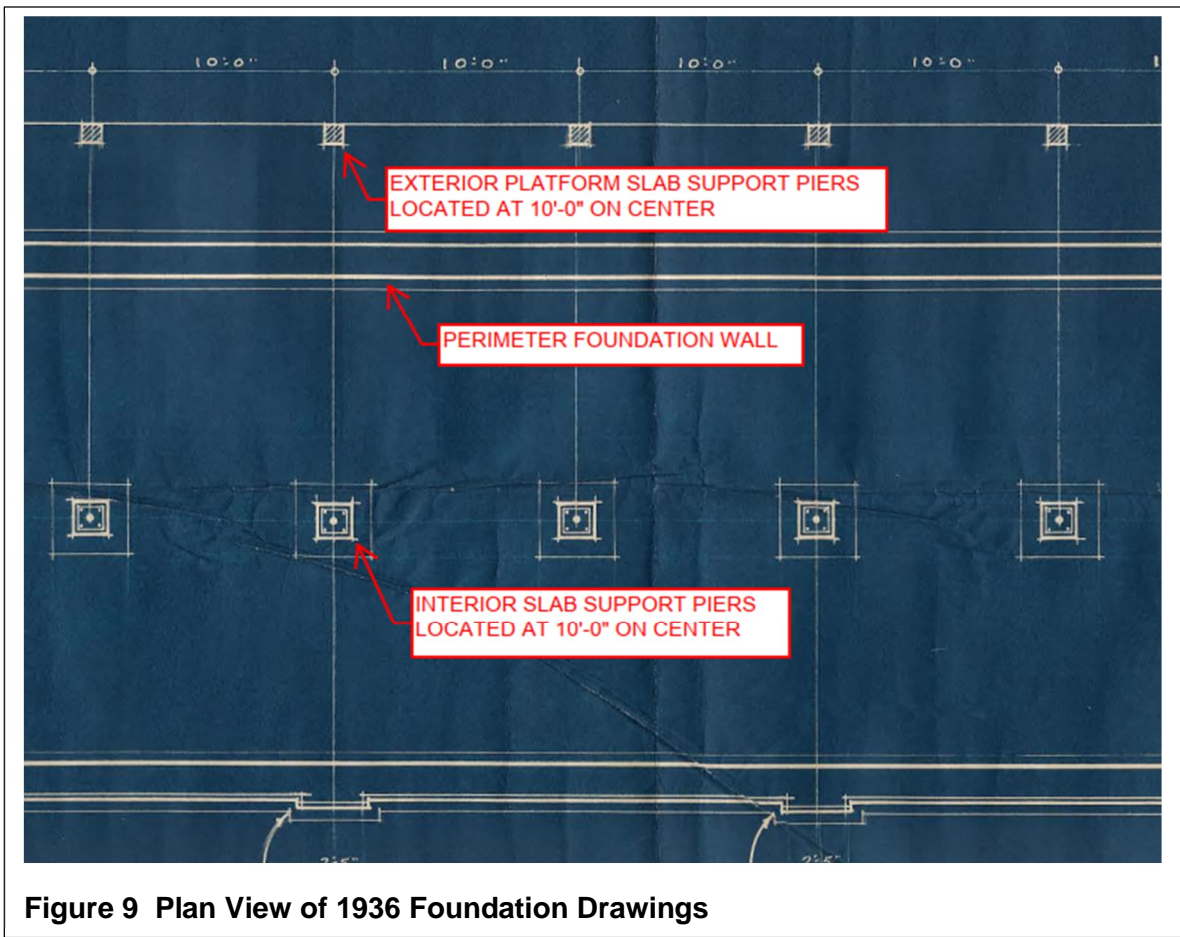
Figure 9 Plan View of 1936 Foundation Drawings

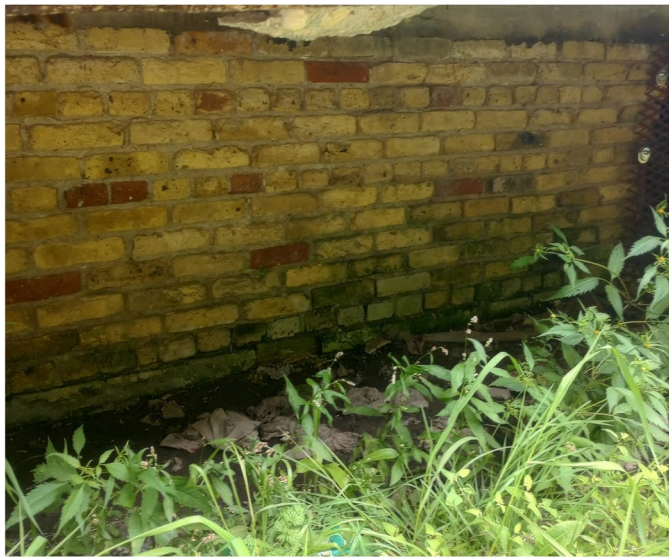
Figure 10 Typical Brick Perimeter Foundation Wall

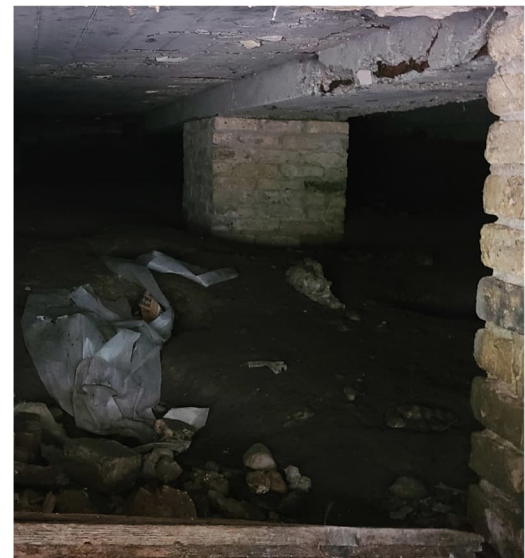
Figure 11 Typical Brick Interior Slab Support Pier

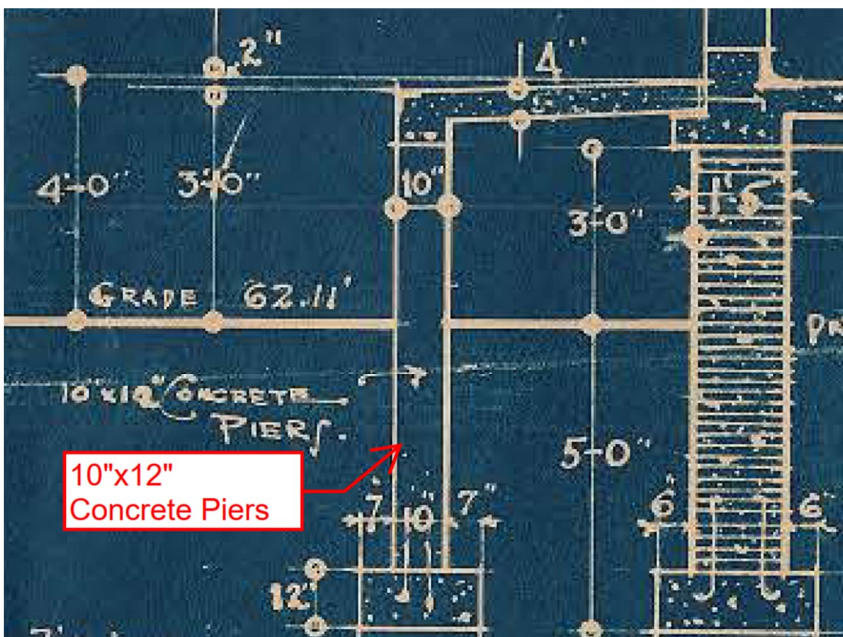
Figure 12 Section View of West Shipping Platform Piers on 1936 Drawings

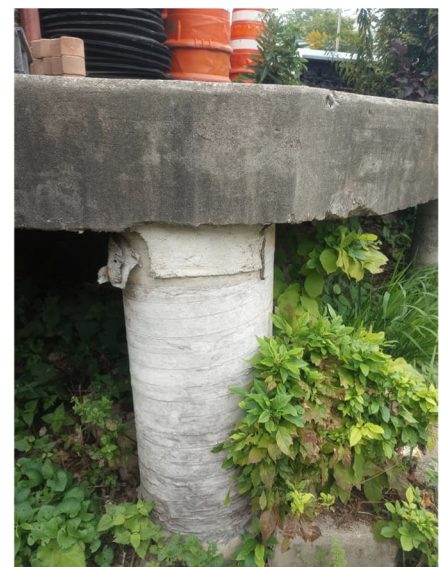
Figure 13 Current Circular Concrete Piers at West Shipping Platform

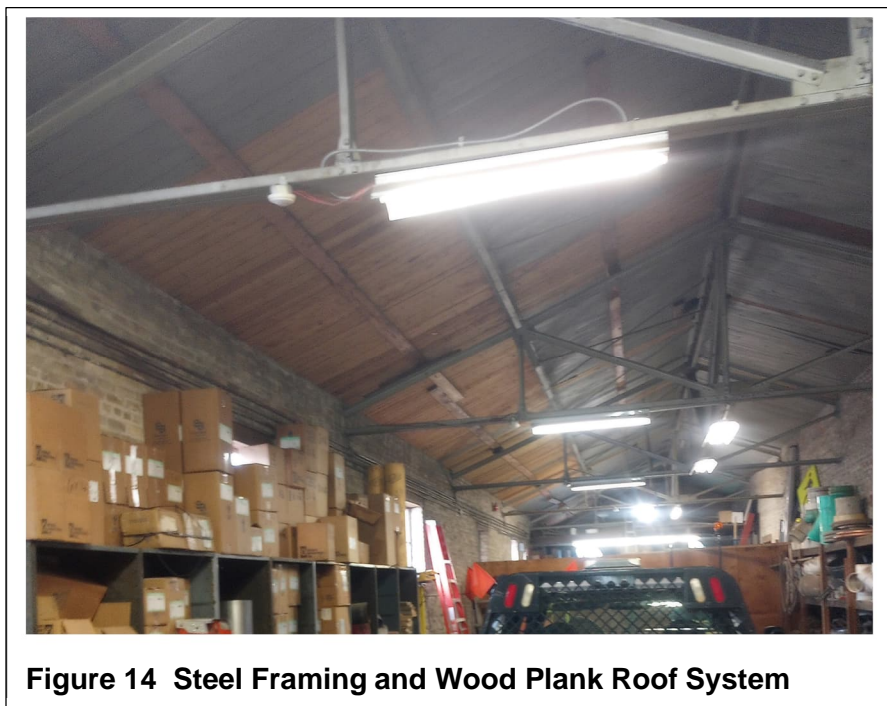
Figure 14 Steel Framing and Wood Plank Roof System

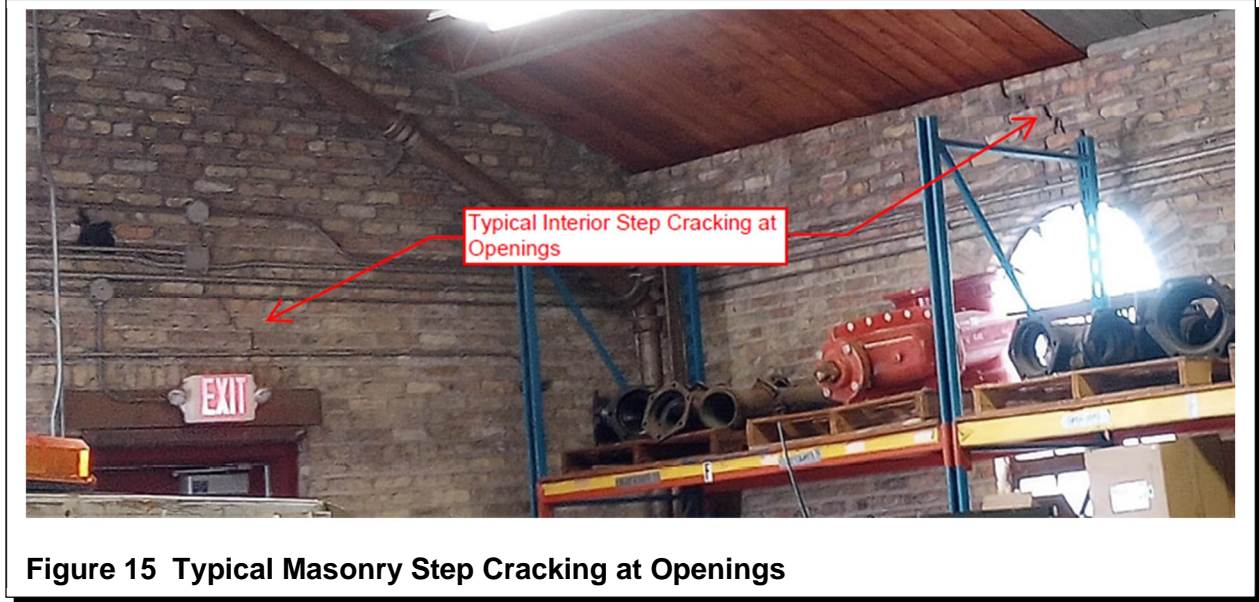
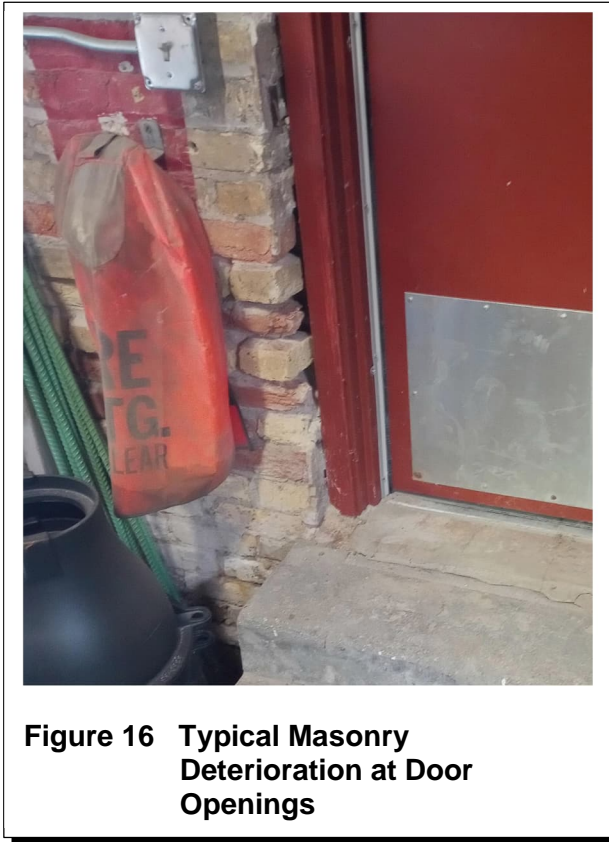
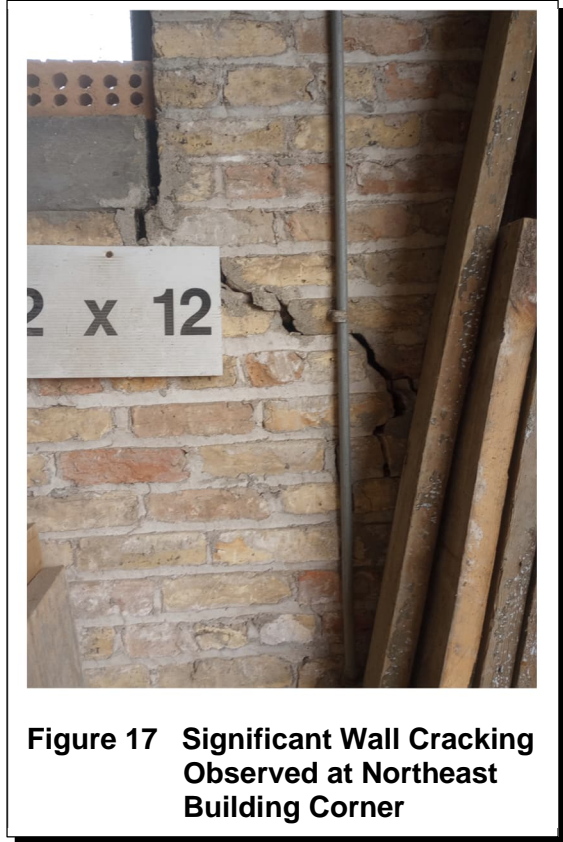
The exterior brick walls are generally in fair condition with select areas in poor condition. As previously noted, the northeast corner of the building has undergone settlement and has previously been repaired, as shown on Figure 18. However, portions of the repairs were completed using caulk, which is an inappropriate repair material and method for masonry. Original door and window openings located on the west side of the building have previously been infilled with masonry. Additionally, portions of the west wall have undergone significant deterioration of the brick and mortar joints, as show on Figure 19.

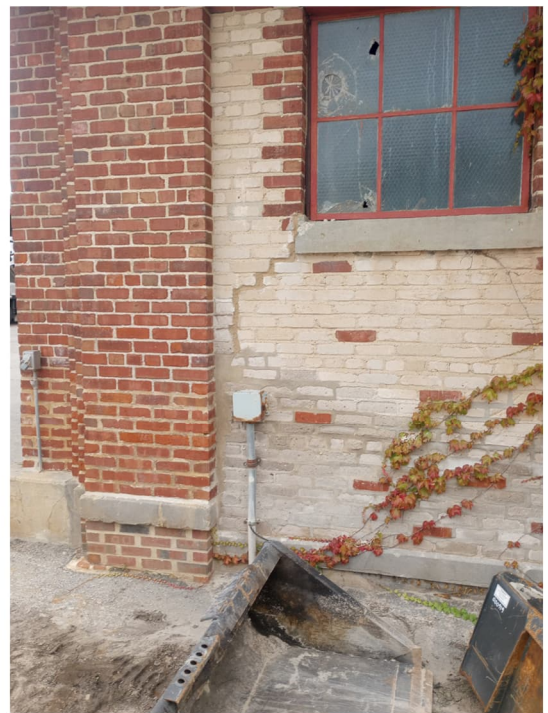
Figure 18 Previous Exterior Repairs at Northeast Building Corner

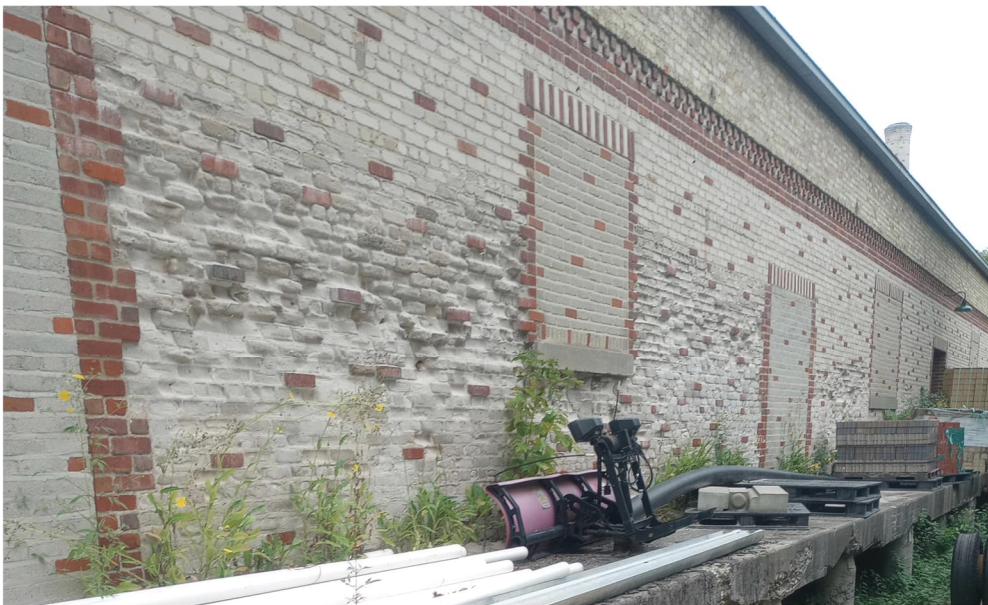
Figure 19 West Wall: Original Openings Infilled with Masonry and Significant Deterioration of Brick and Mortar Joints

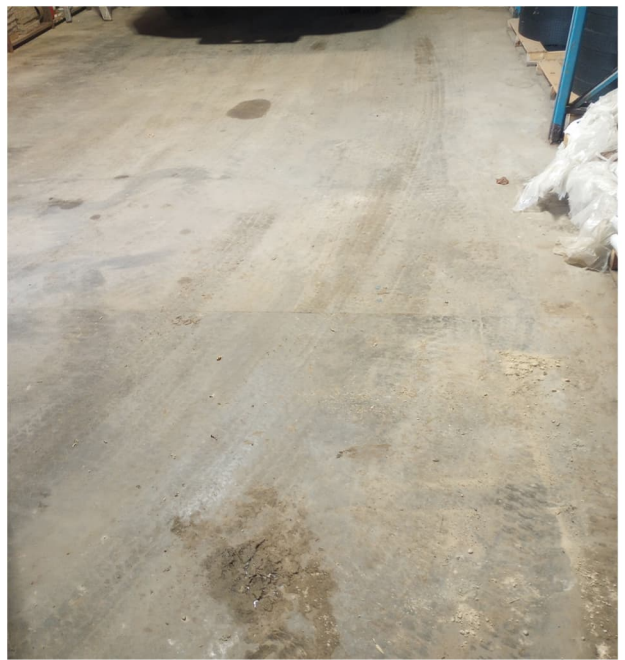
Figure 20 Typical Interior Concrete Slab in Main East-West Portion of the Building

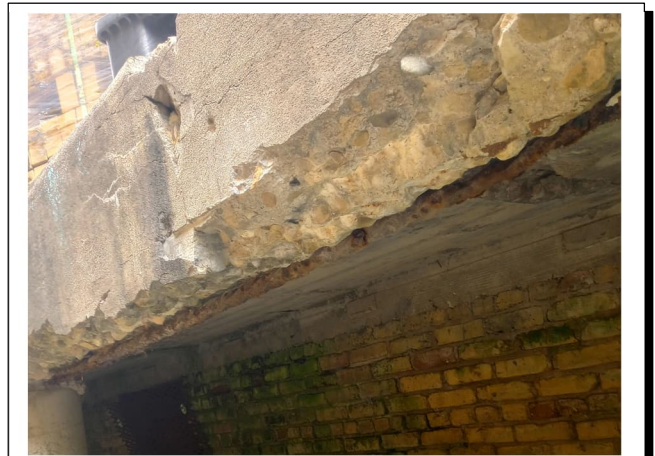
**Figure 23 Exterior Platform Slab
Deterioration-2**

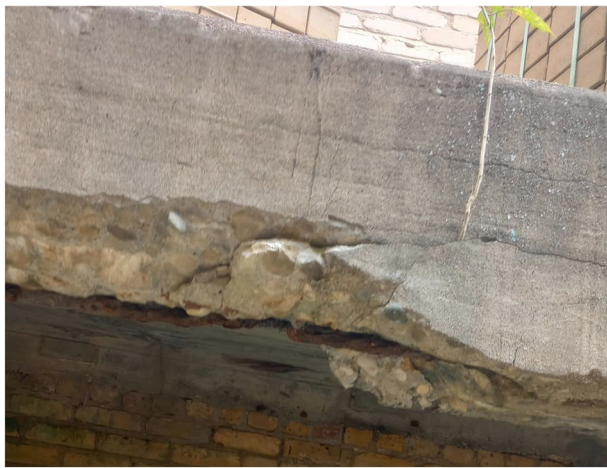
Figure 24 Exterior Platform Slab
Deterioration-3

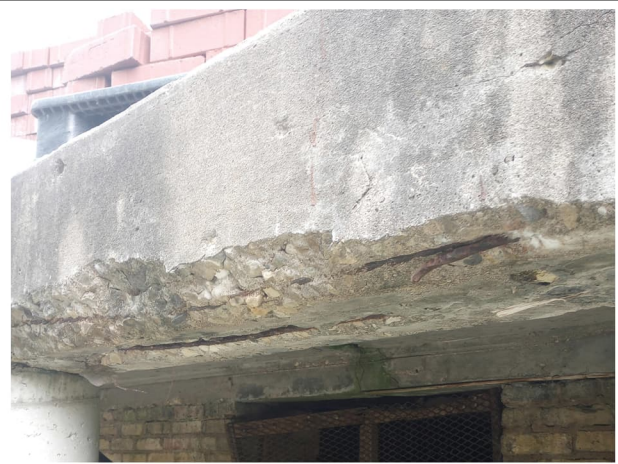
Figure 25 Exterior Platform Slab
Deterioration-4

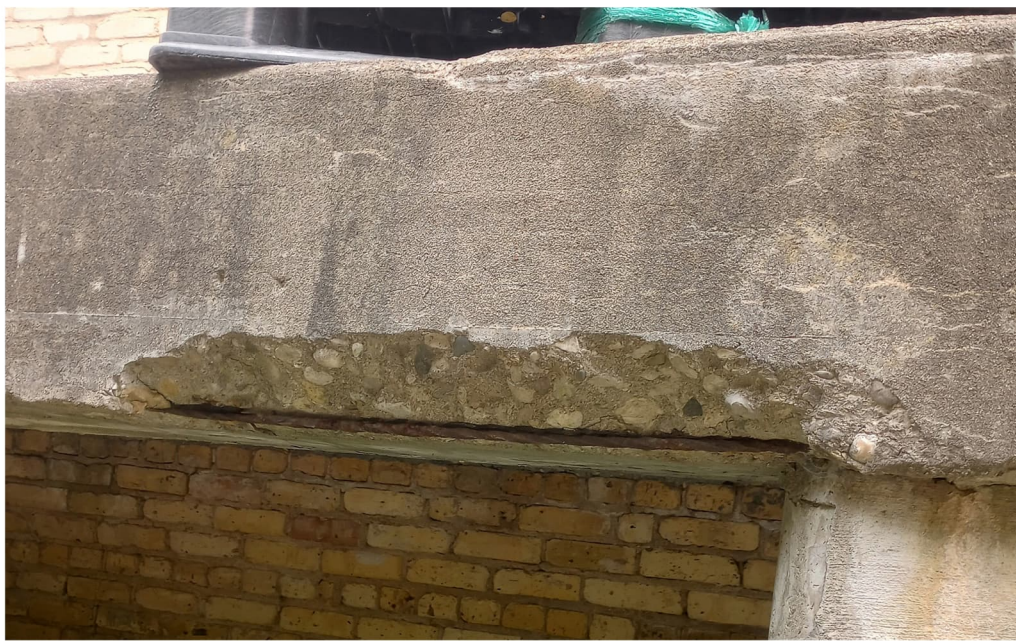
Figure 26 Exterior Platform Slab Deterioration-5

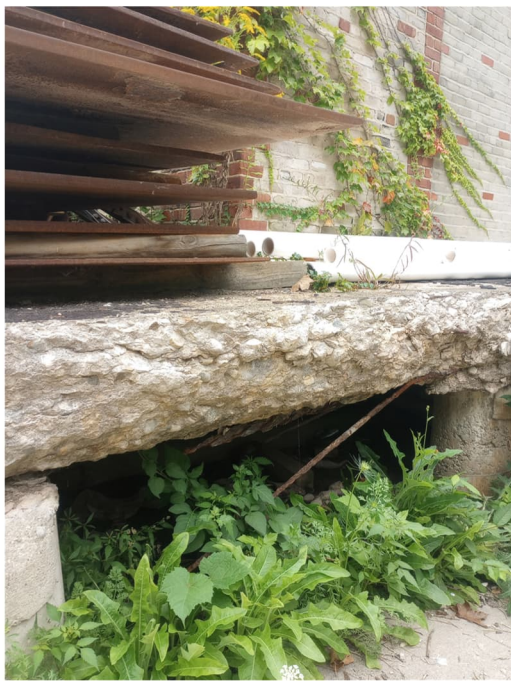
**Figure 30 Exterior Platform Slab
Deterioration-9**

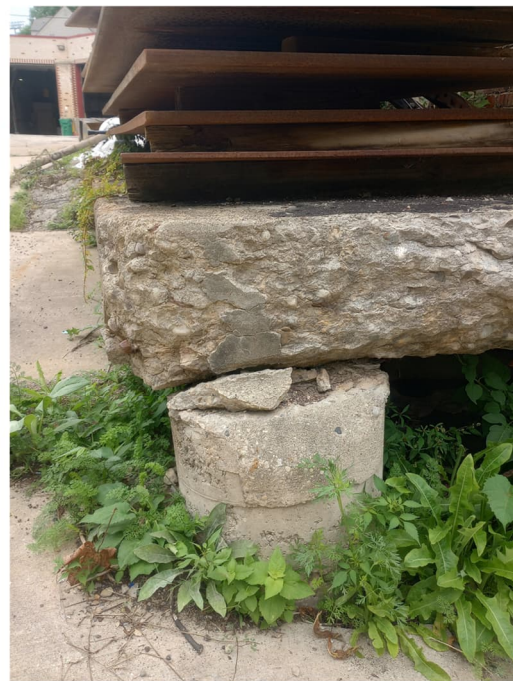
**Figure 31 Exterior Platform Slab
Deterioration-10**

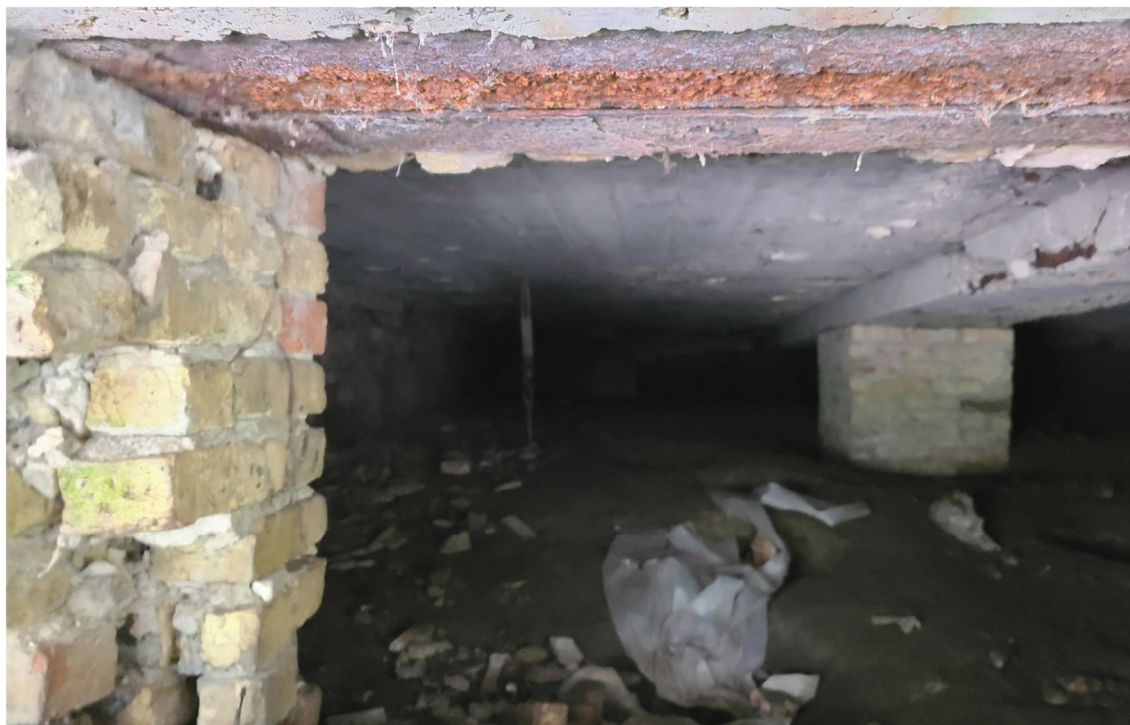
Figure 33 Corroded Steel Beam Lintel Above Access Opening

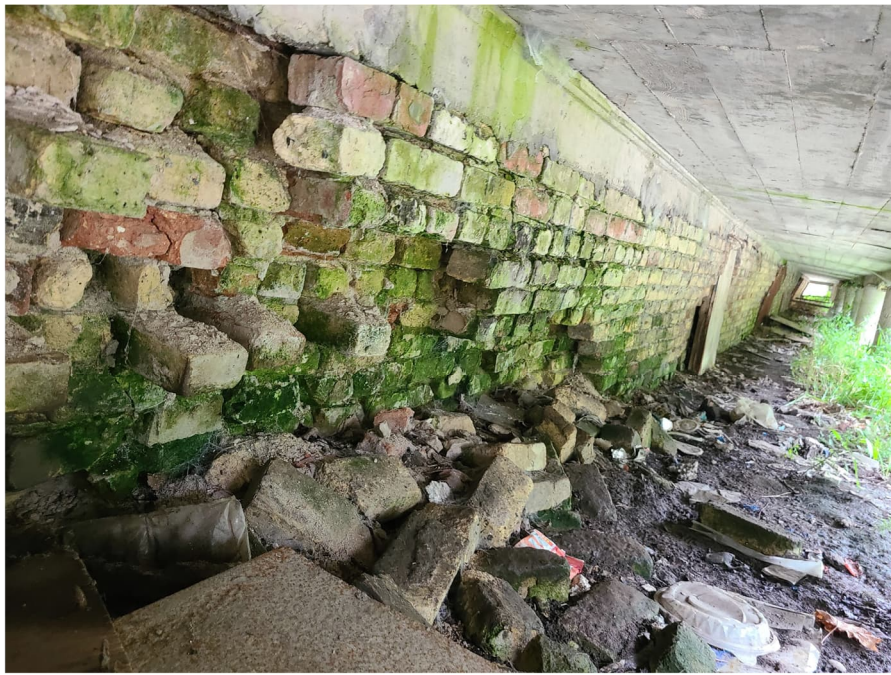
Figure 35 Collapsed Brick Foundation Wall Along West Wall
