**ATWATER PARK AND EDGEWOOD DEVELOPMENT  
EROSION CONTROL**

## INTRODUCTION

## ATWATER PARK HILLSLOPE EROSION STABILIZATION

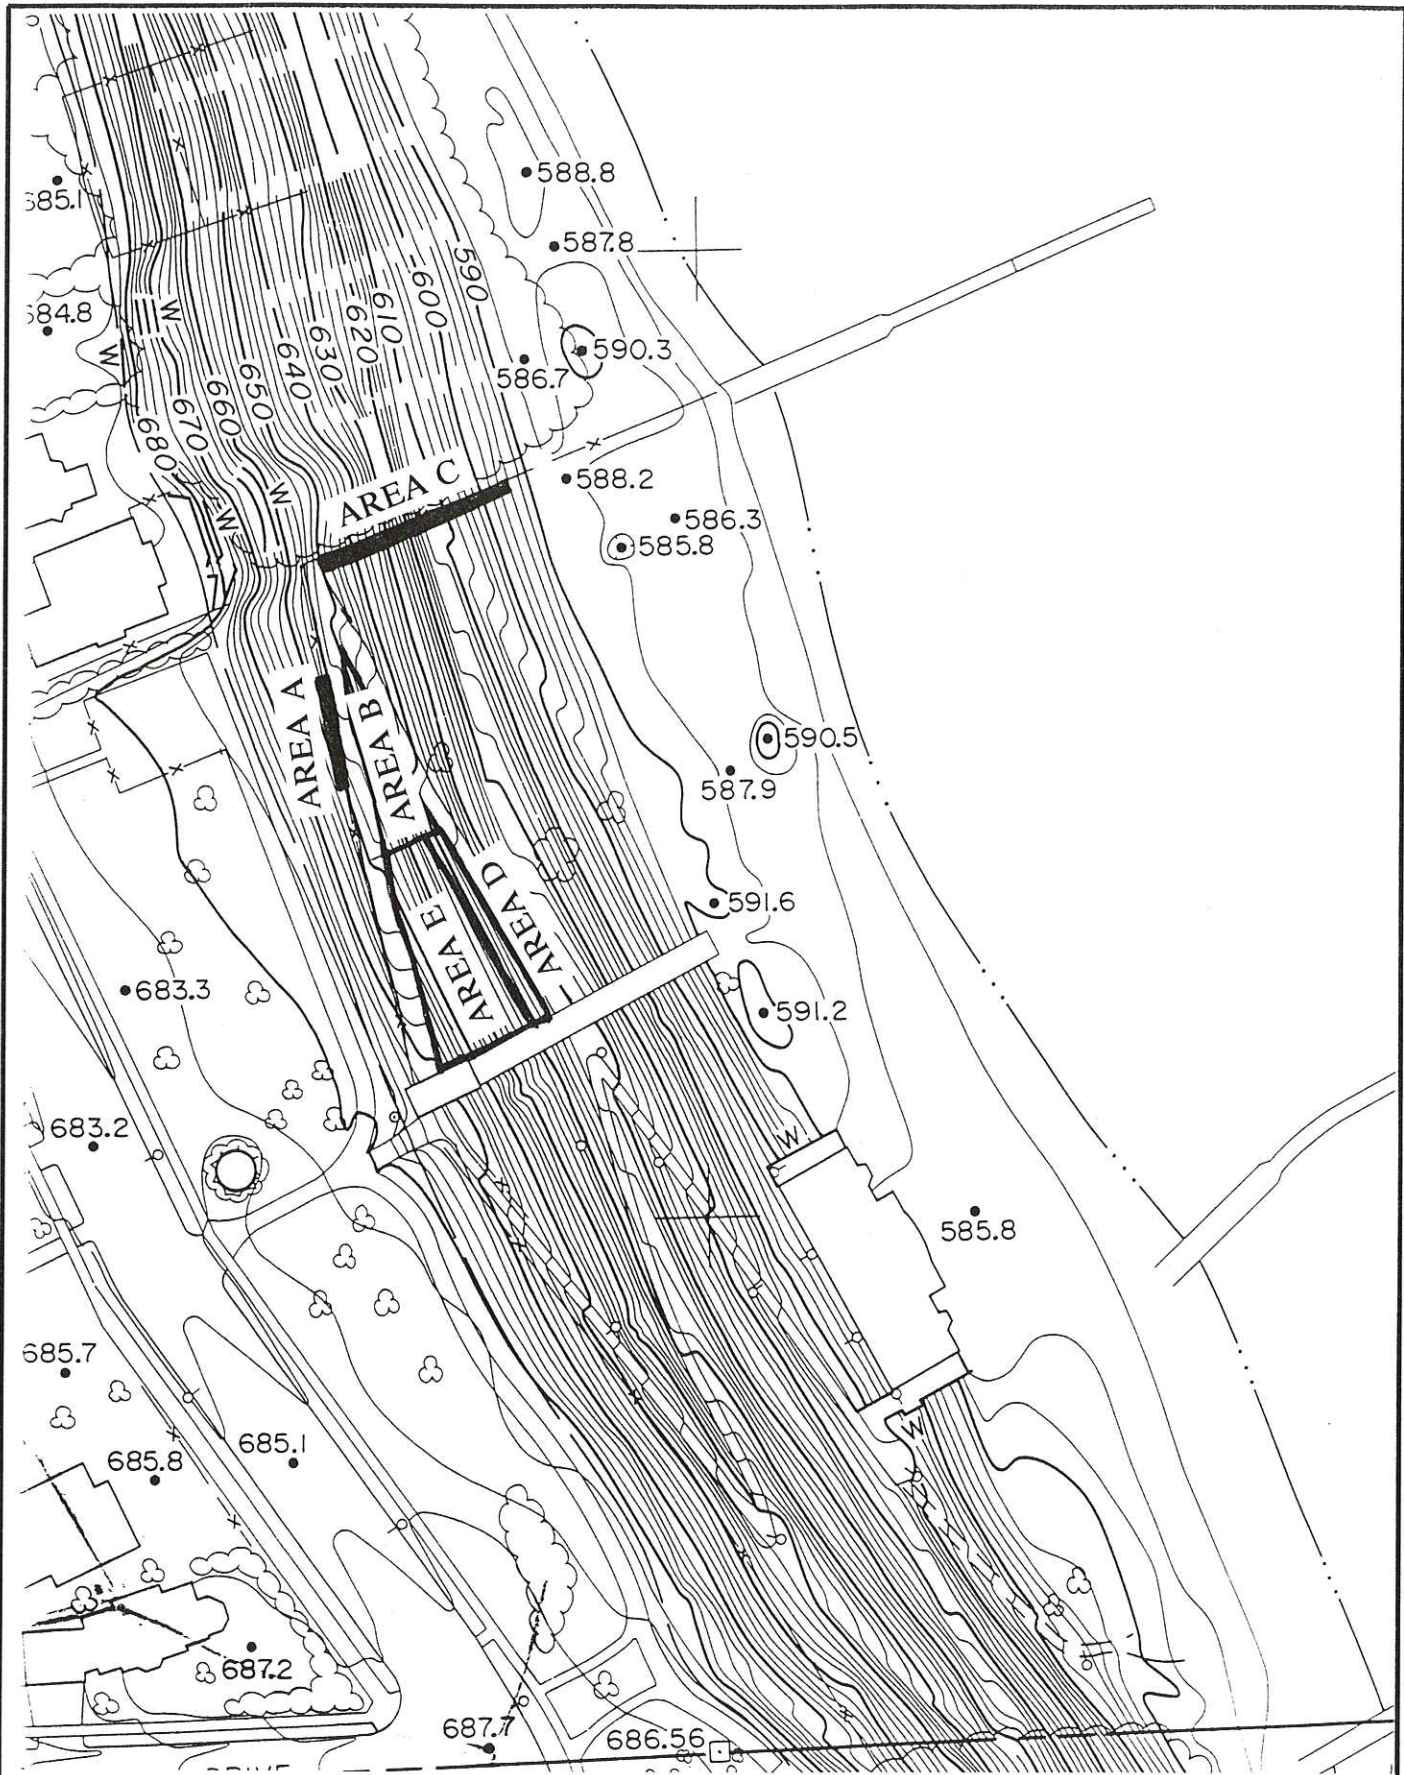
**FIGURE A-1**  
**ATWATER PARK**  
**EROSION CONTROL AREAS**  
**VILLAGE OF SHOREWOOD**  
**STORMWATER MANAGEMENT PLAN**

Atwater Park and Beach is located on Lake Drive, north of Capitol Drive. The park has a recreation area on the top of the Bluff and two walkways going down to the beach area. See Figure A-1 for schematic of the area. One walkway is a series of stairs from the top of the bluff to the beach. The other walkway is a sloping path that runs north from the top of the bluff to a landing and then south to a second landing and finally north to the beach. The erosion problem is occurring along the upper part of this bituminous path (Figure A-1). The most severe erosion is occurring near the first or north landing and between the paths.

The first segment of erosion (Area A) is located east of the path before the first landing. It appears that this erosion maybe caused by people entering the park from under the fence. The second area (Area B) is the area along the path by the first landing. The slope in this area is very steep, and although the area is partially vegetated, the amount of exposed soil at the ground level is significant. The third area (Area C) is an eroded gully along the north property line. The fourth area (Area D) is south of Area B and is similar to Area B, except the slope is not as steep. The final area (Area E) is west and upslope of Area D. This area has poor vegetative ground cover but is not eroding as severely as the other areas. These areas are shown on Figure A-1.

This area is experiencing erosion along the chain link fence. The eroding face is relatively short (~ 2 feet high). The cement foundations for the fence posts are exposed. Given the tight confines of the eroded area the recommended solution is to build a short concrete block wall as described above. The area of backfill would be minimal. The fence line would be temporarily removed and then reinstalled, leaving no gaps for people to take a short cut through.

This area has the steepest slopes and the most erosion. Slopes are approximately 1.5:1. Either the installation of the cellular web mats or a concrete block retaining wall and backfilling to 3:1 slopes may be appropriate. Additional evaluation may be required to determine whether or not the cellular web mats can hold the existing slopes. The total retaining wall total wall height at the south end of the area would be around 11 feet. The wall would probably be in two tiers. The effect of the additional weight of the backfill on slope stability should be considered.

Area C is an eroded gully along the north property line caused by the runoff coming off of the trail landing and from a 4" PVC drain tile outfall. The drain tile originates at the keystone walls at the first landing. It is recommended that the curb at the landing be rebuilt so that surface runoff does not overtop it. There are two approaches to alleviating the gully erosion. One is to extend the drain tile sub-surface to the sand beach at the base of the hill. The other is to carry the surface flow down a series of terraces constructed out of treated timbers filled with gravel.

The strip of land immediately adjacent to the trail in Area D is steep and prone to erosion. Slopes within 10 feet of the trail are approximately 1.5:1. As in Area B both the use of the cellular web mats and a concrete block wall were considered. The matting could be installed in 8 - 10 foot widths along the trail if the slopes are suitable. A short (1 foot) concrete block wall is used to tie in the bottom edge of the mat. A concrete block wall installed without cellular web matting and backfilled would be approximately three feet high.

While not as erosion prone as the other sites, this area is still lacking adequate erosion protection. Therefore, it would be beneficial to provide additional protection. Average slopes in this area are approximately 2:1. Installing cellular web mats or taking vegetation management actions to enhance the ground cover were considered.

The recommended solution, installing a cellular web mat is less costly and requires the addition of less backfill on the slope, than the alternate solution of constructing a concrete block retaining wall.

The recommended solution, the extension of the drain tile to the bottom of the hill, is less costly and disruptive than the installation of a series of timber terraces.

The recommended solution, the concrete block wall, is slightly less costly than the cellular web mat. The incremental cost of going from a one foot concrete block wall to three foot wall is more than offset by the cost of the web matting.

The recommended solution, vegetation management is less costly and disruptive than the alternate solution of installing the web matting.

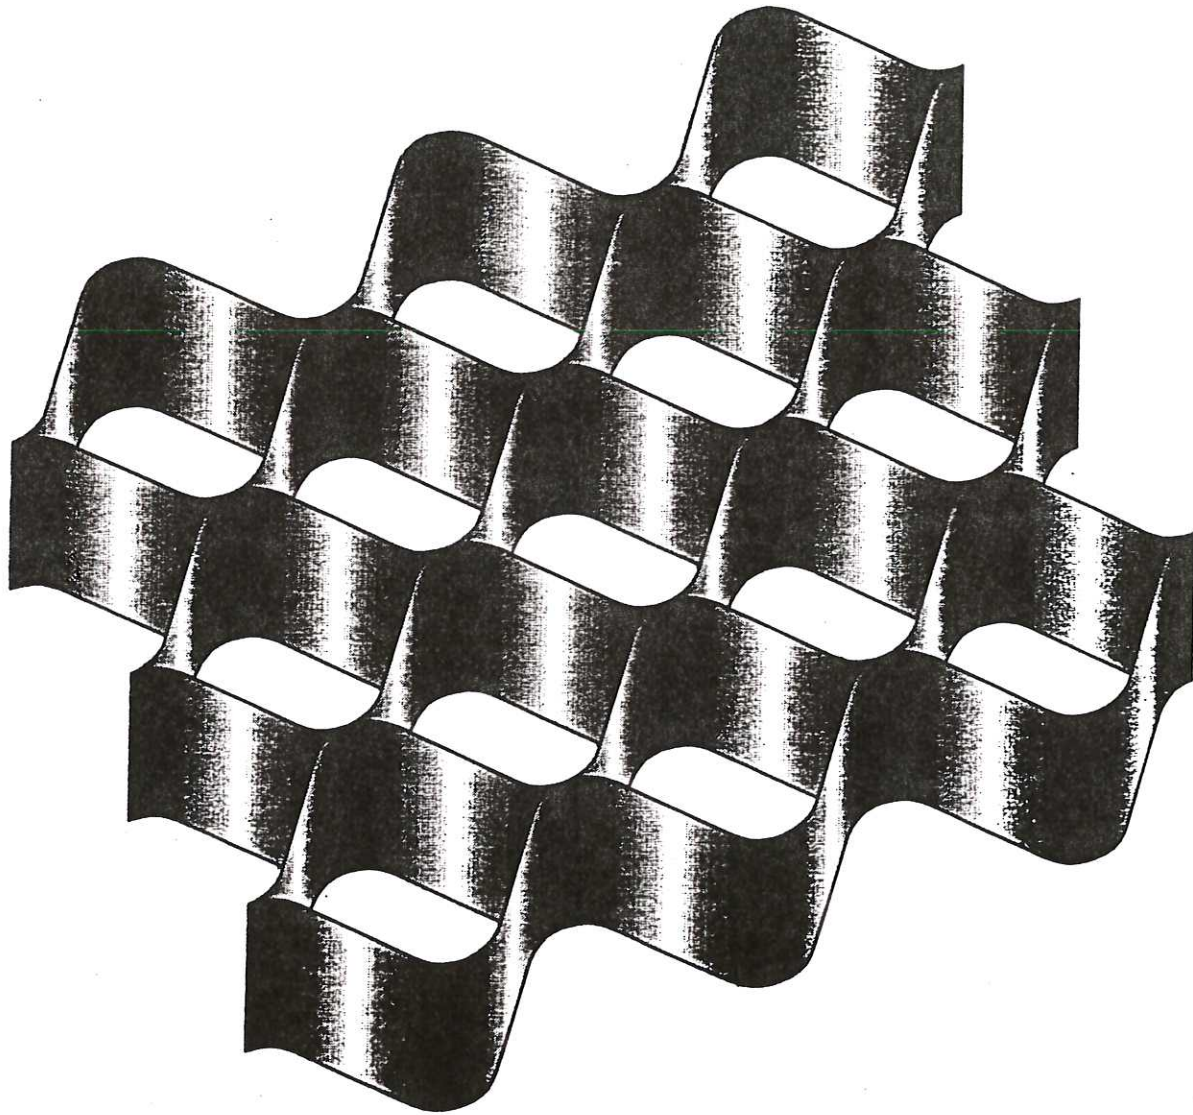
FIGURE A-2  
CELLULAR WEB MAT  
VILLAGE OF SHOREWOOD  
STORMWATER MANAGEMENT PLAN

2. **Cellular Confinement System Slope Protection (cellular web mats).** The cellular confinement system (such as Geo-Web) consists of flexible web mats of polyethylene honeycomb cells which are filled with soil backfill (Figure A-2). The cellular web mats which are anchored to a slope with long pins or wooden stakes are filled with soil and vegetated. The cells confine and reinforce the vegetation and soil structure. This system is good for protecting against surface erosion on steep slopes, but does not provide protection against large scale slope failure. The maximum slope is dependent on the soils, but it has been used on slopes as steep as 1:1. It may be possible to use the cellular web mats on this site

All topsoil and easily degraded soil should be removed before laying down the cellular sheets. A loamy soil is recommended for the fill. The cellular web mats with notches between cells for drainage are recommended. A bedding layer of sand or a non-woven geo-textile is recommended between the mats and the native soil. The geo-textile may impede rooting of plants. Suggested vegetation would be a prairie mix with a deep rooting system. A few small scale trees or shrubs may be planted in large spaces in the web by cutting the dividers between a couple of cells. After seeding a straw matting should be placed to hold in soil and seed before sprouting. It may be more aesthetically pleasing to dress the bottom edge of the mat along the trail with a row of concrete block or treated timbers.
