Comprehensive Facility Plan

June 8, 2011

Revision 1: October 7, 2011

Sanitary Sewer, Combined Sewer and Storm Sewer Improvements

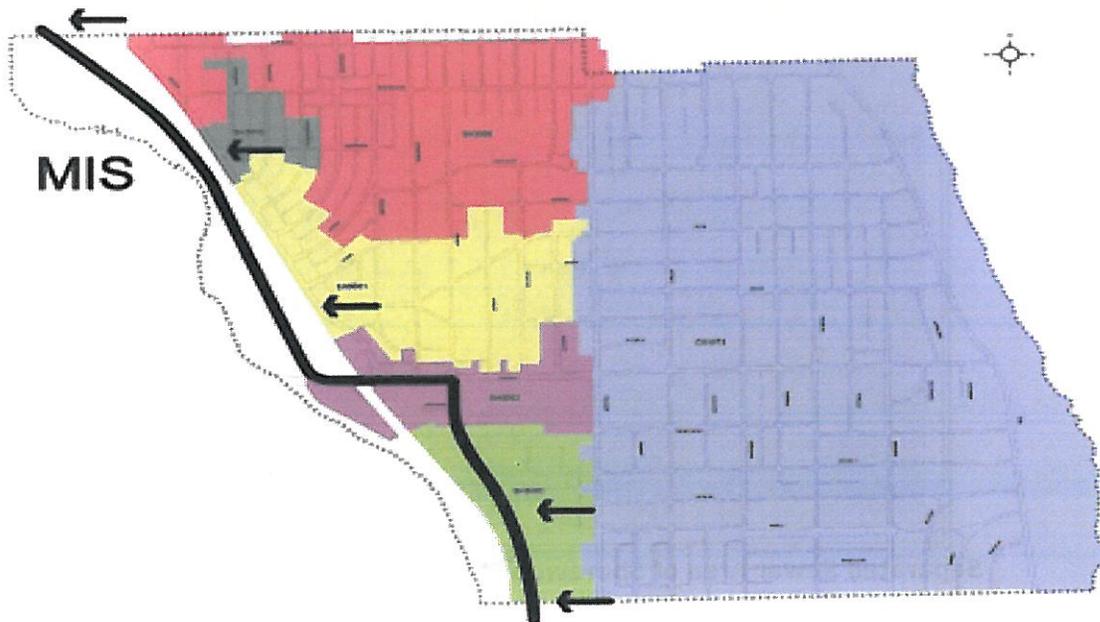
Sanitary sewer service in Shorewood consists of separate sanitary sewers and combined sewer systems. All sewers are connected to the MMSD North Shore MIS. In the nearby figure, the eastern half of the Village, shown in blue, is the combined sewer service area and connects to the MIS at a single location, near the intersection of North Oakland Avenue and East Edgewood Avenue. This is represented by the southernmost arrow to the MIS.

There are five separate sewer basins (sewersheds) on the west half of the Village, each with its own connection to the North Shore MIS. The figure on the previous page schematically describes this configuration.

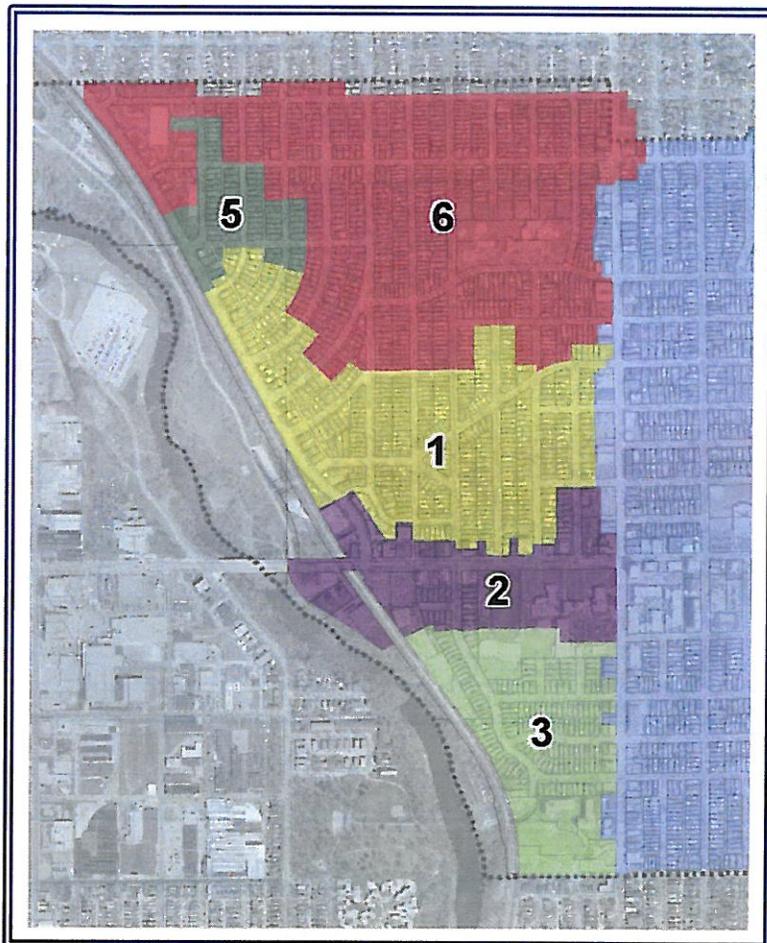
Separated Sewer Area of Shorewood – Sewershed ID Numbers

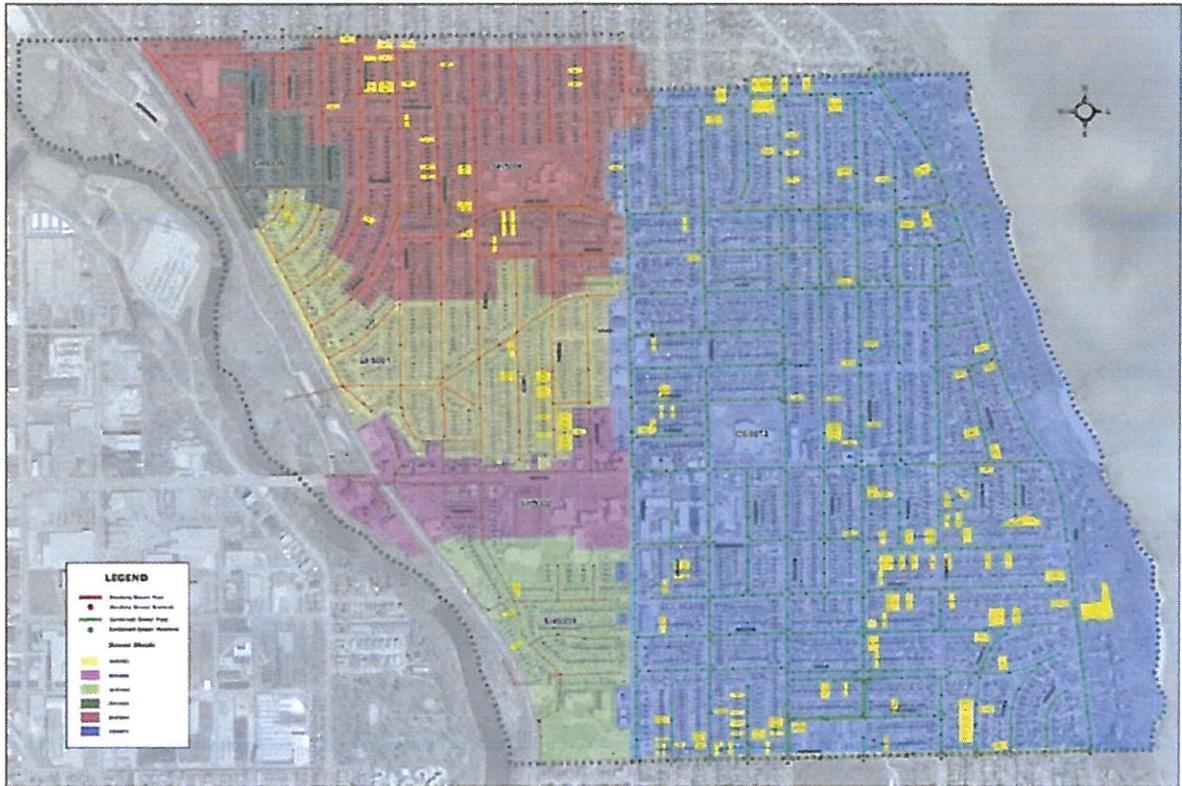
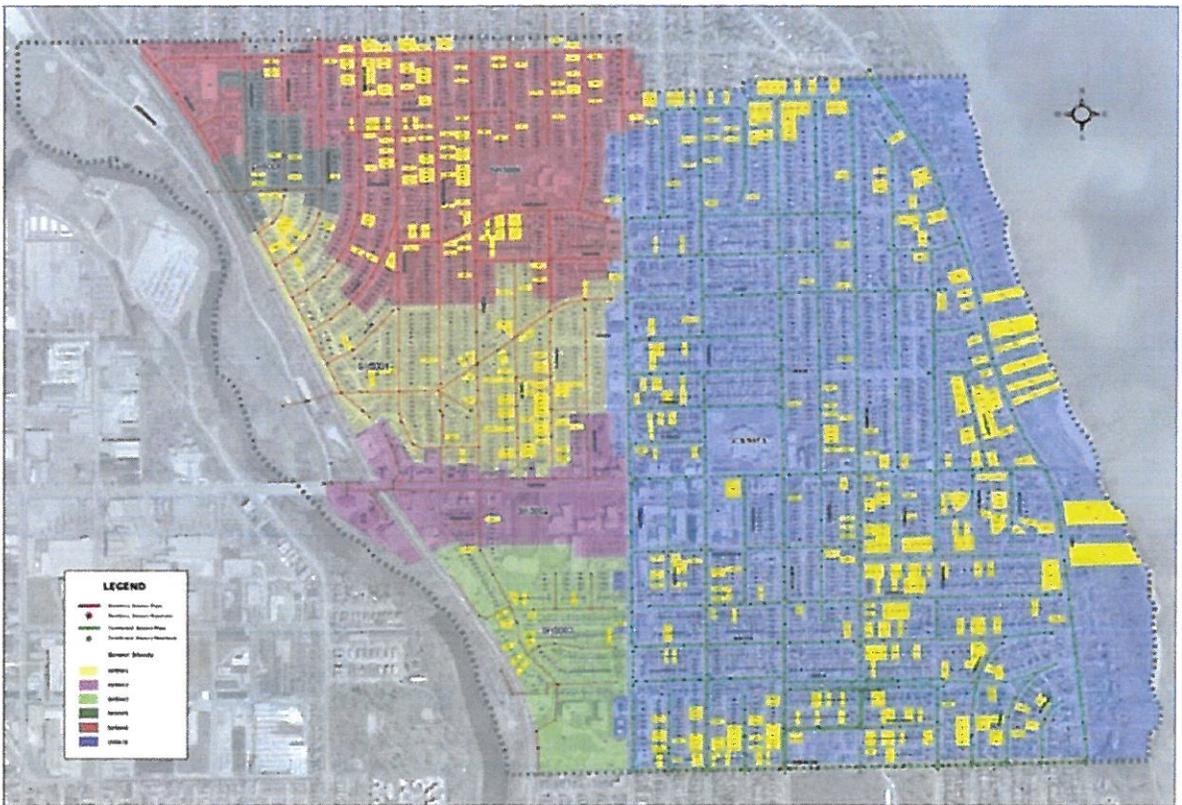
The two maps on the following page show the impact of the July 15 and July 21 rainfalls on Shorewood. Yell properties reported flooding by either surface runoff or basement backups.
