**Ecological Study and Management Plan for Atwater Park Beach  
Final Report**

**Sponsor: Village of Shorewood**

**January 2010**

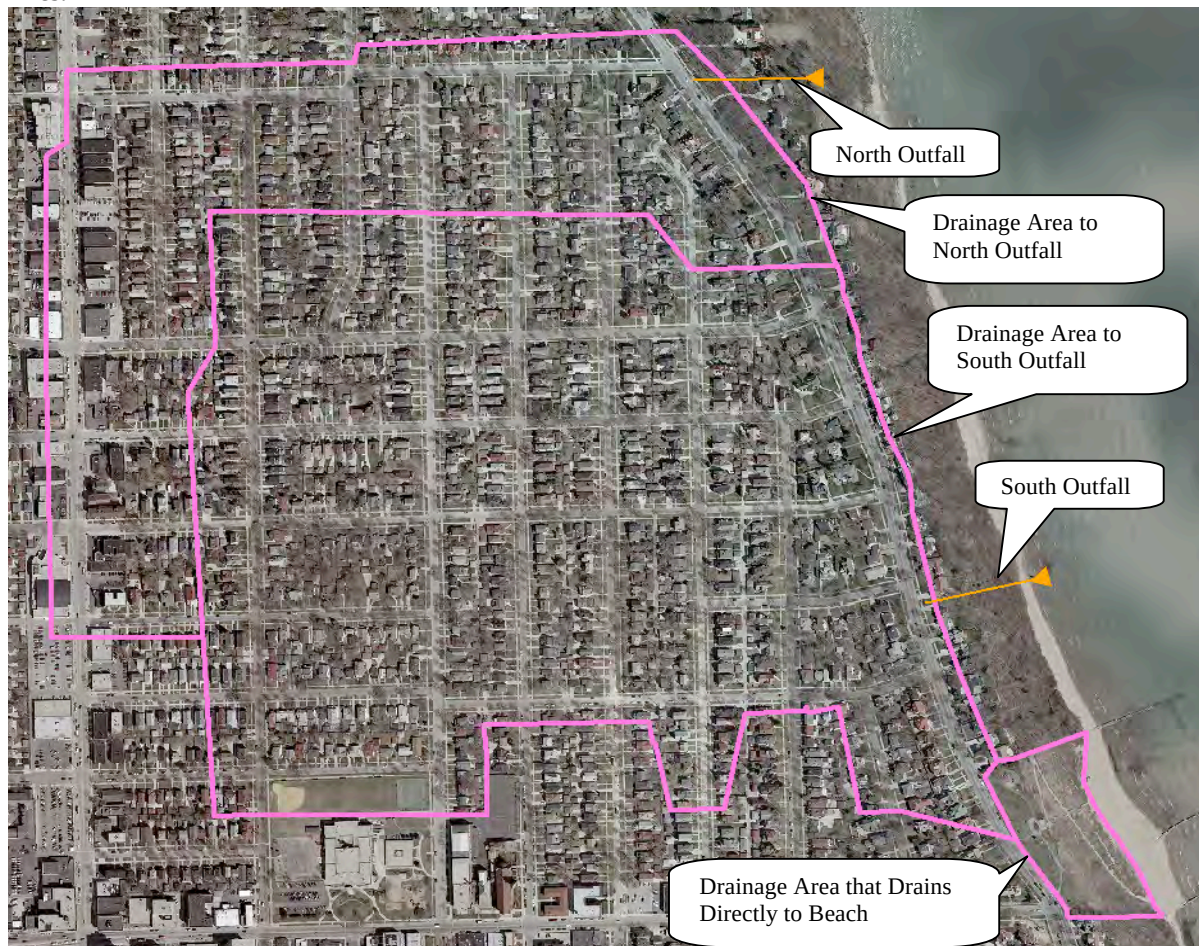
**Figure 4: Drainage Basins.** Drainage areas are designated by pink outline. Outfalls are designated by yellow lines.

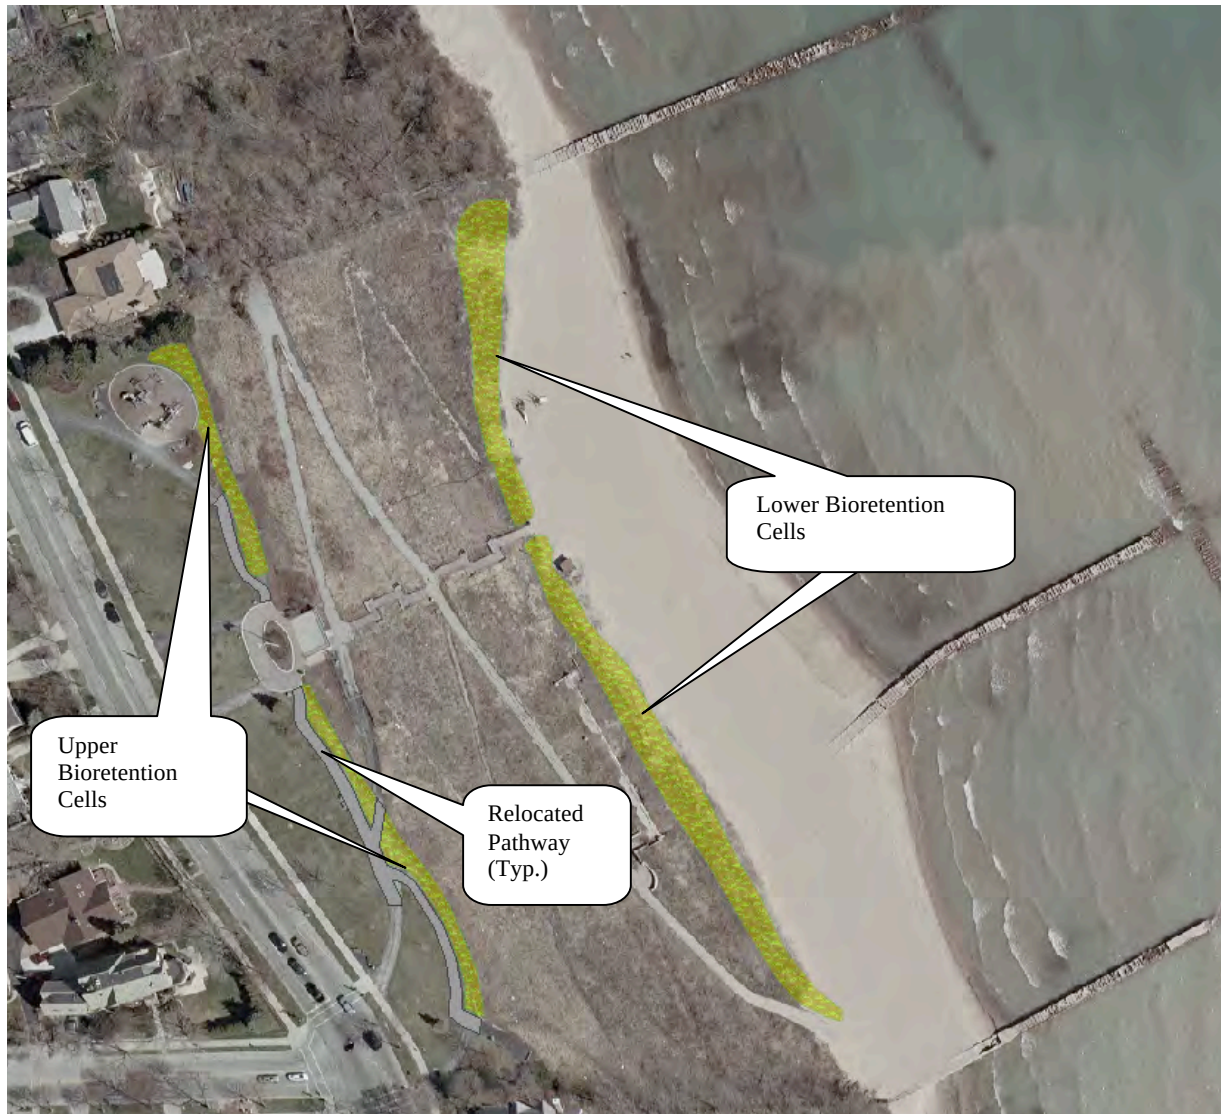
**Figure 5: Bioretention Area at Park**

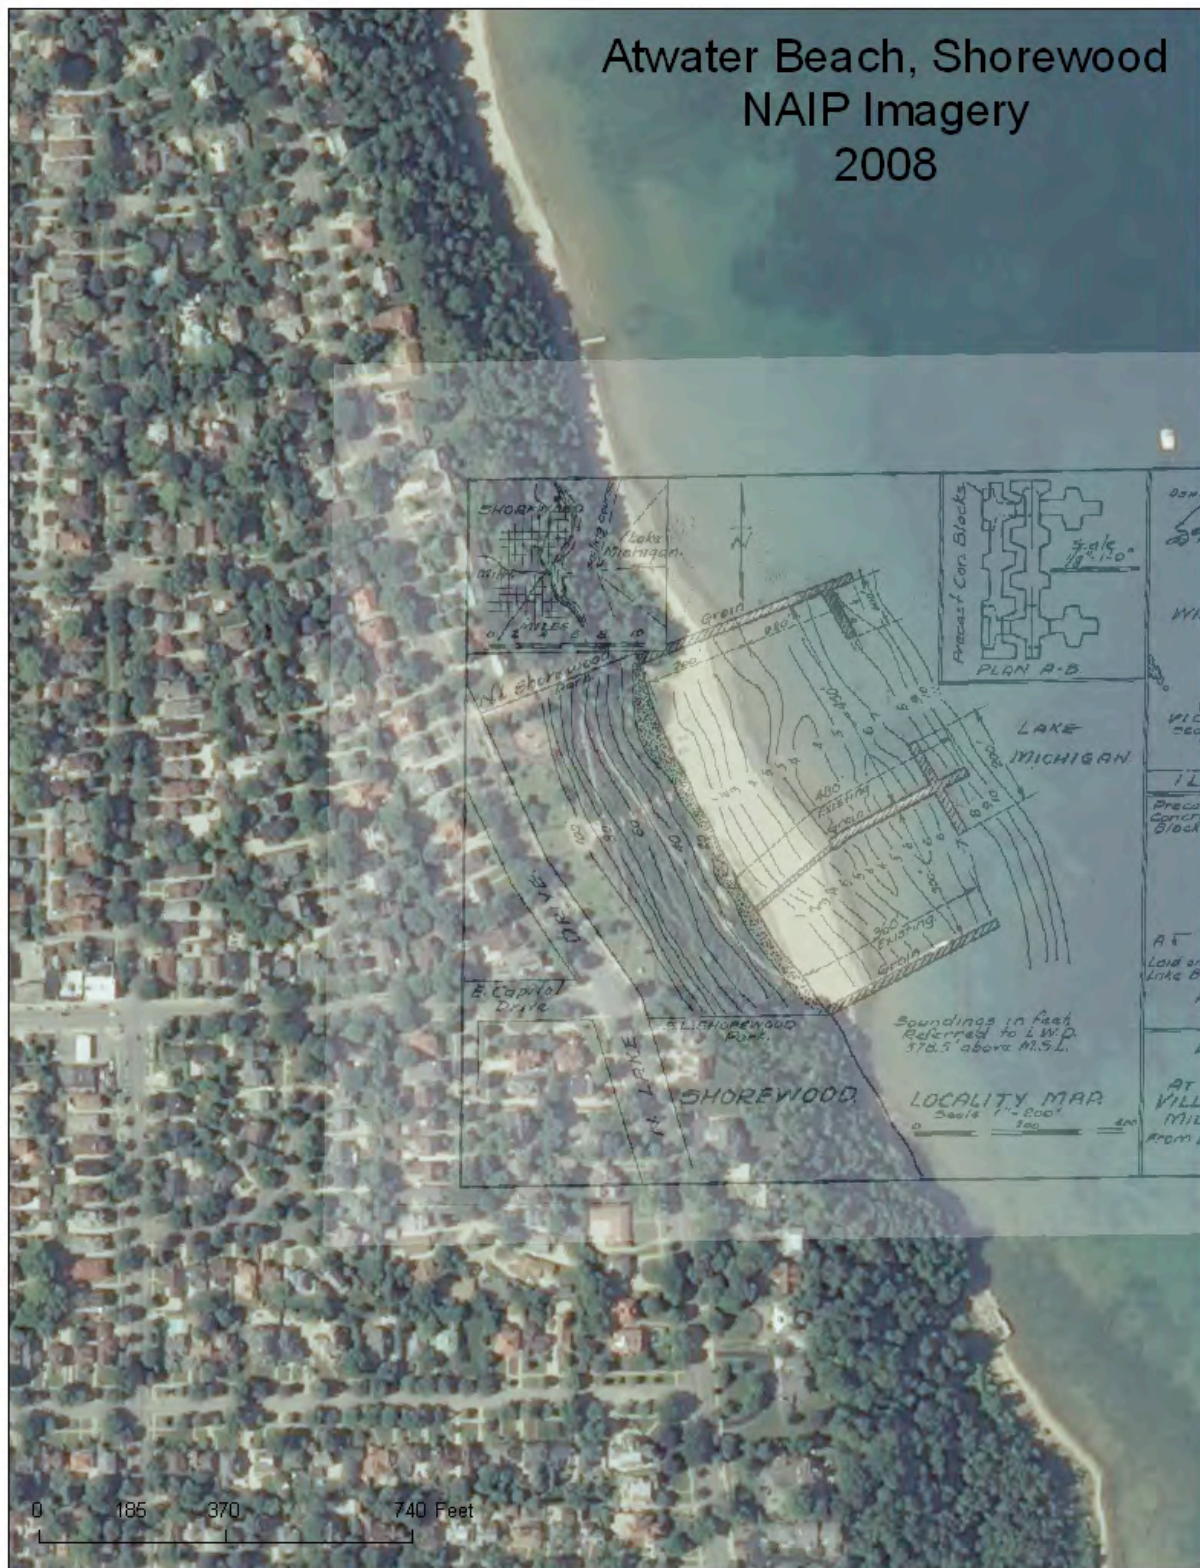
Figure 23: 2008 aerial photograph with groin map superimposed. Mean annual lake level: 577.59 ft.

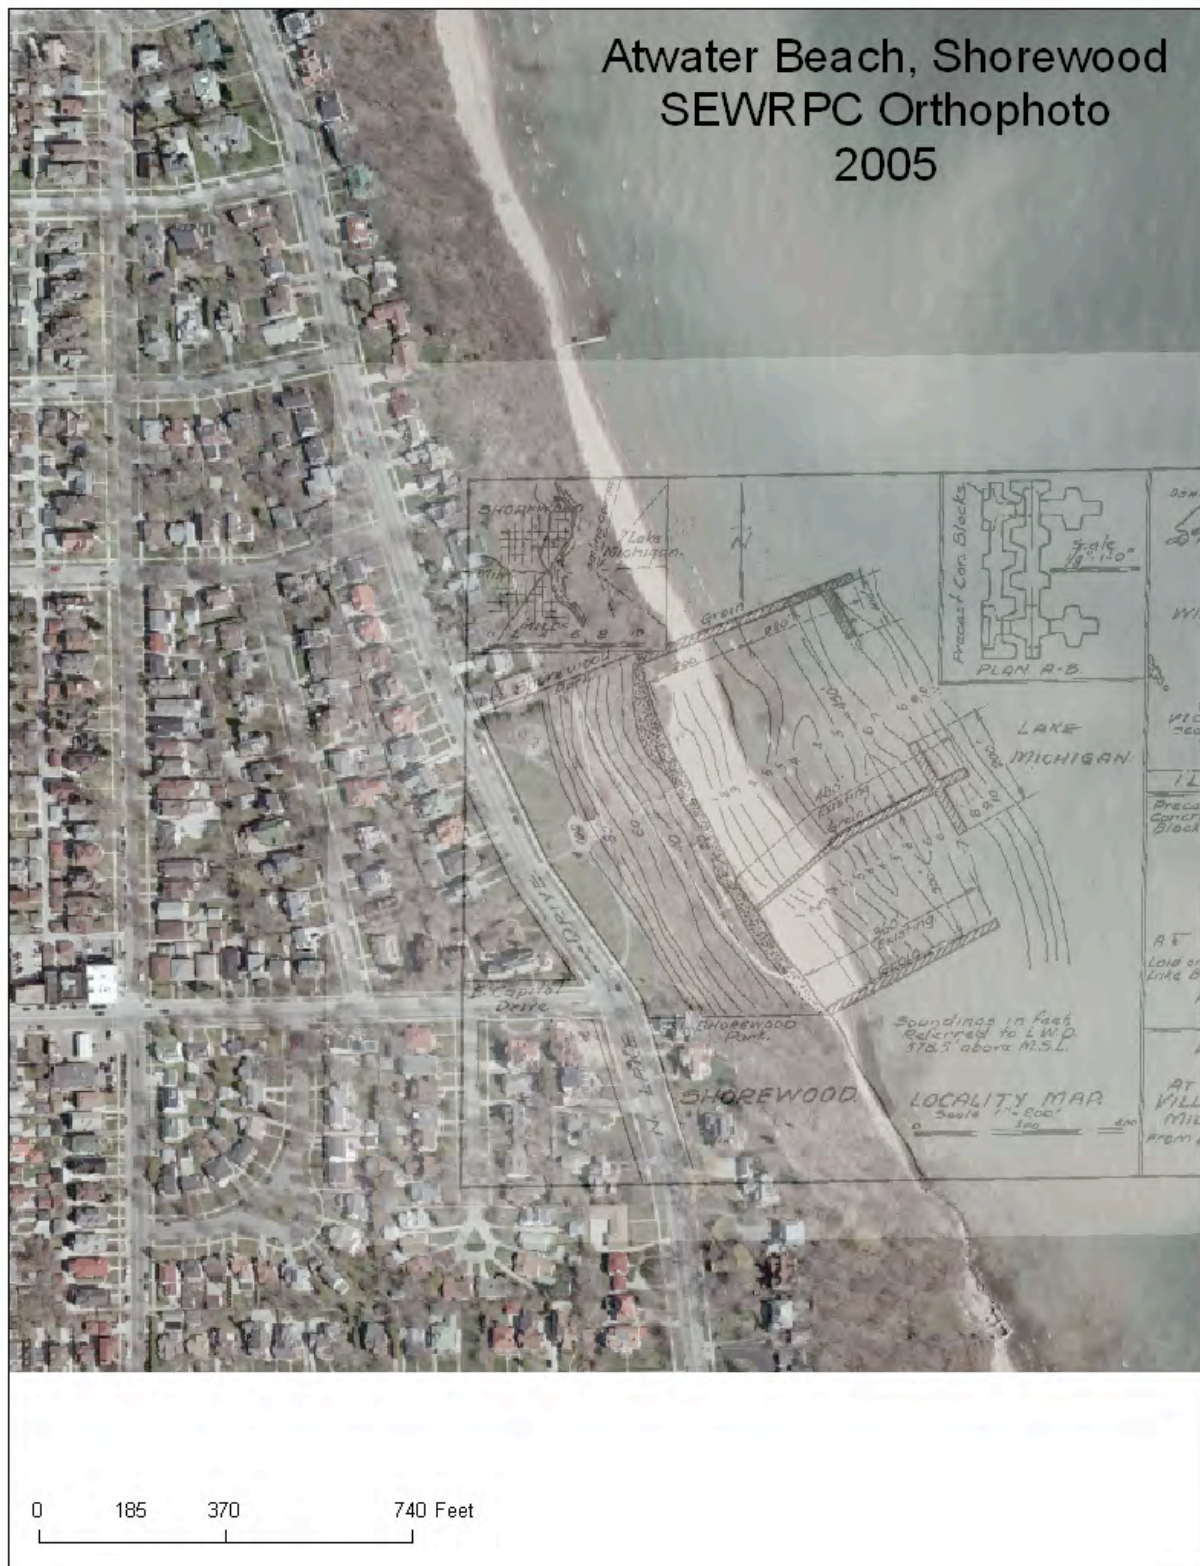
Figure 24: 2005 aerial photograph with groin map superimposed. Mean annual lake level: 577.74 ft.

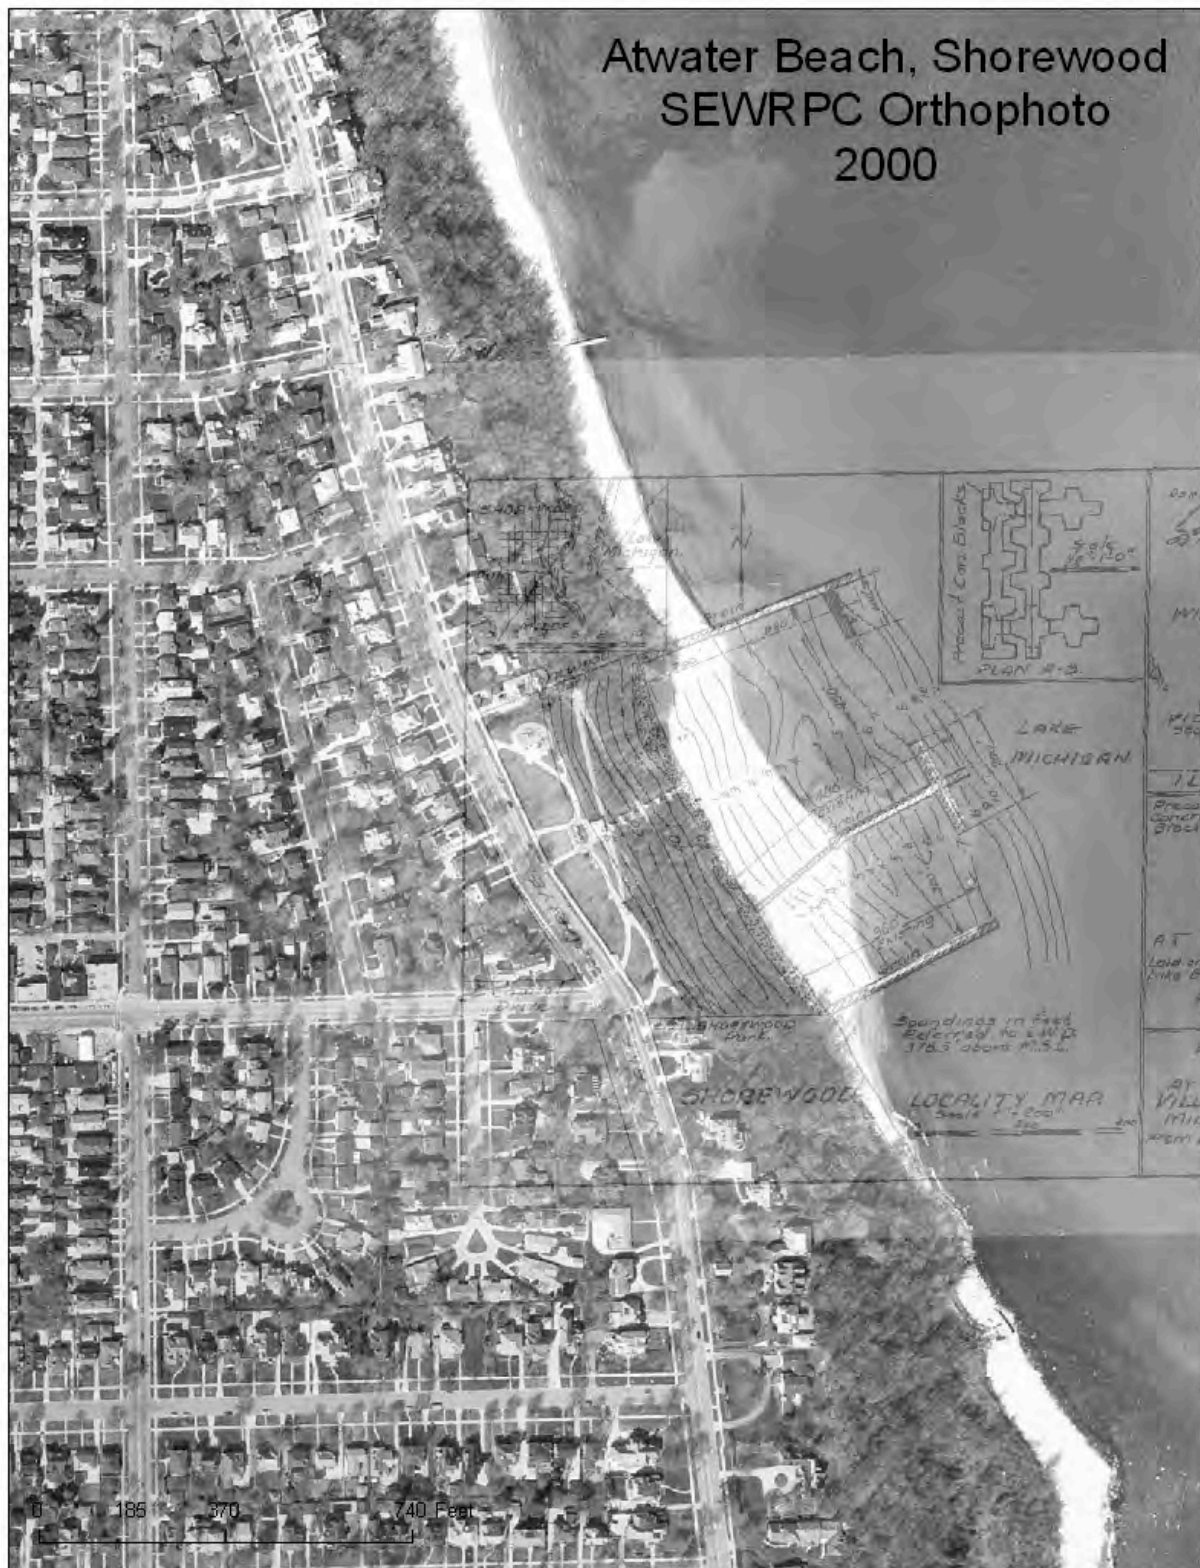
Figure 25: 2000 aerial photograph with groin map superimposed. Mean annual lake level: 577.36 ft.

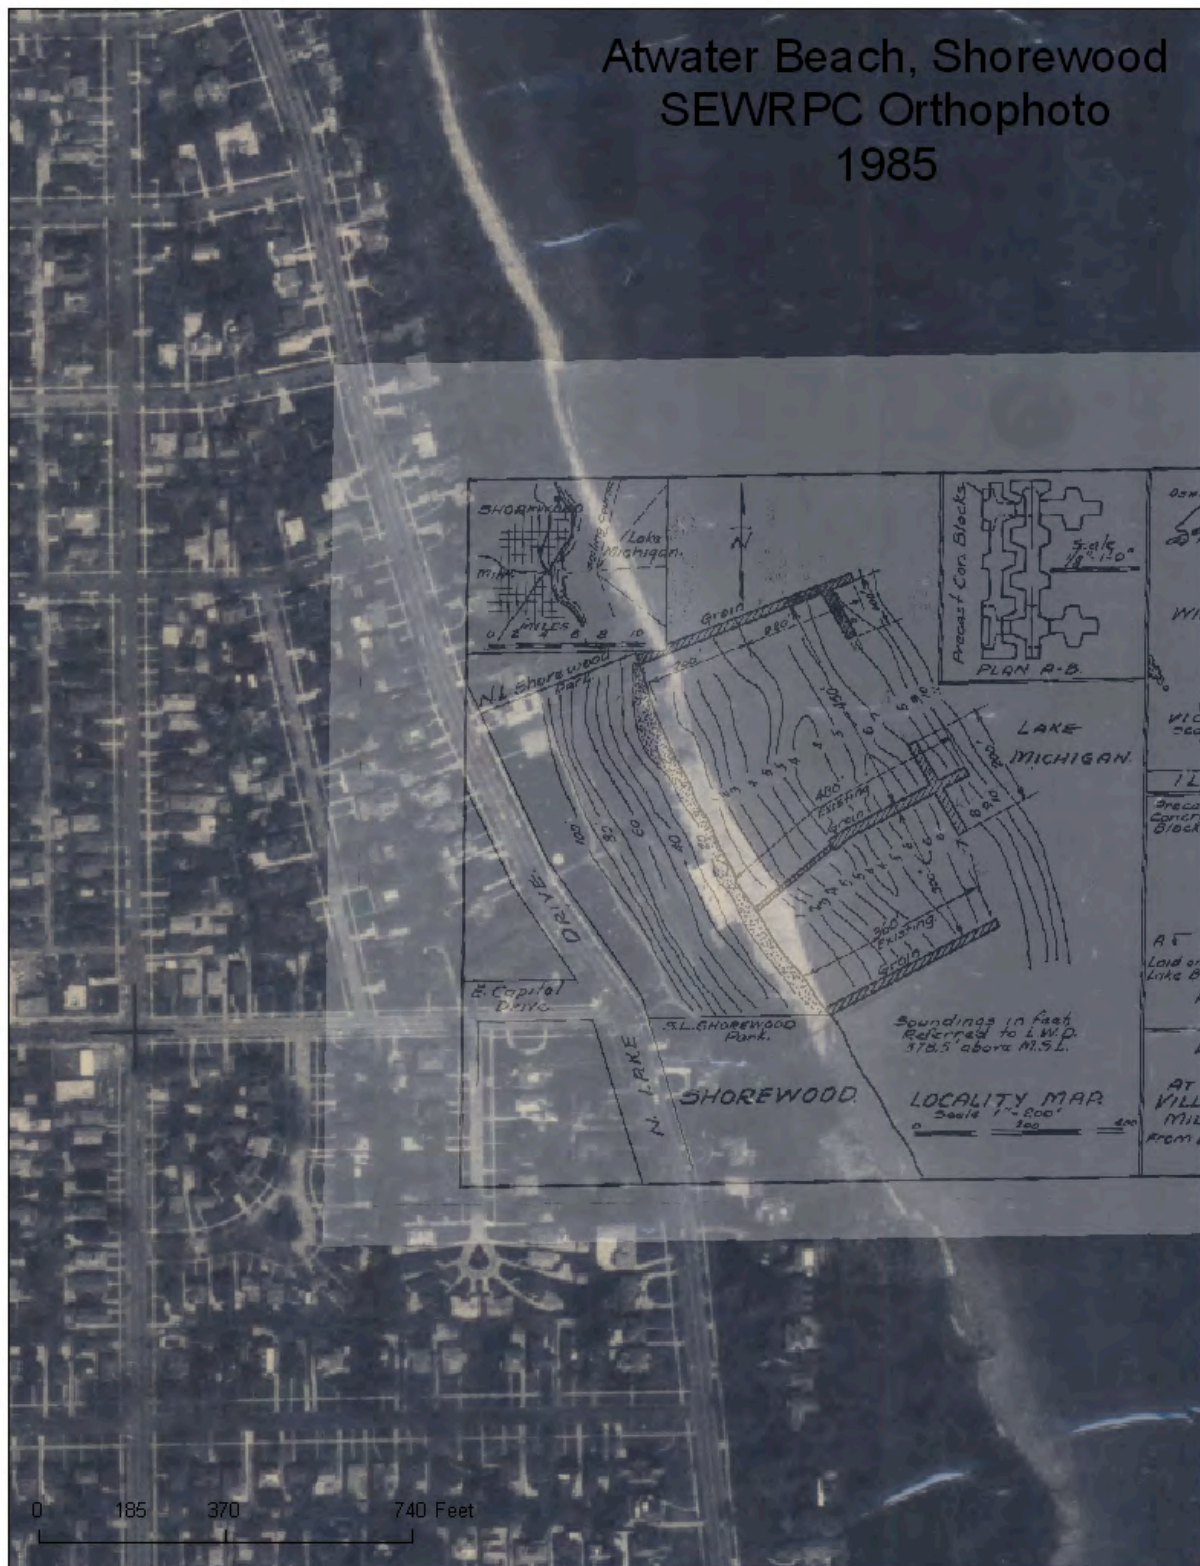
Figure 27: 1985 aerial photograph with groin map superimposed. Mean annual lake level: 580.79 ft.

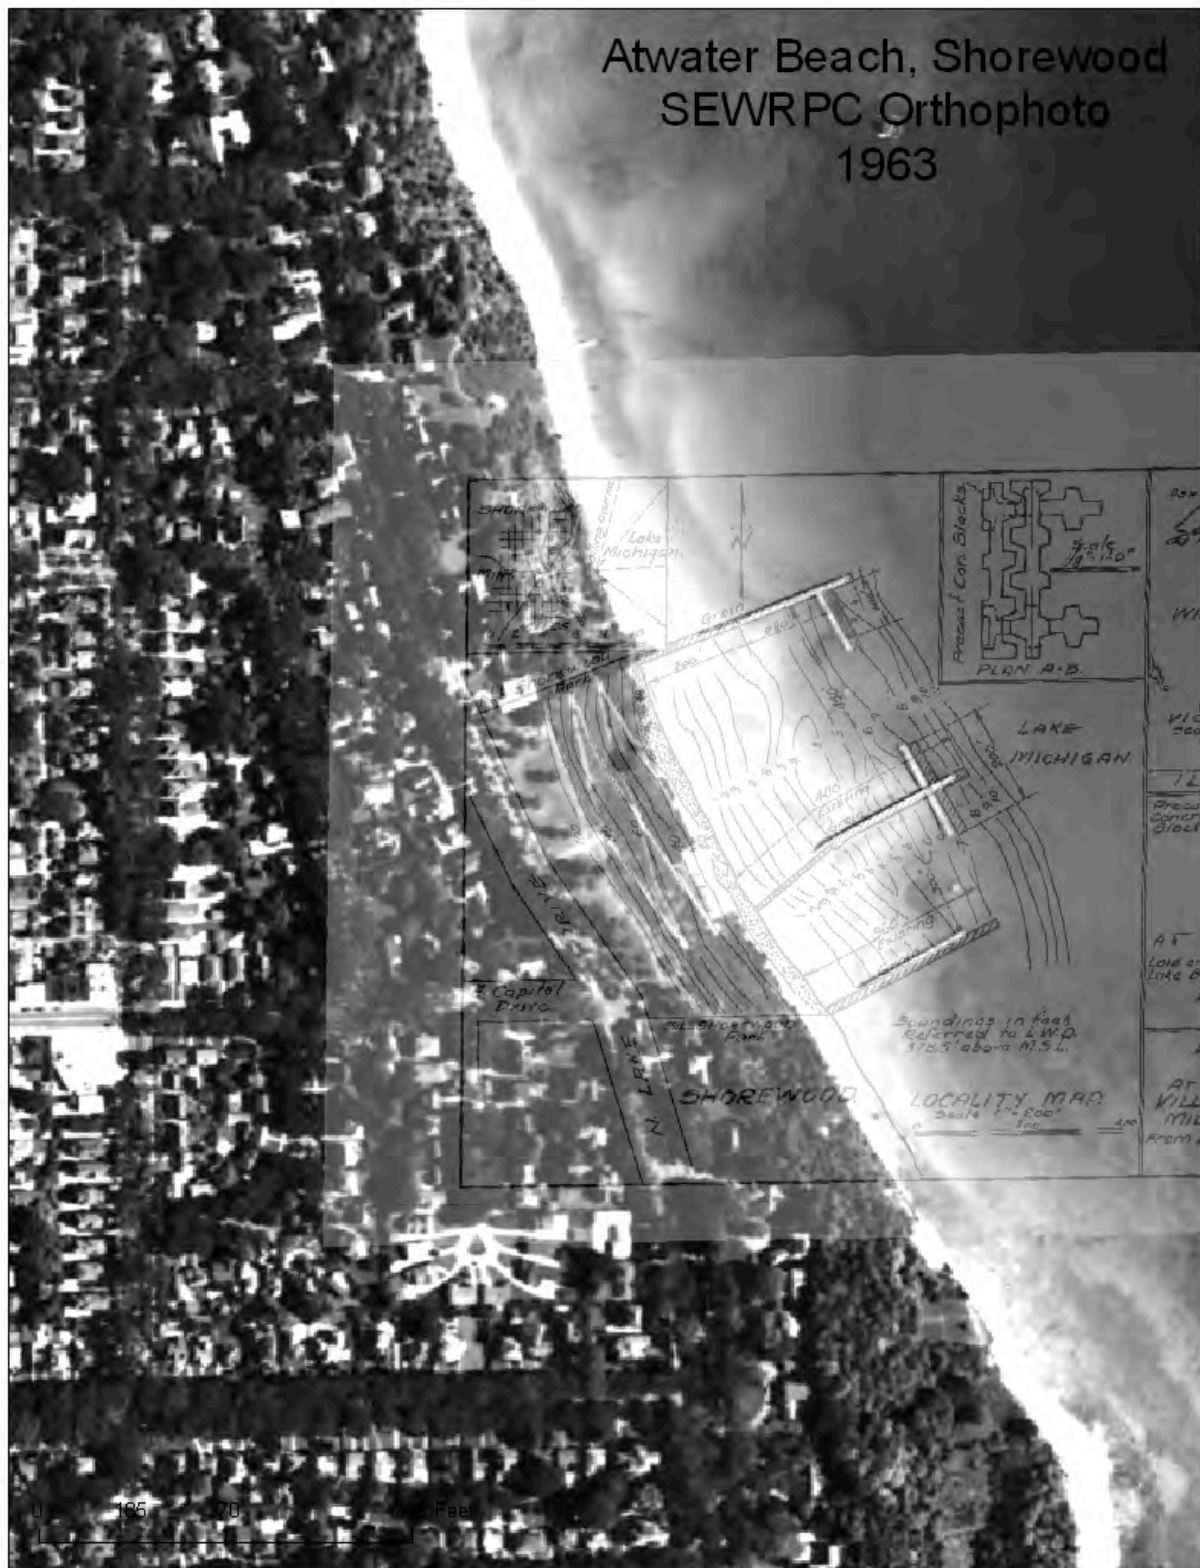
Figure 28: 1963 aerial photograph with groin map superimposed. Mean annual lake level: 577.33 ft.

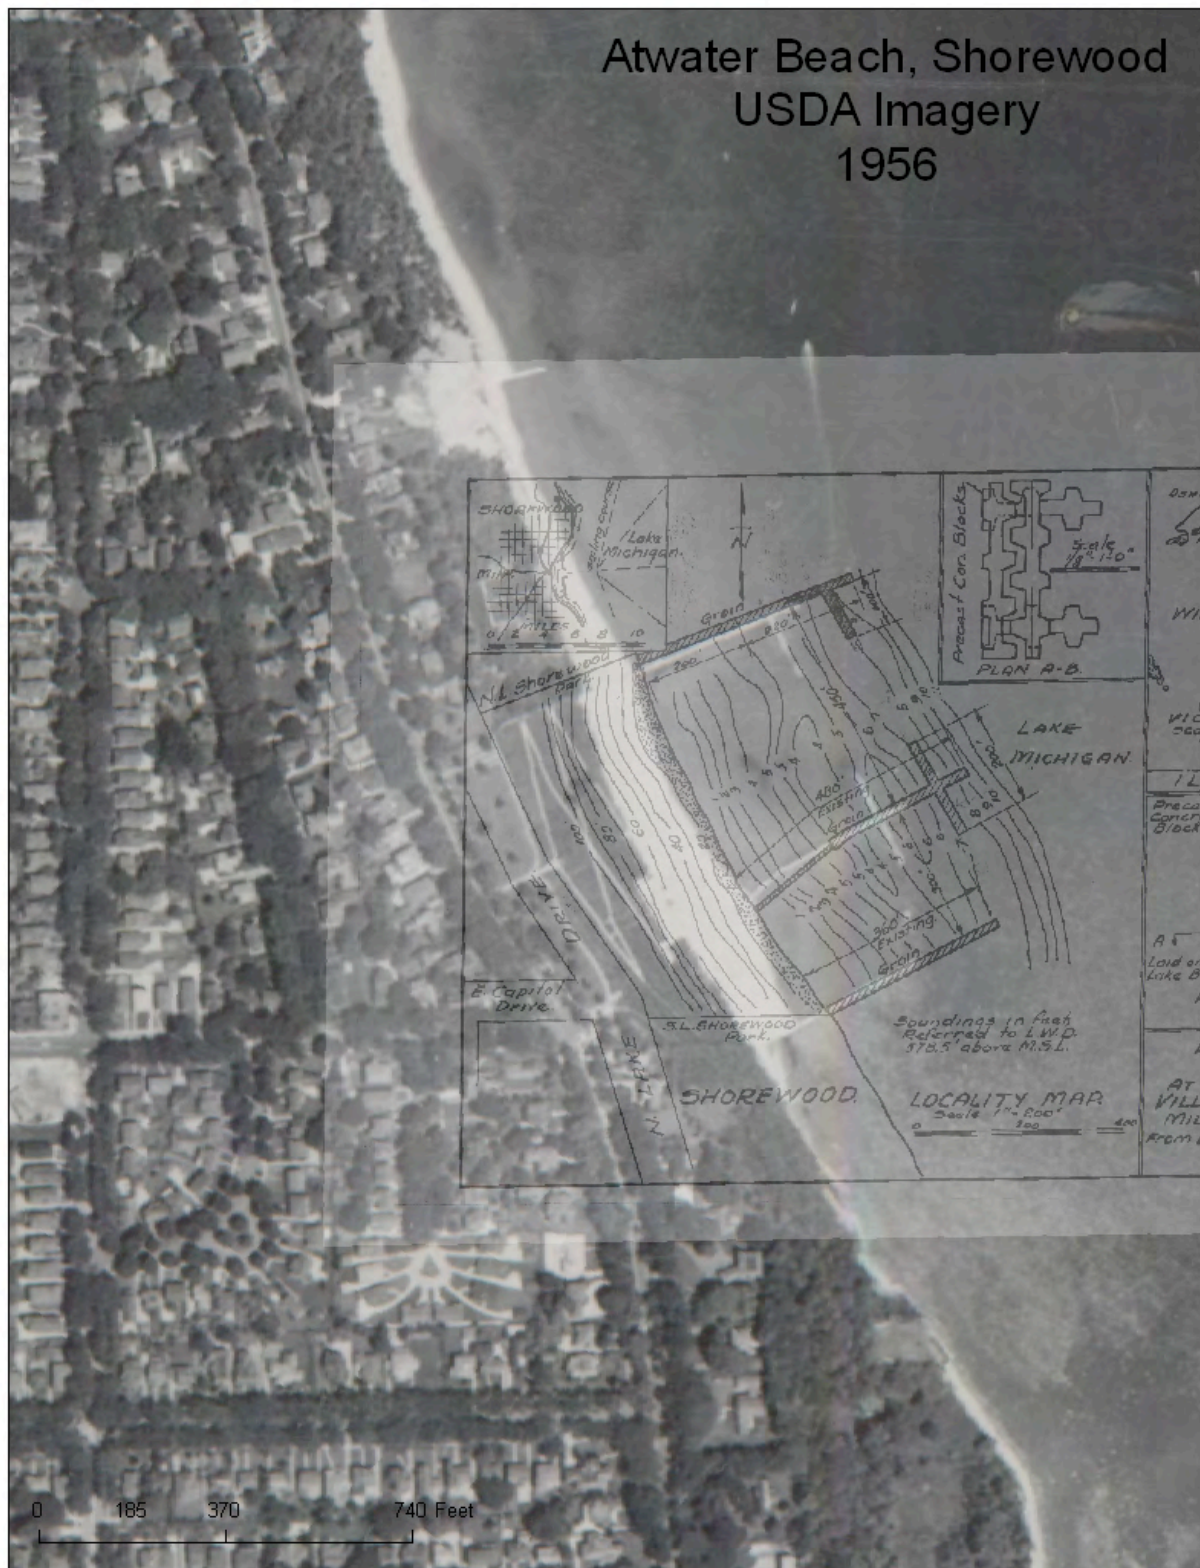
Figure 29: 1956 aerial photograph with groin map superimposed. Mean annual lake level: 579.00 ft.

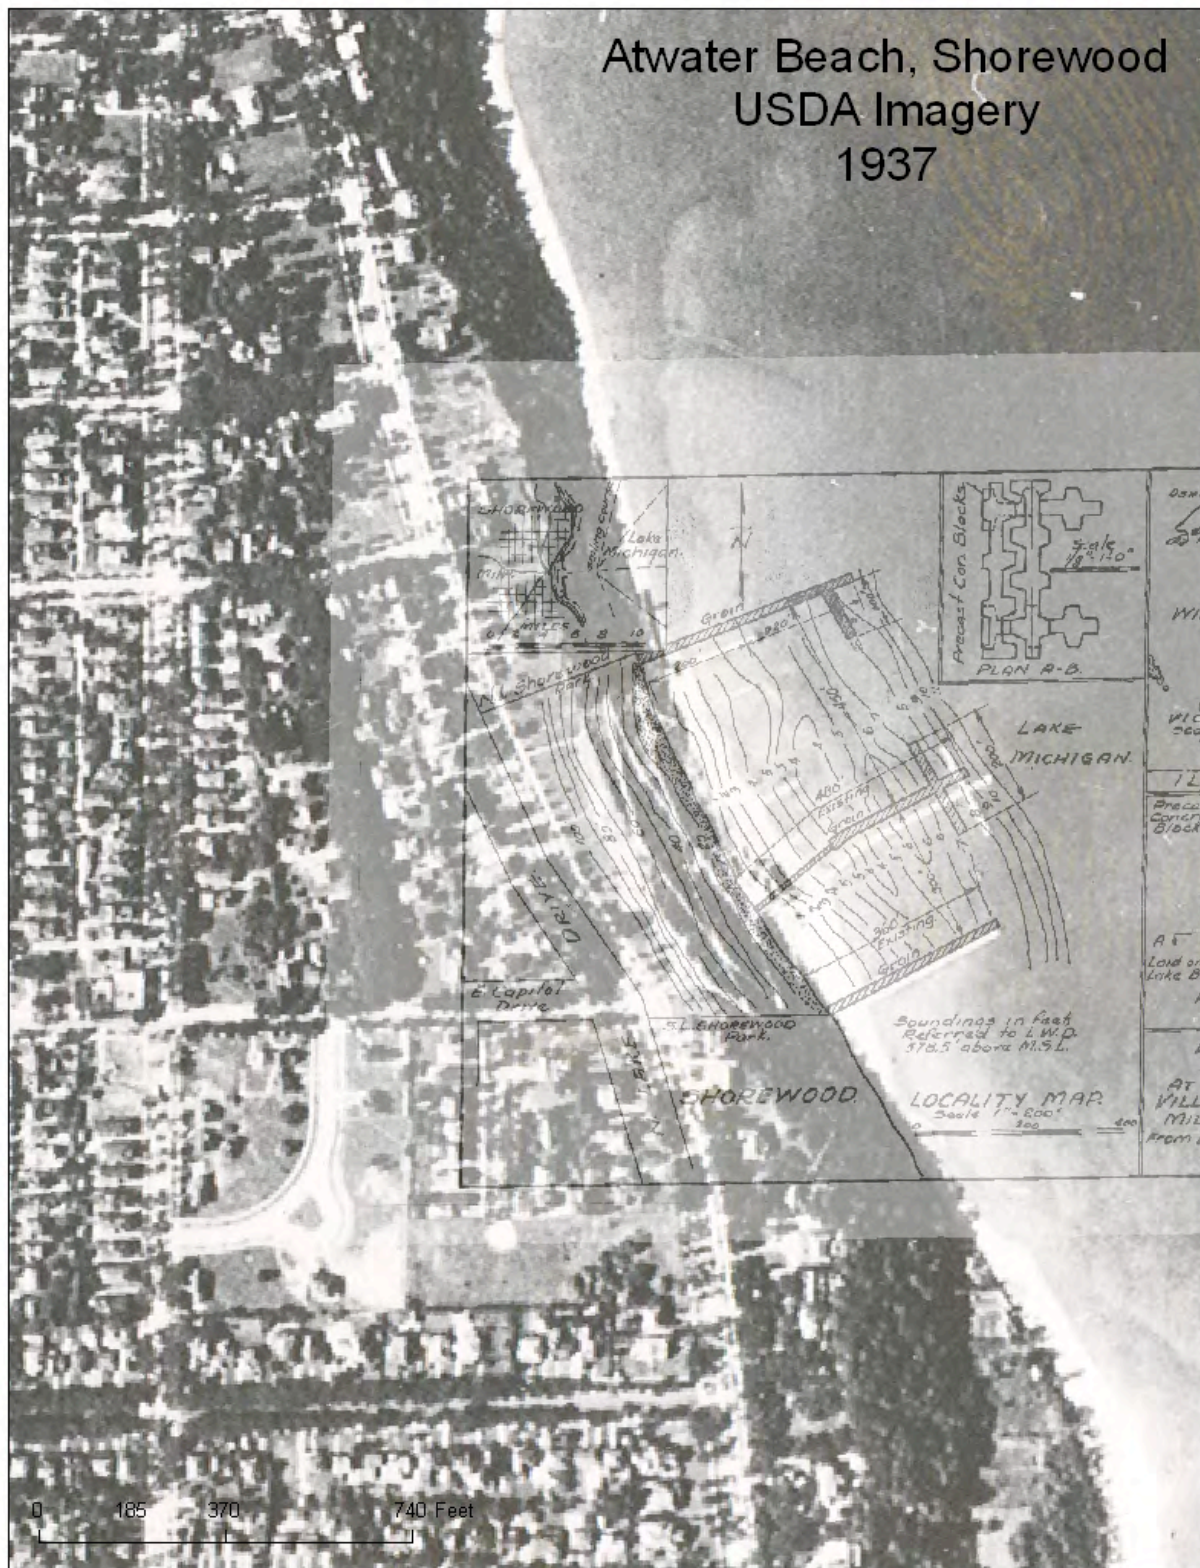
Figure 30: 1937 aerial photograph with groin map superimposed. Mean annual lake level: 577.27 ft.

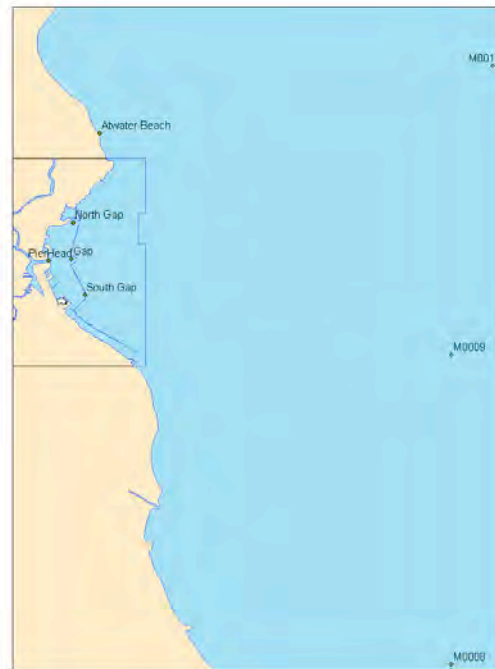
**Figure 33: USACE WIS wave hindcast sites located near Atwater Beach**

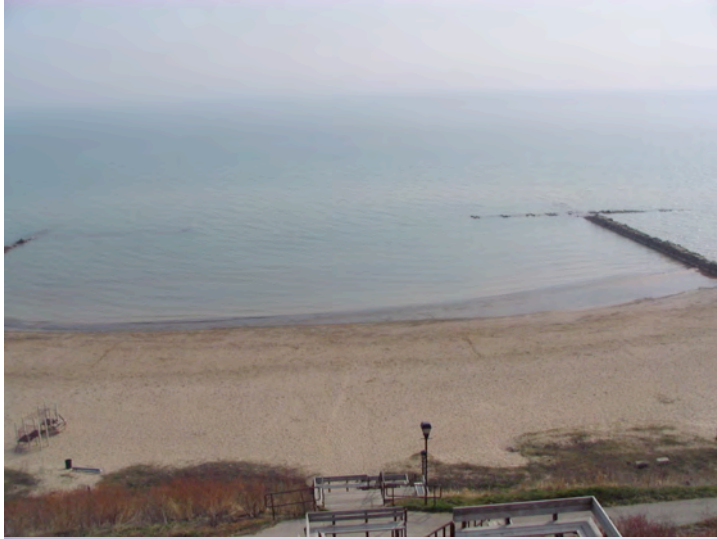
North cell as seen from the top of the bluff.

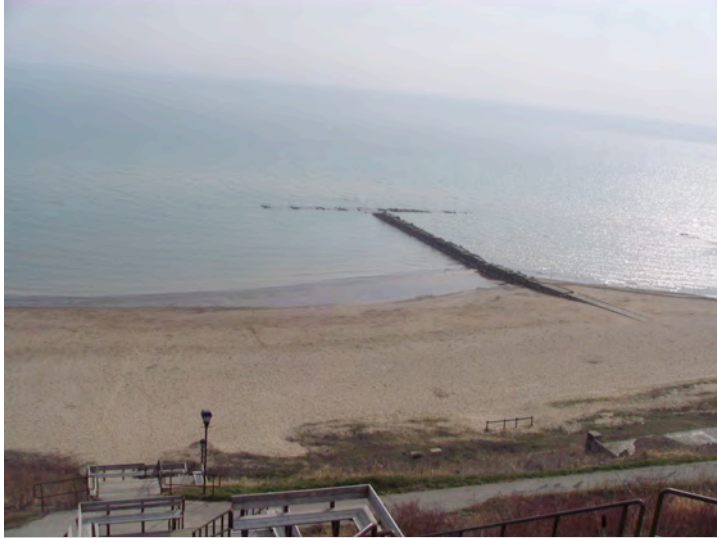
Central groin as seen from the top of the bluff.

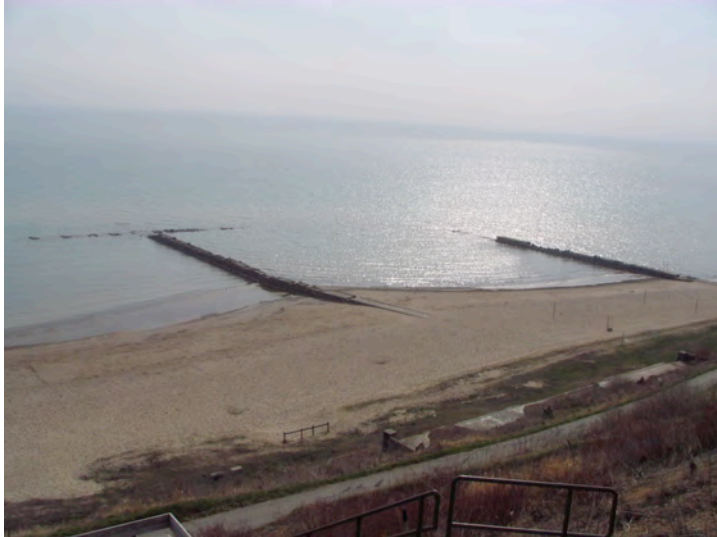
South cell as seen from the top of the bluff.

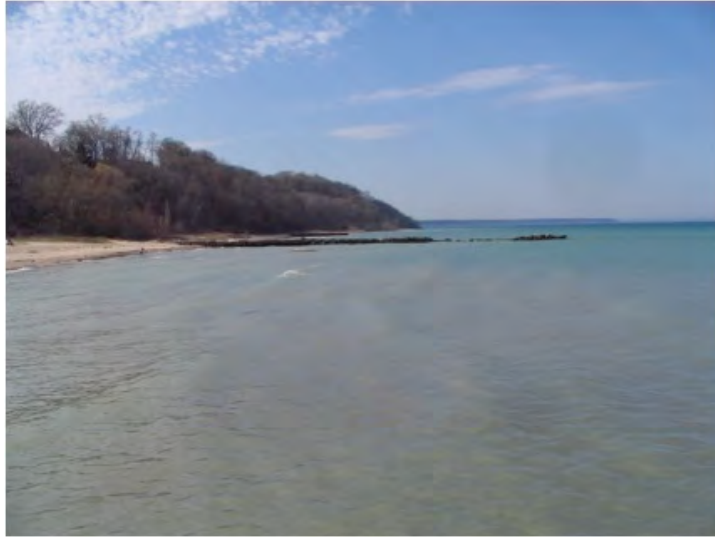
North cell as seen from the central groin.

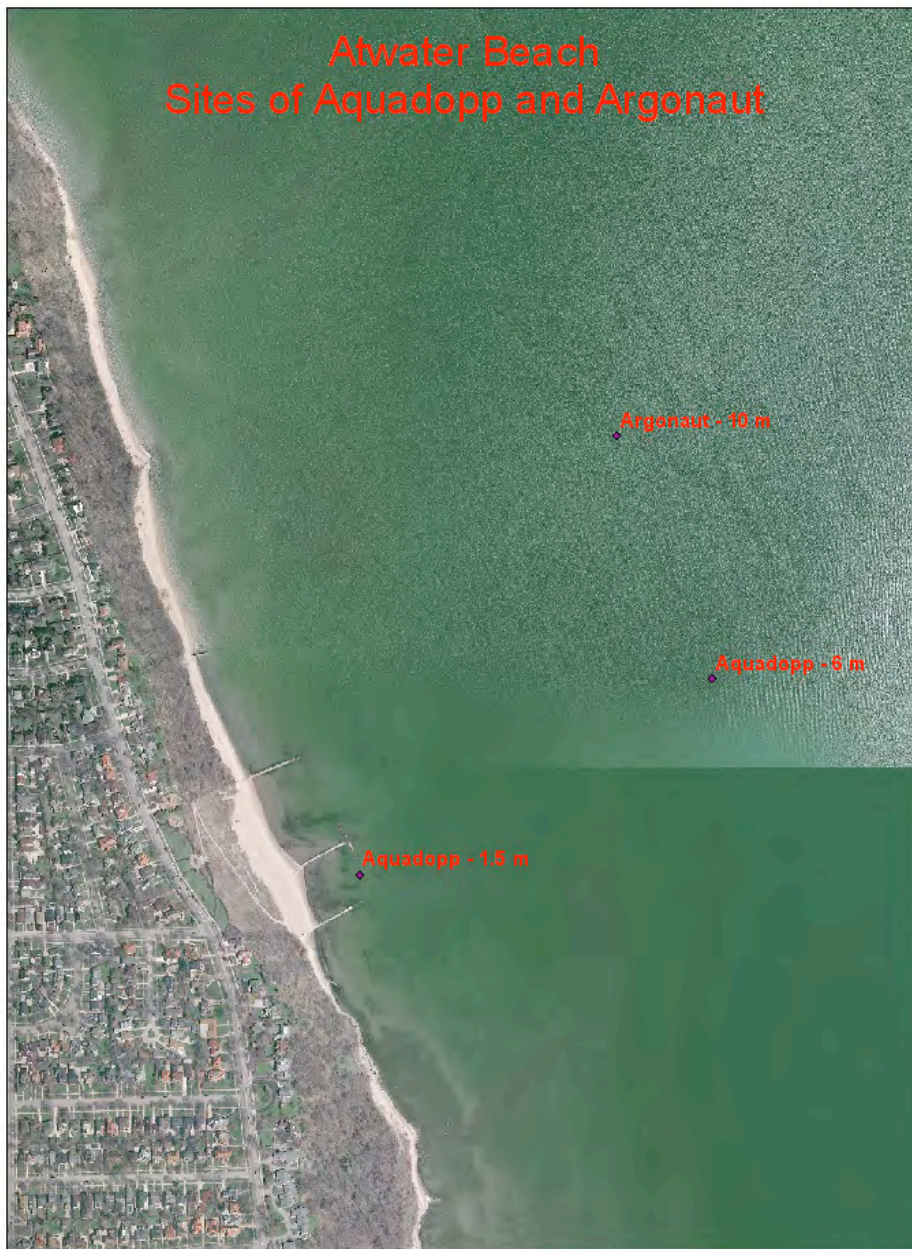
**Figure 36: Location of wave measurements**

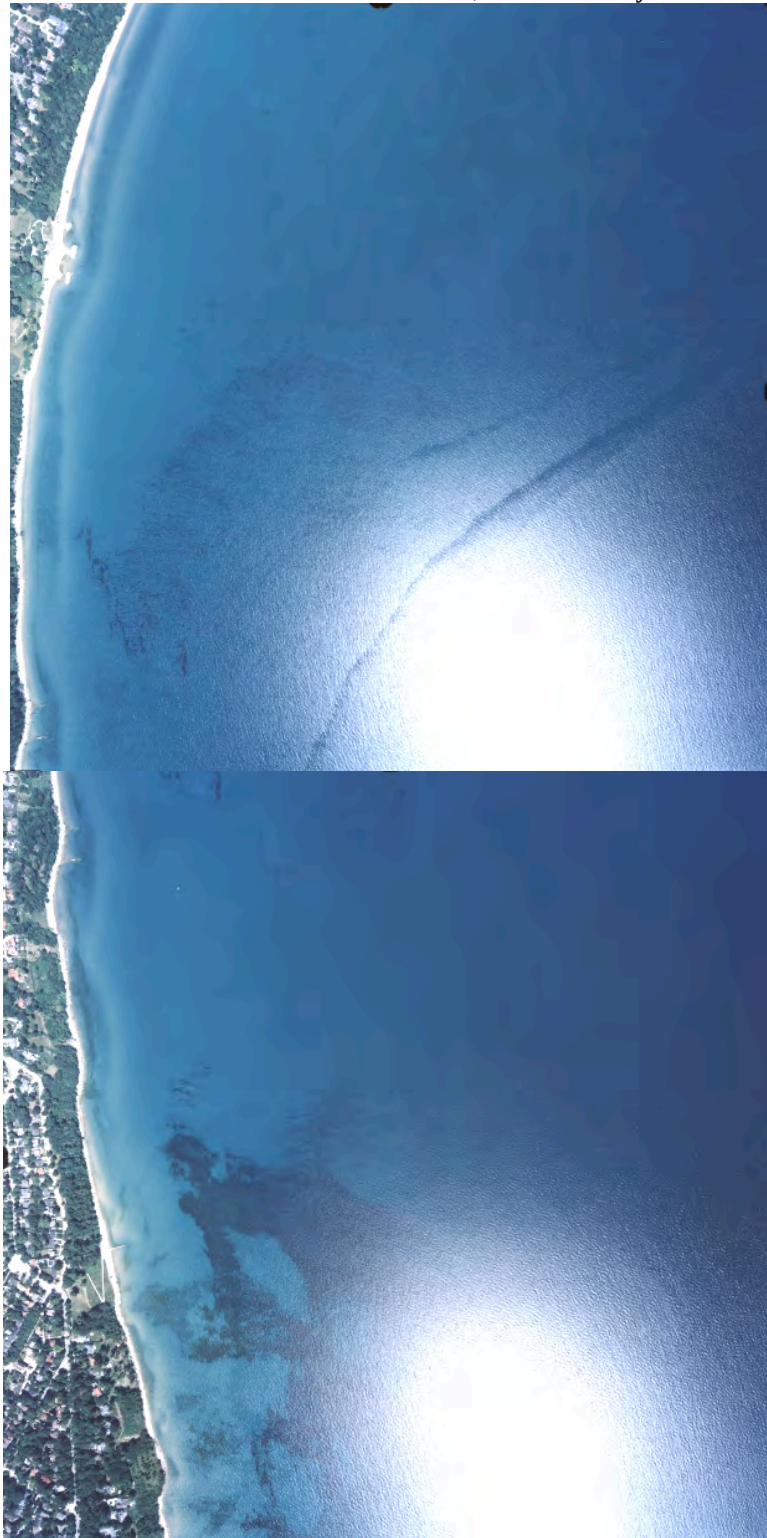
**Figure 38: *Cladophora* distribution offshore from Klode Beach, Whitefish Bay**

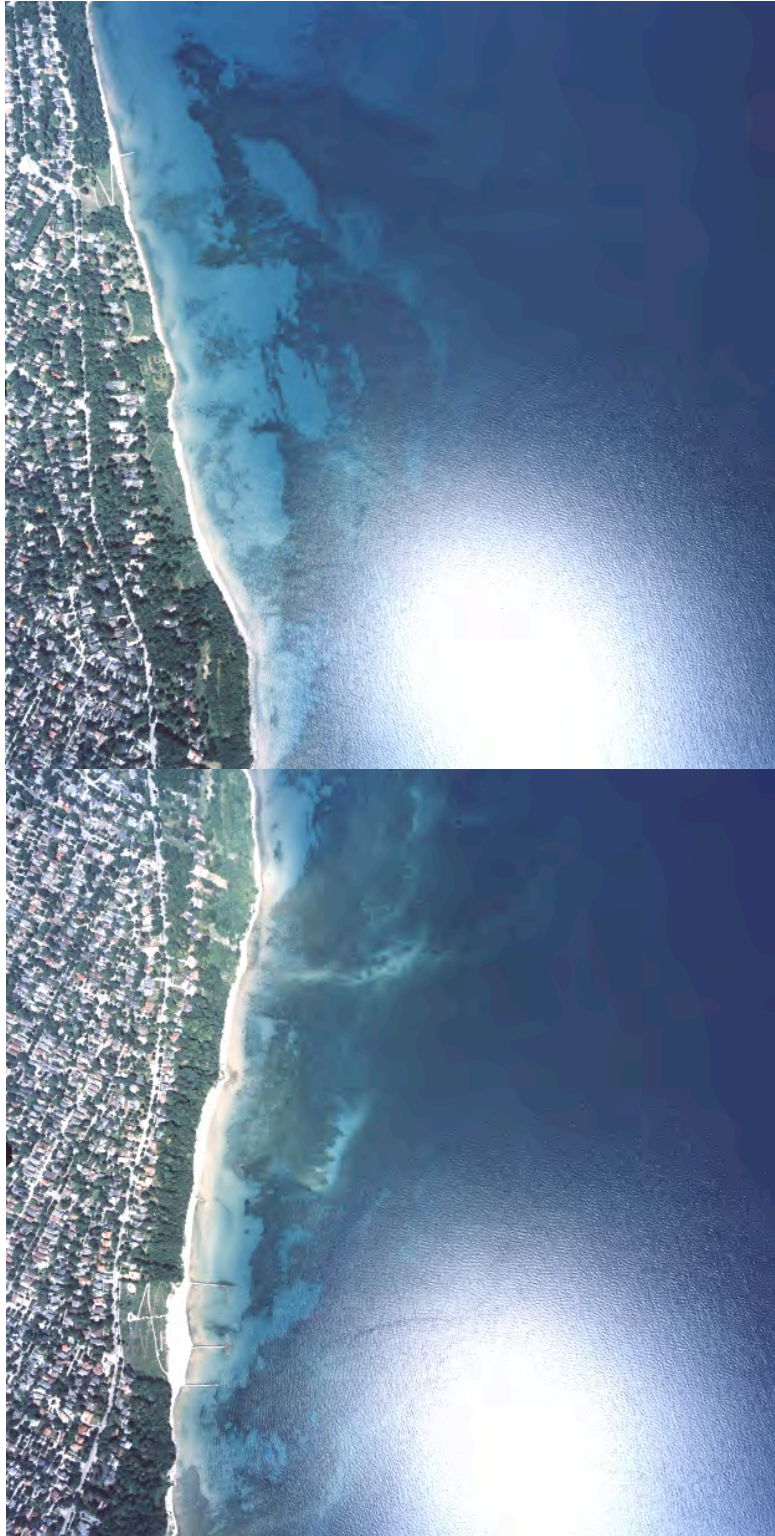
**Figure 39: *Cladophora* distribution offshore from Atwater Beach, Shorewood**

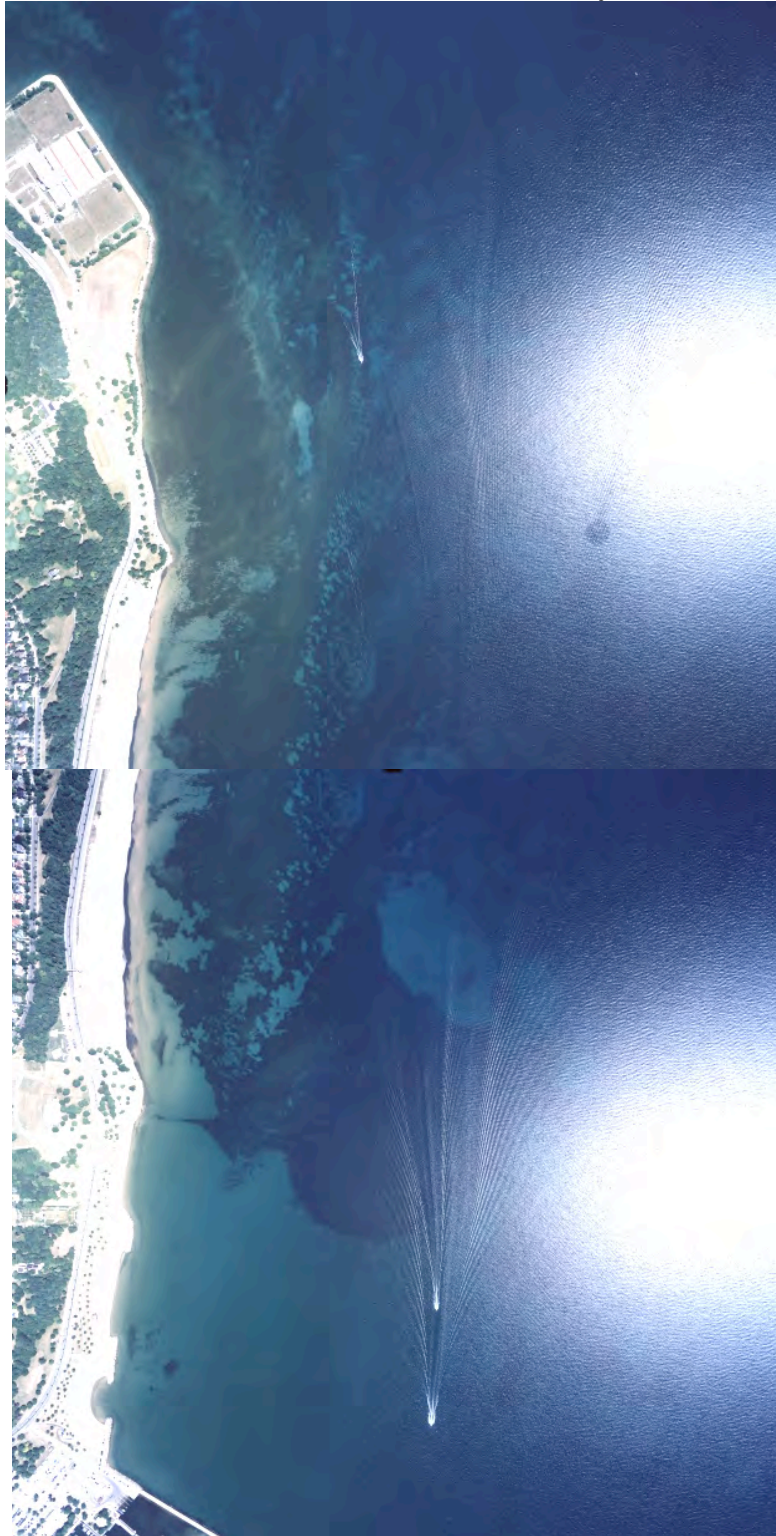
**Figure 40: *Cladophora* distribution offshore from Bradford and McKinley Beaches, Milwaukee**
