Village of Shoreland, Wisconsin

**Pedestrian/Bicycle Safety
Intersection Review**

December 2005

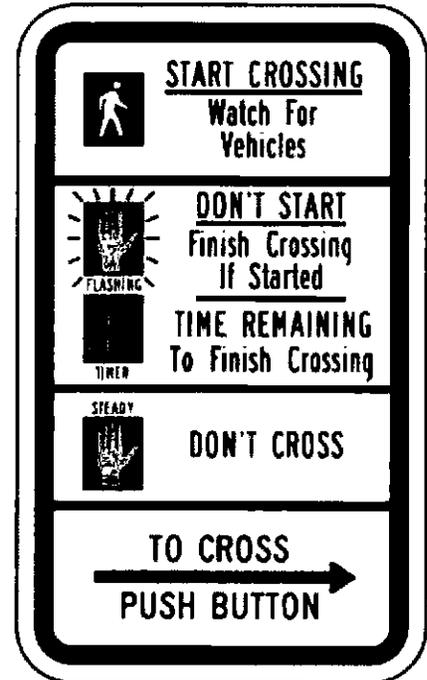
Picture 3 – Crosswalk Sign

*4) Pedestrian Crosswalk Signs. “Walk” vs. “Don’t Walk” pedestrian symbols are commonly misunderstood. The walk symbol (an upright pedestrian) on a properly designed pedestrian signal, at a minimum, provides time for pedestrians to react to the signal and begin crossing a crosswalk. This amount of time is typically 6 or 7 seconds minimum and can be much longer if the concurrent green traffic signal stays on for a long time. The don’t walk symbol (flashing hand) on a properly designed pedestrian signal provides enough time for a pedestrian, traveling at a speed of 4 feet per second to cross a road from one side of the road to the other side of the road. For example, if a crosswalk is 80-foot wide, the flashing hand should be 20 seconds long. This provides a pedestrian, who is just about to step into the crosswalk when the walk symbol changes to the flashing hand, with enough time to finish crossing to the other side of the road. Pedestrians commonly mistake the flashing hand to mean that he/she must either run to get to the other side or run back to the corner they came from and wait for the next walk signal.

Solution: Install signs at all four corners of signalized intersections similar to that shown in Picture 3, which is meant to educate pedestrians regarding pedestrian signals. This in turn will decrease the potential for pedestrian / vehicle accidents at signalized intersections. Note that similar signs without the countdown timer indication are available for intersections the Village does not wish to install countdown pedestrian signals.

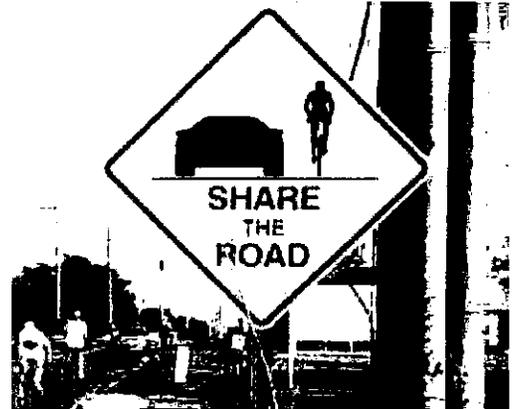
Picture 4– “Share the Road” Sign

Measures can be taken, however to encourage bicycles to travel on the road and to improve safety for those bicyclists. Picture 4 shows a “Share the Road” sign that is meant to make drivers more aware of bicyclists that may be traveling on the road and to also encourage bicyclists to use the road rather than the sidewalk.

We recommend installing “share the road” signs at the north and south ends of Oakland Avenue for vehicles entering the Village. The signs will be especially helpful for northbound vehicles at the south end of town to remind drivers that even though Milwaukee’s marked bike path ends, bicyclists are still present on Oakland Avenue and vehicles must drive with caution. Also, consider installing bicycle racks along Oakland and Capitol to provide bicycle riders with a secure place to leave their bicycles while patronizing local businesses.
