Village of Shorewood

Village Hall and Public Works Department
Facilities Condition Assessment

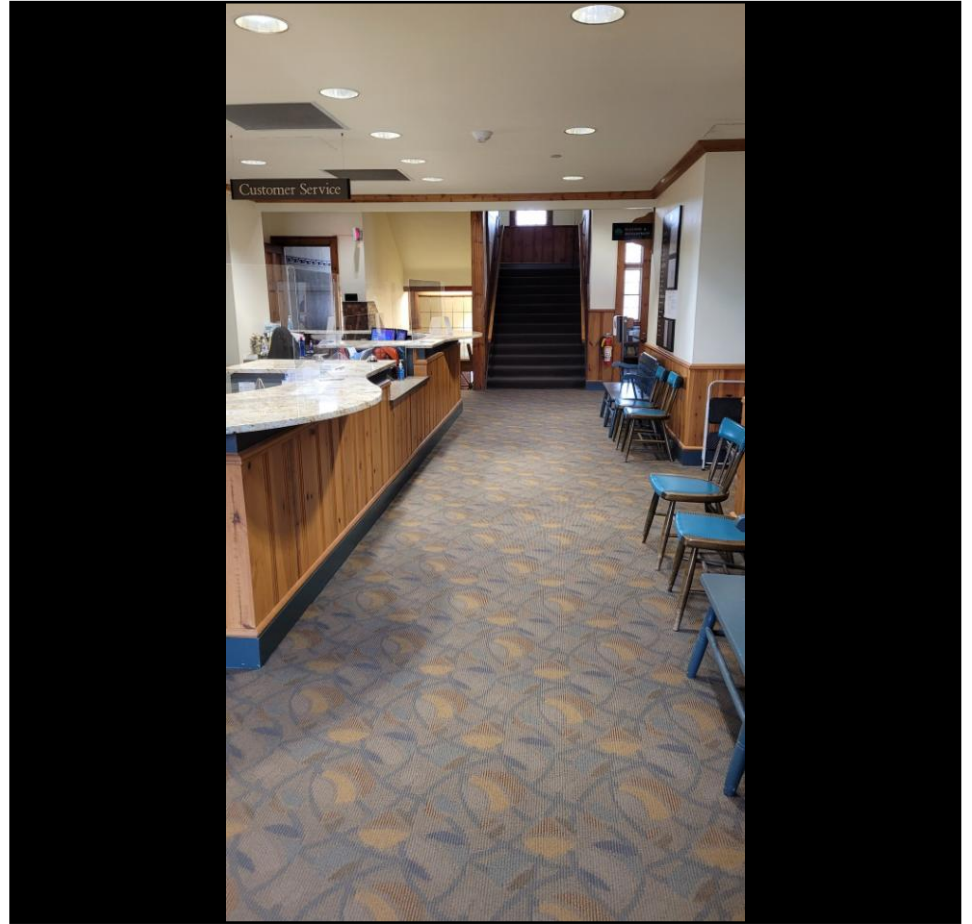
13

Flooring

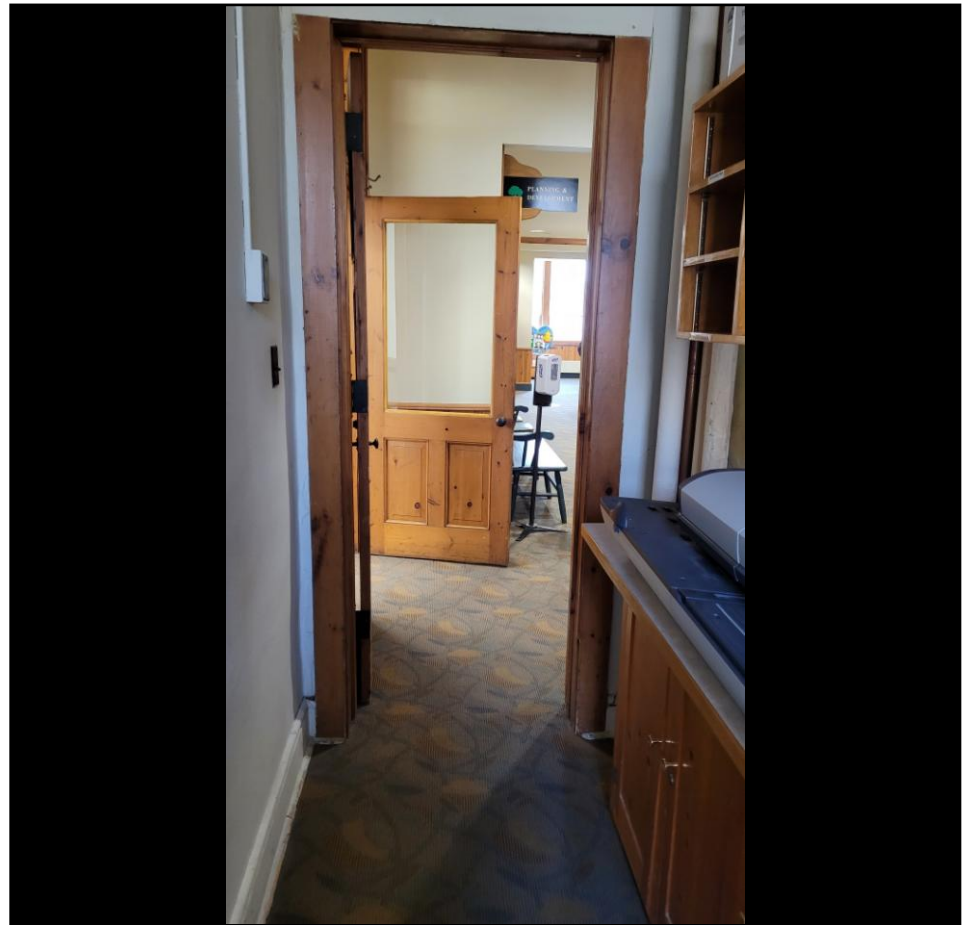
52

ADA requirements

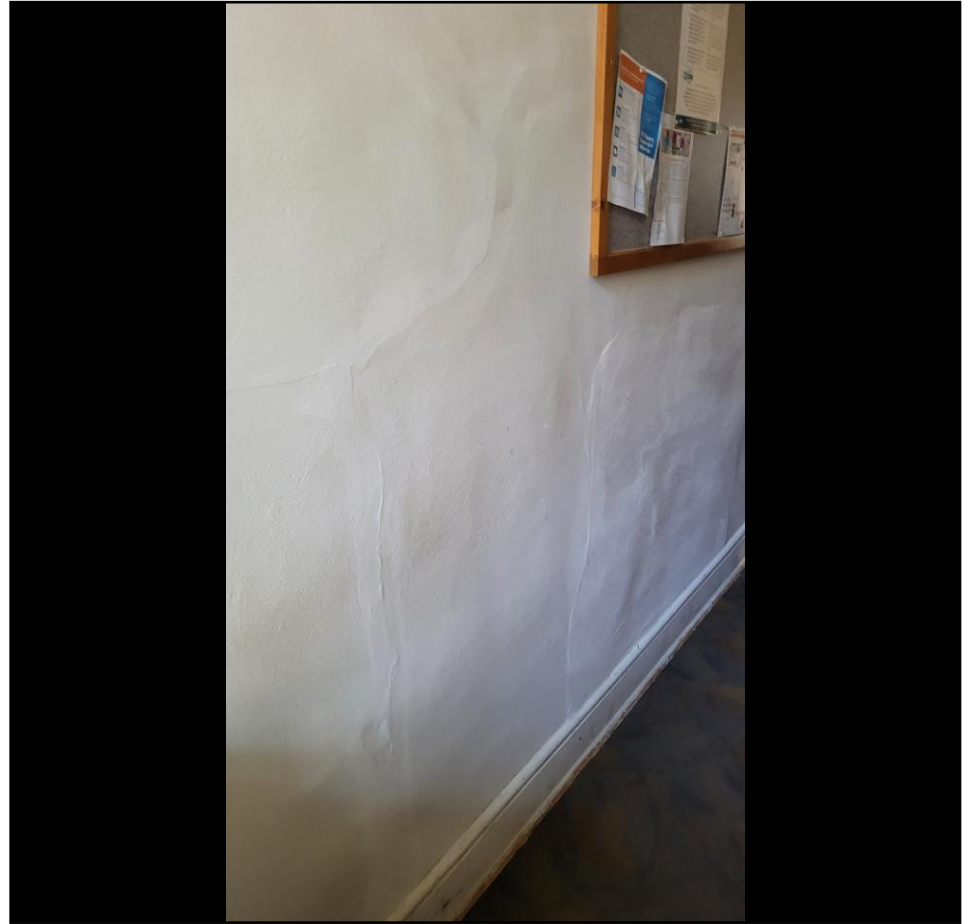
54

Walls

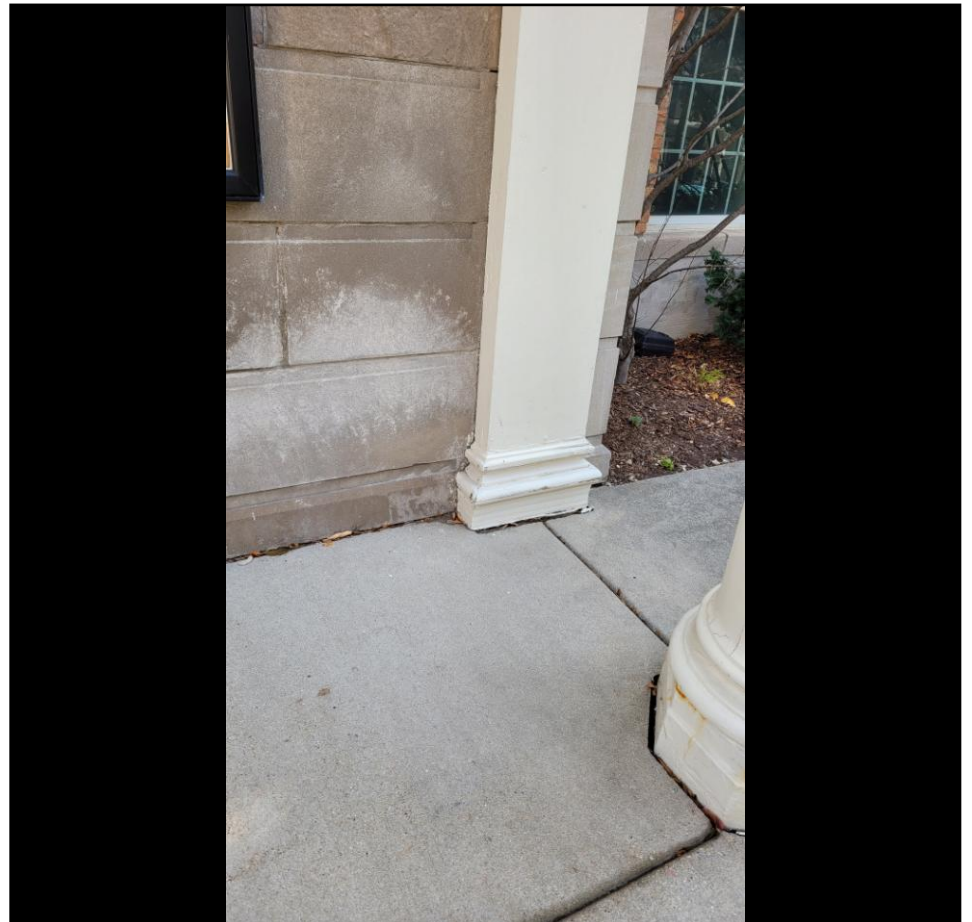
55

Exterior Siding

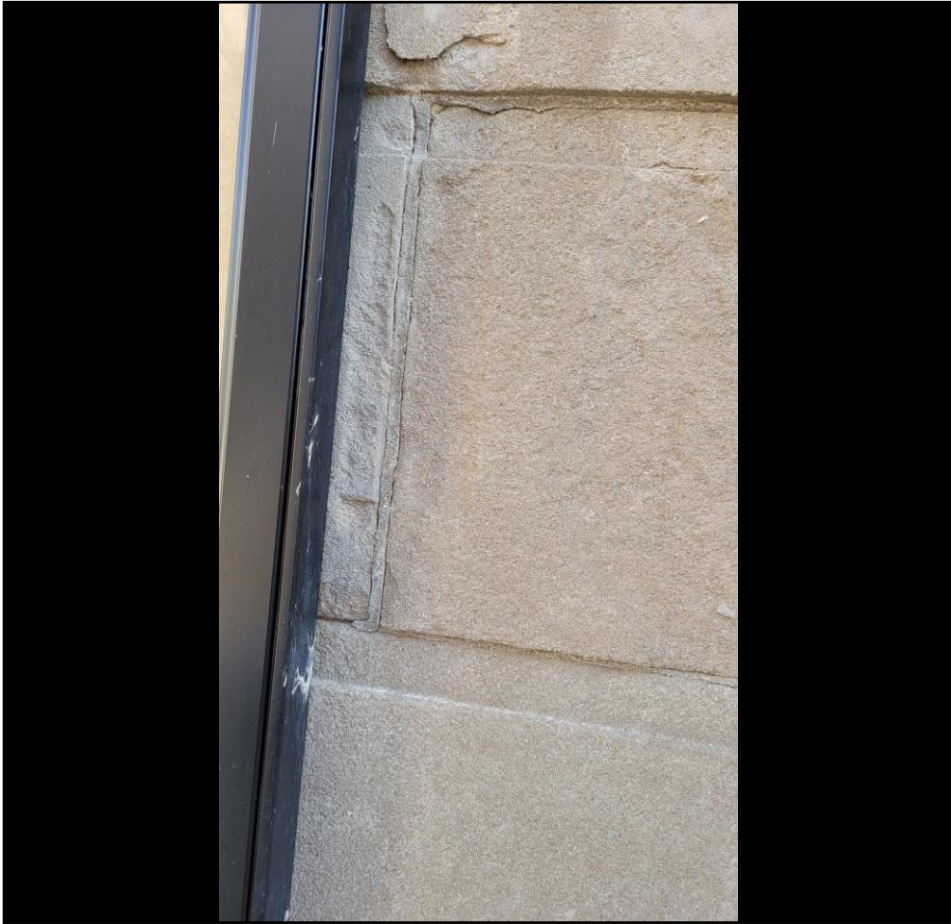
57

Exterior Siding

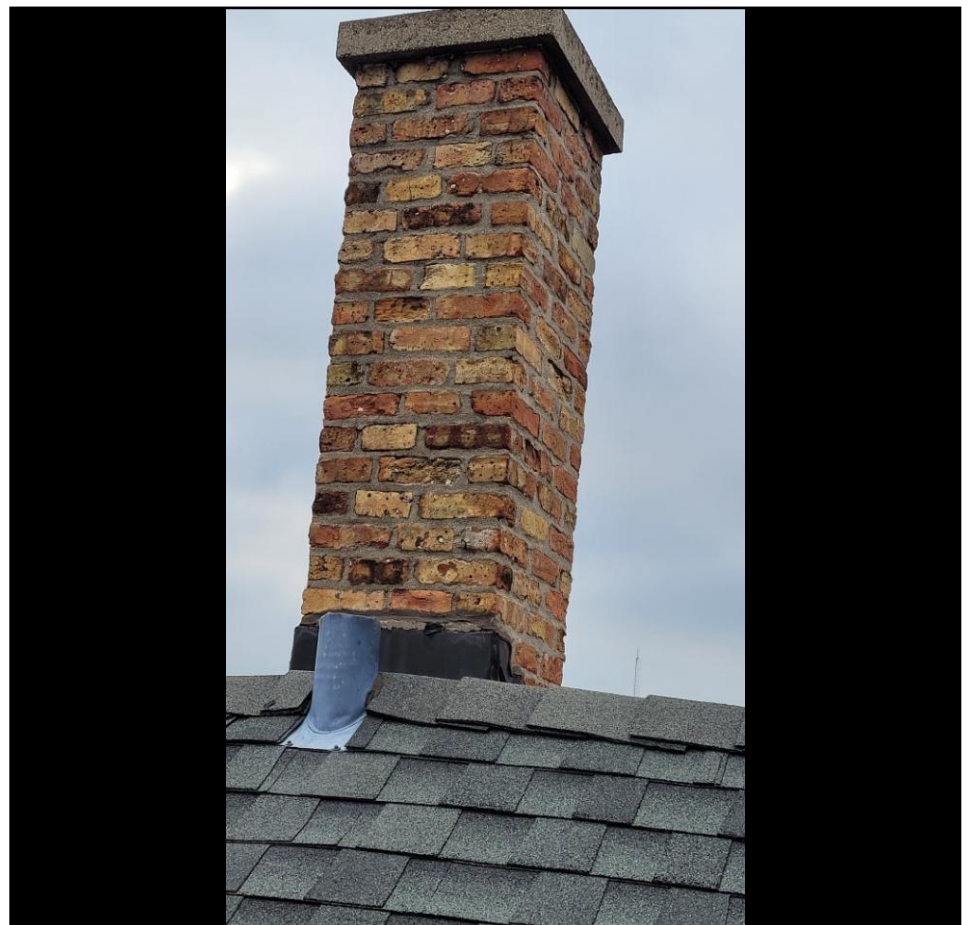
63

Roof

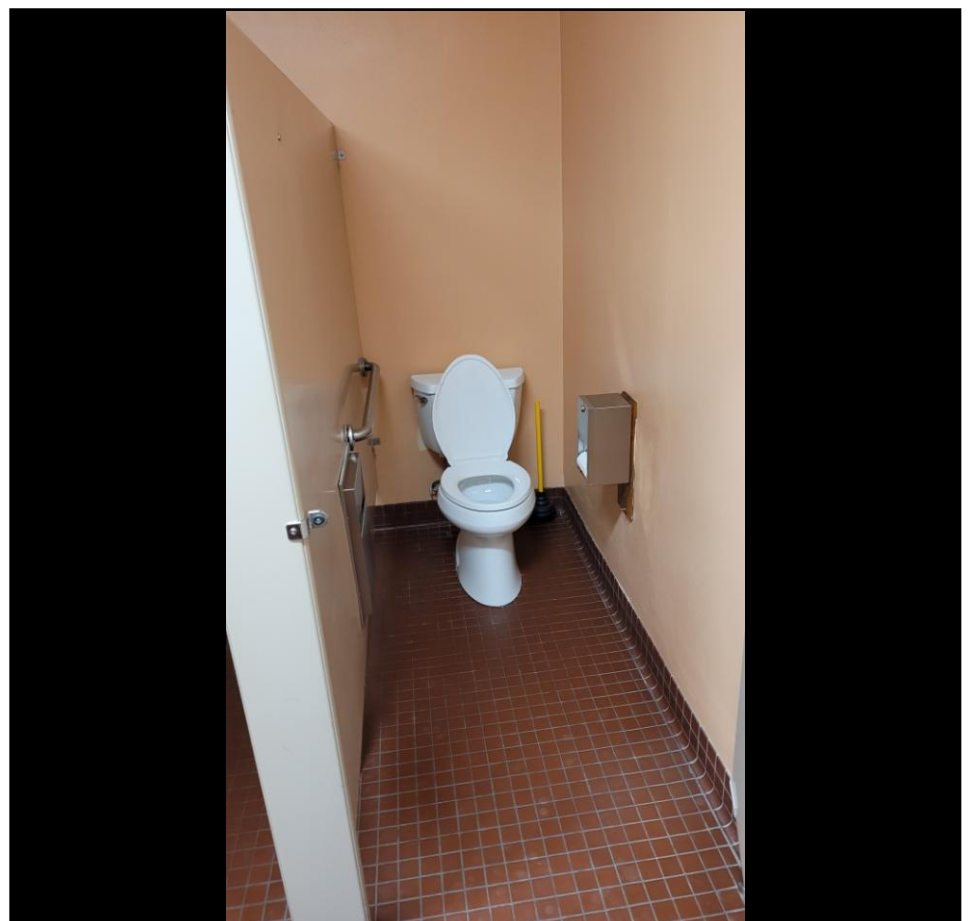
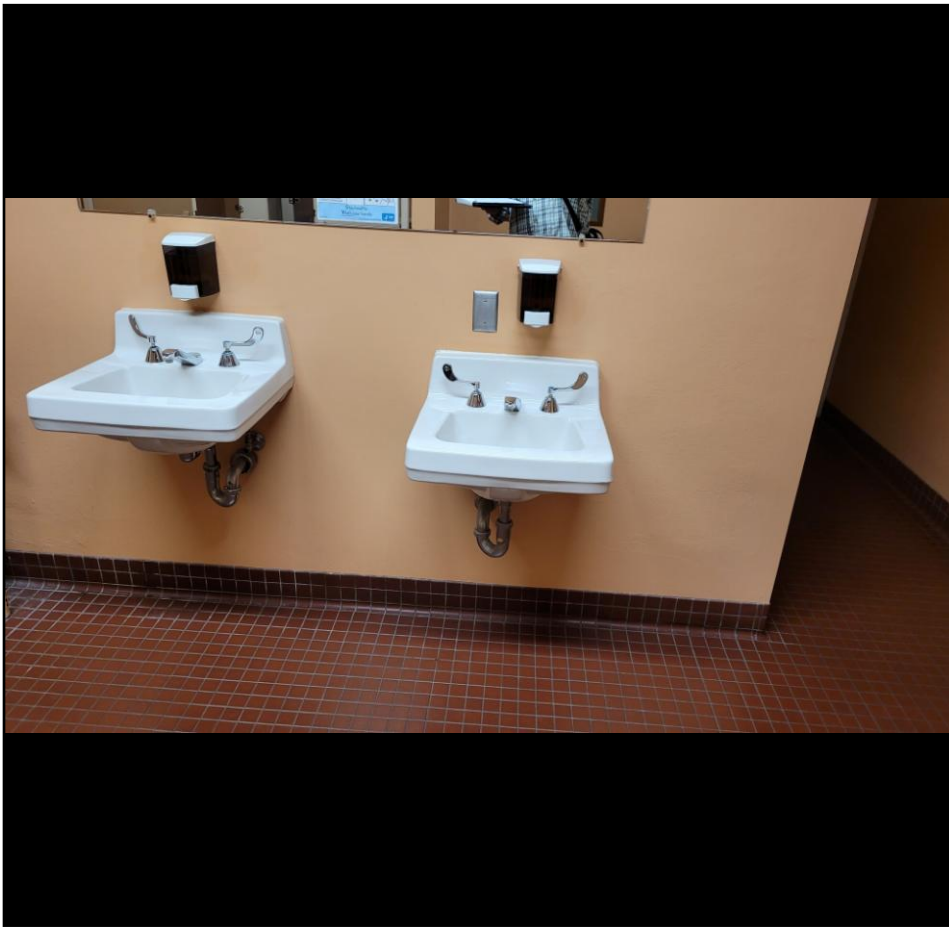
68

ADA requirements

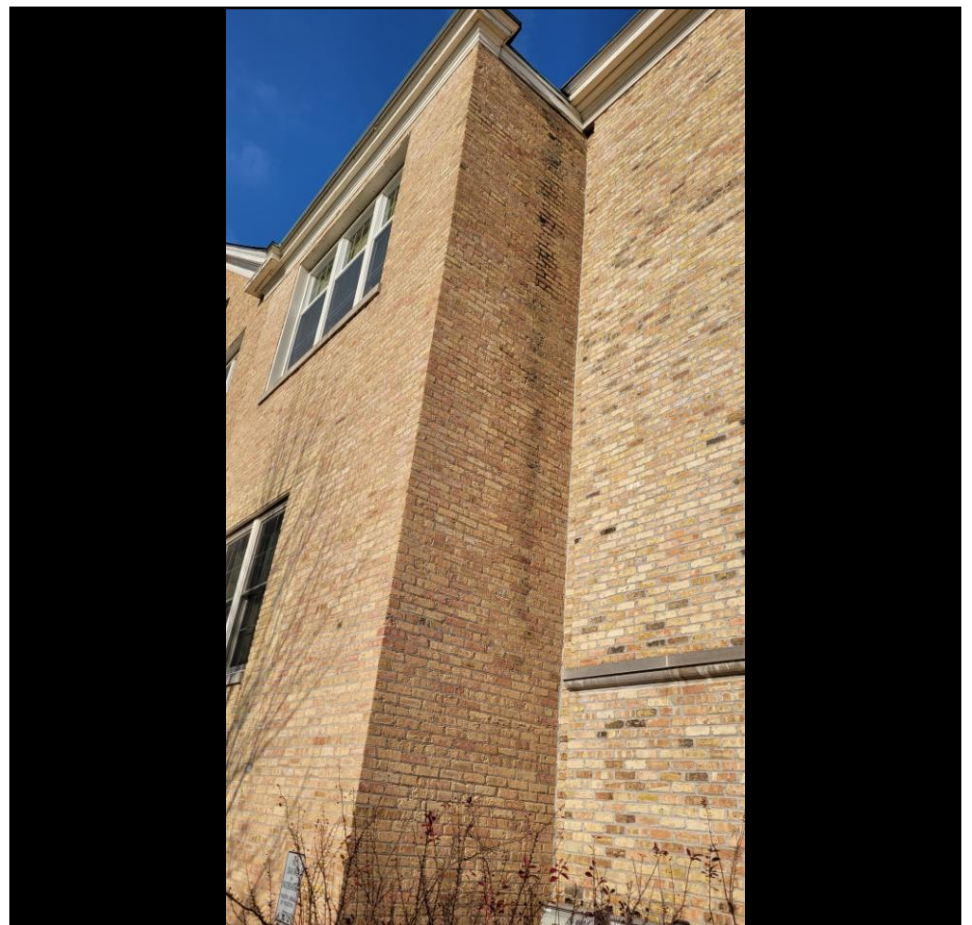
69

Exterior Siding

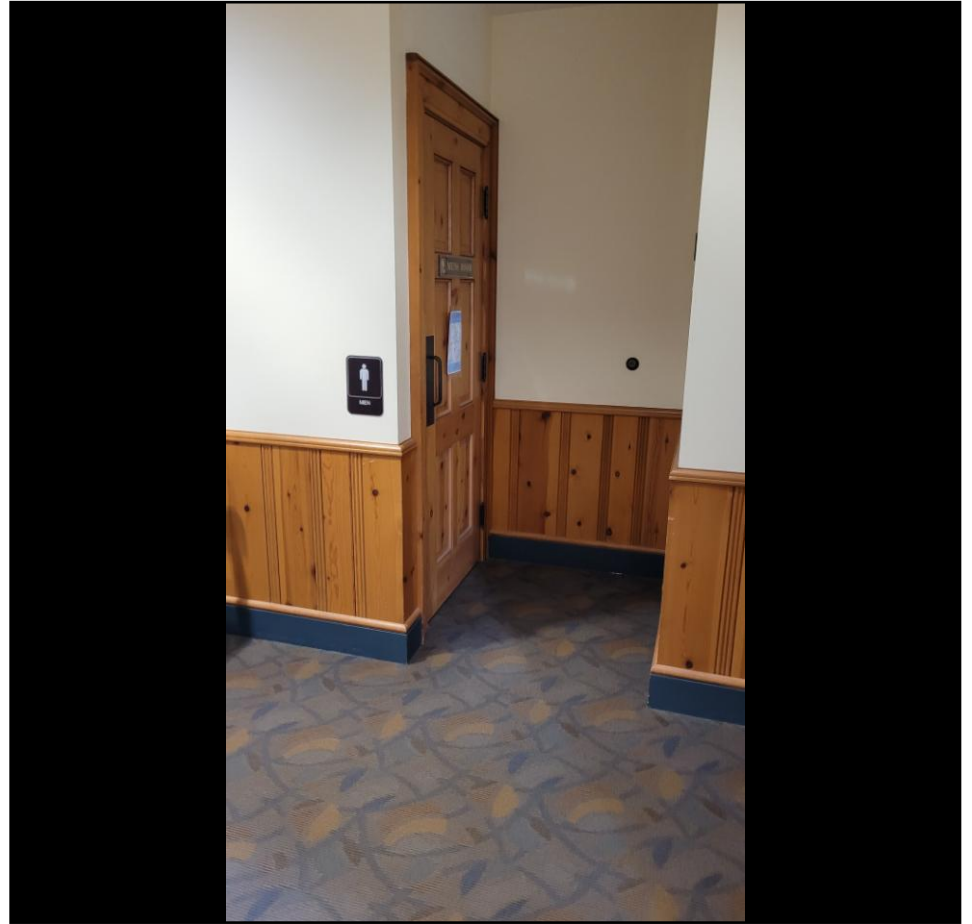
77

ADA requirements

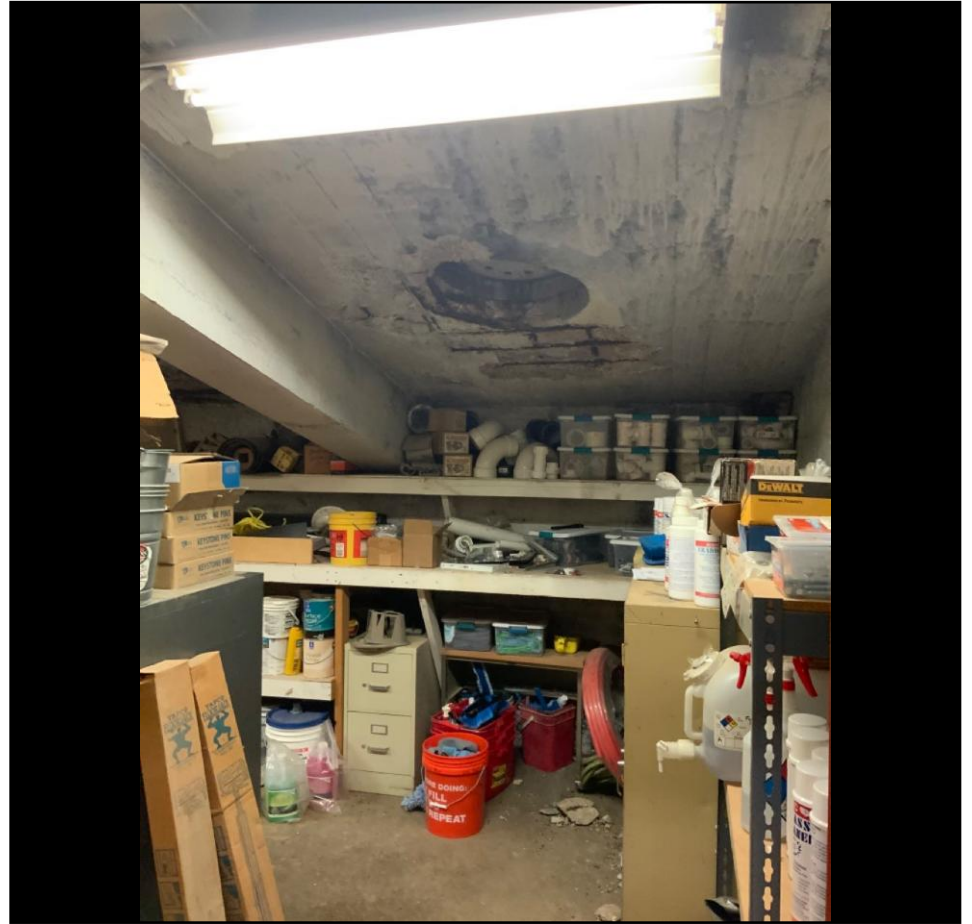
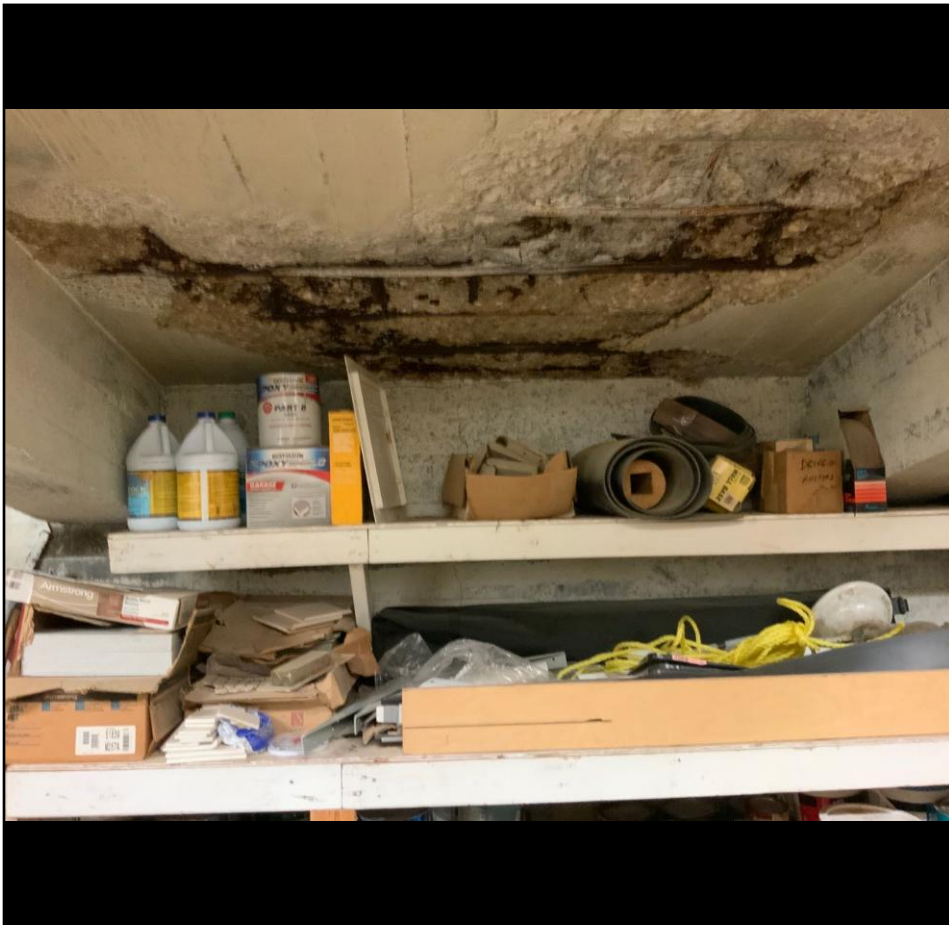
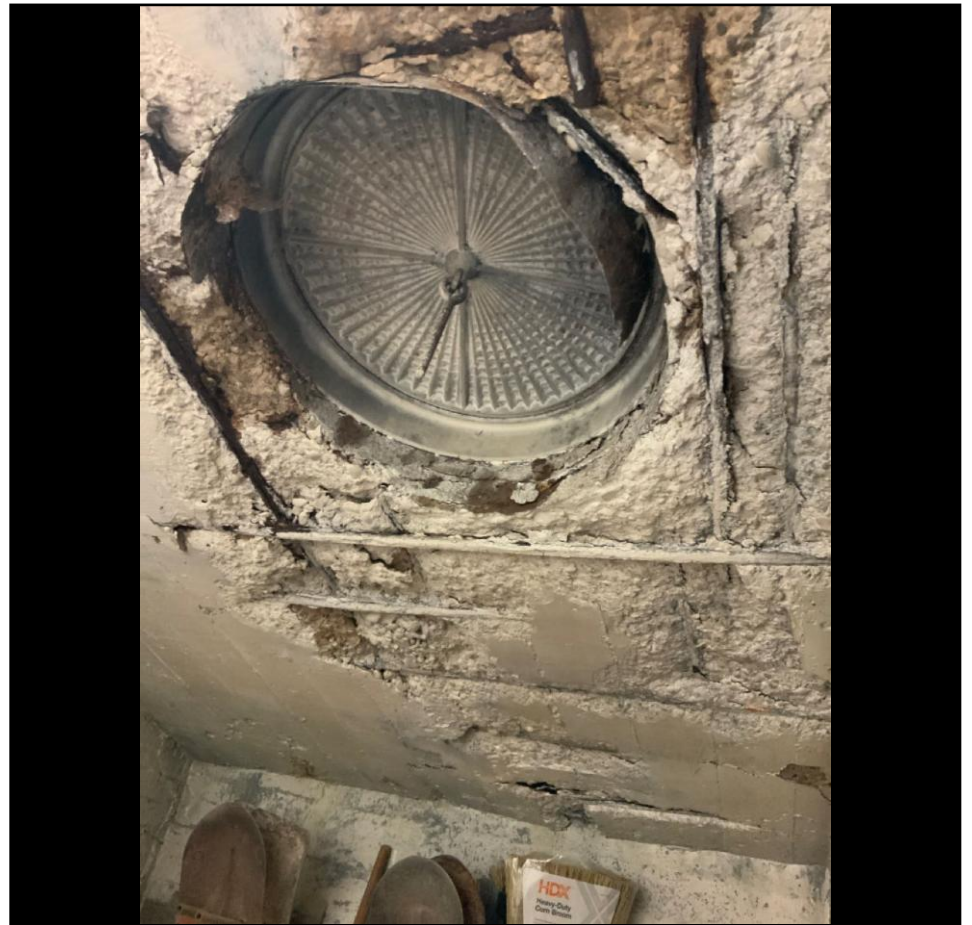
Priority 1			
 	62	Ceilings	Priority 1	Category 1	Deterioration of existing concrete structural slab on ramp above.	\$28,000

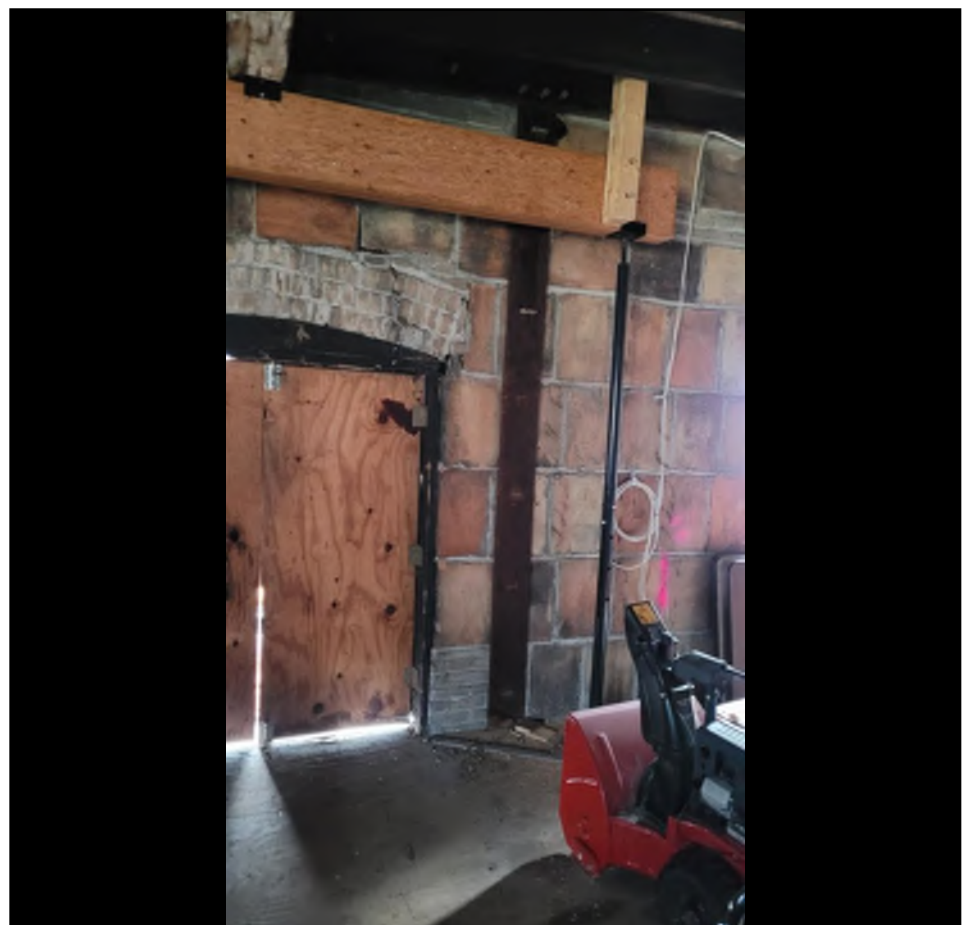
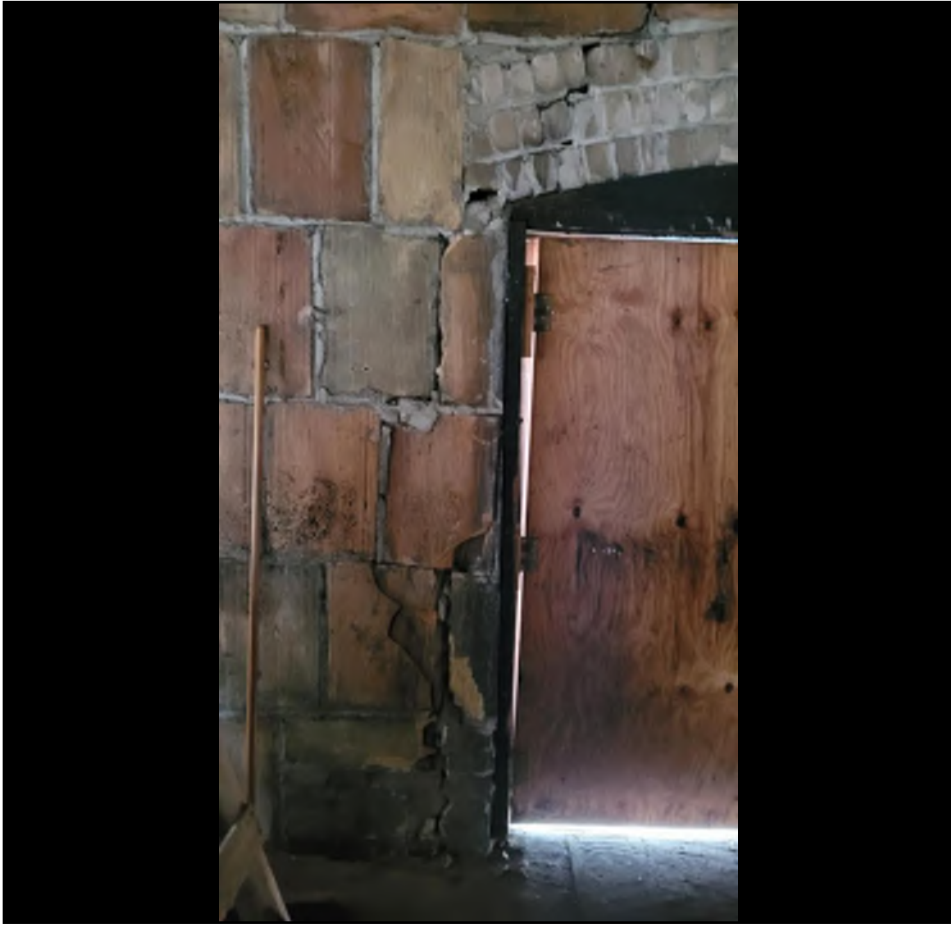
52

Visible Structural Components

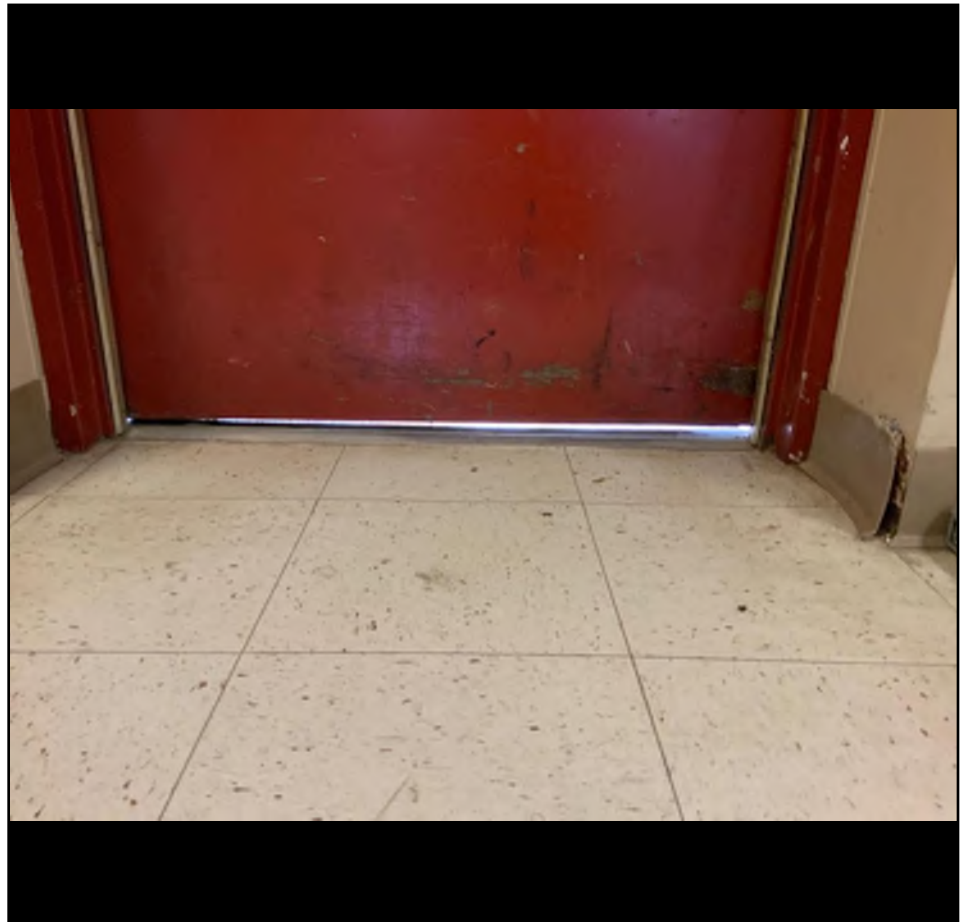
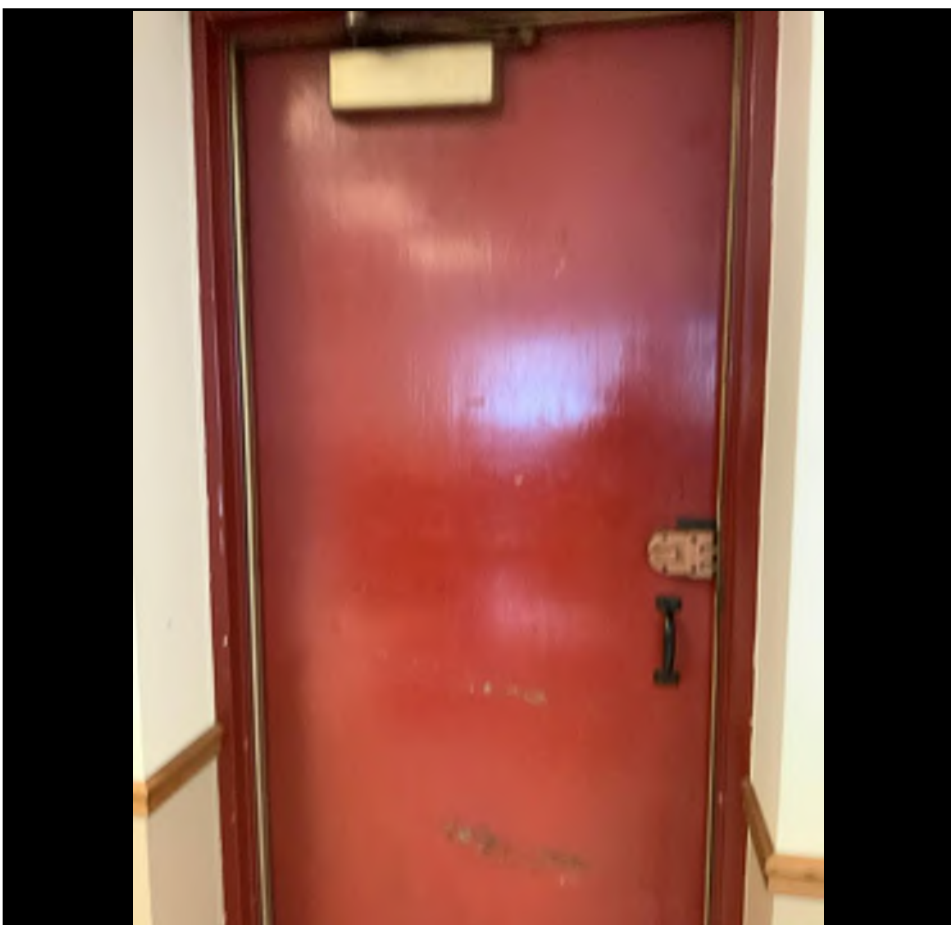
7

Doors

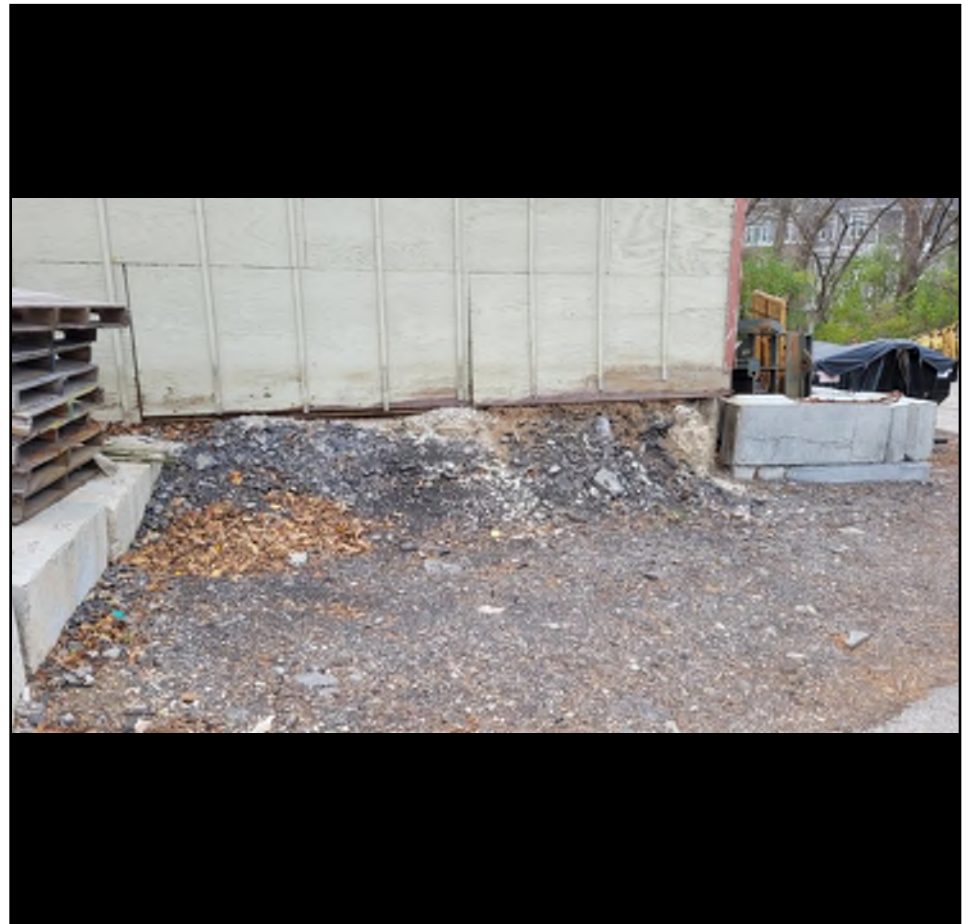
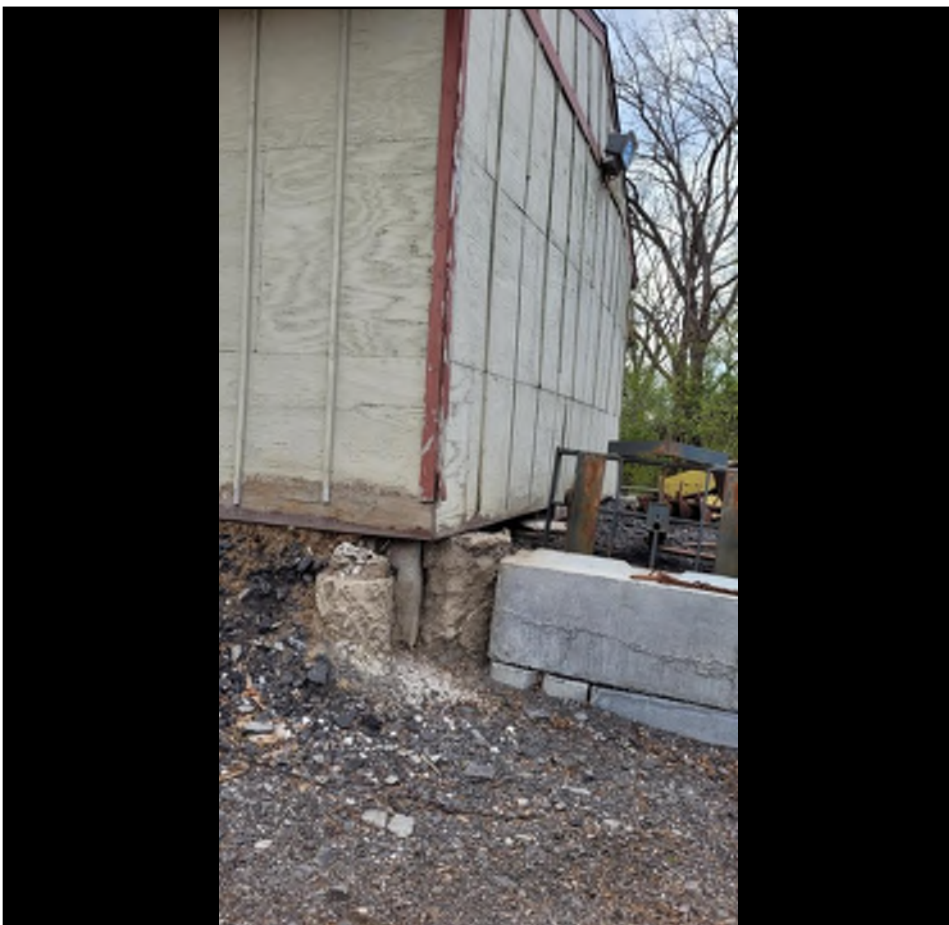
46

Exterior

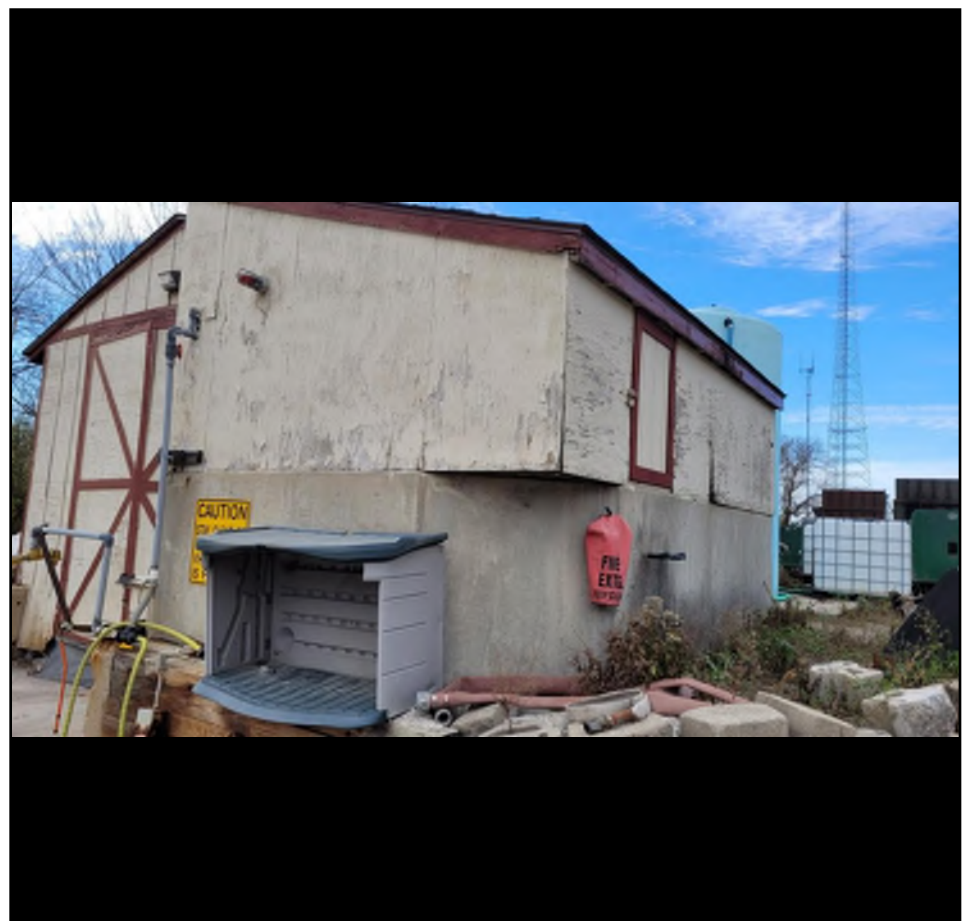
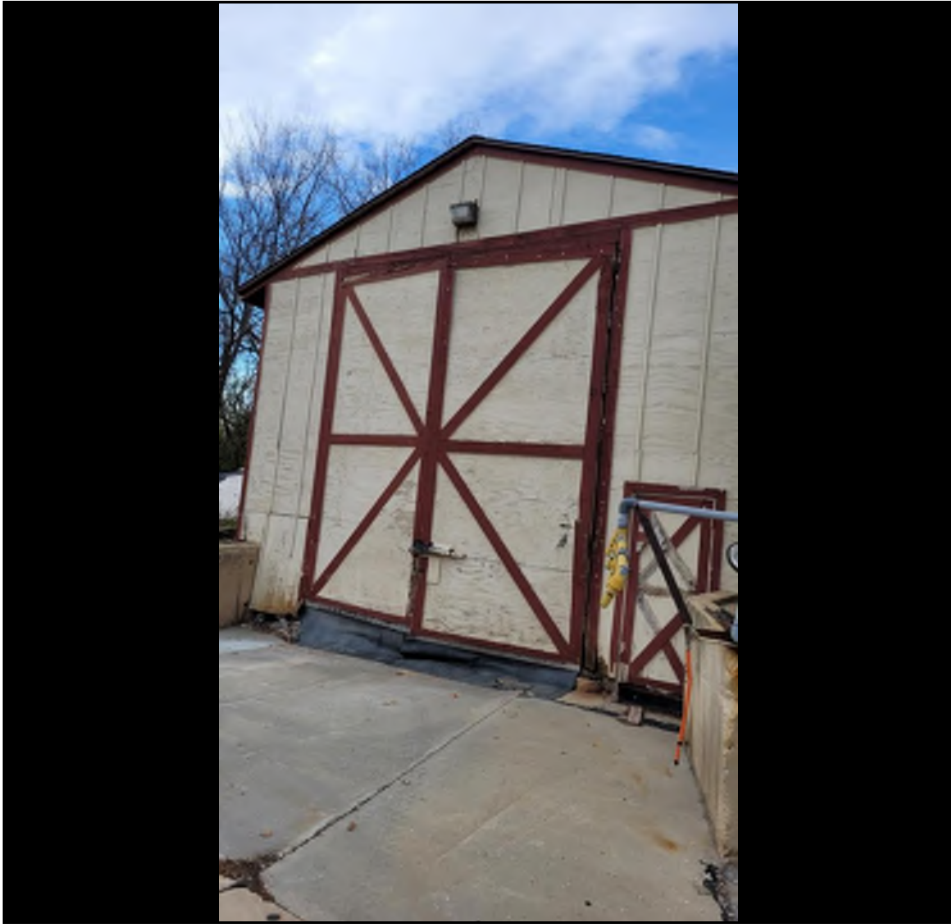
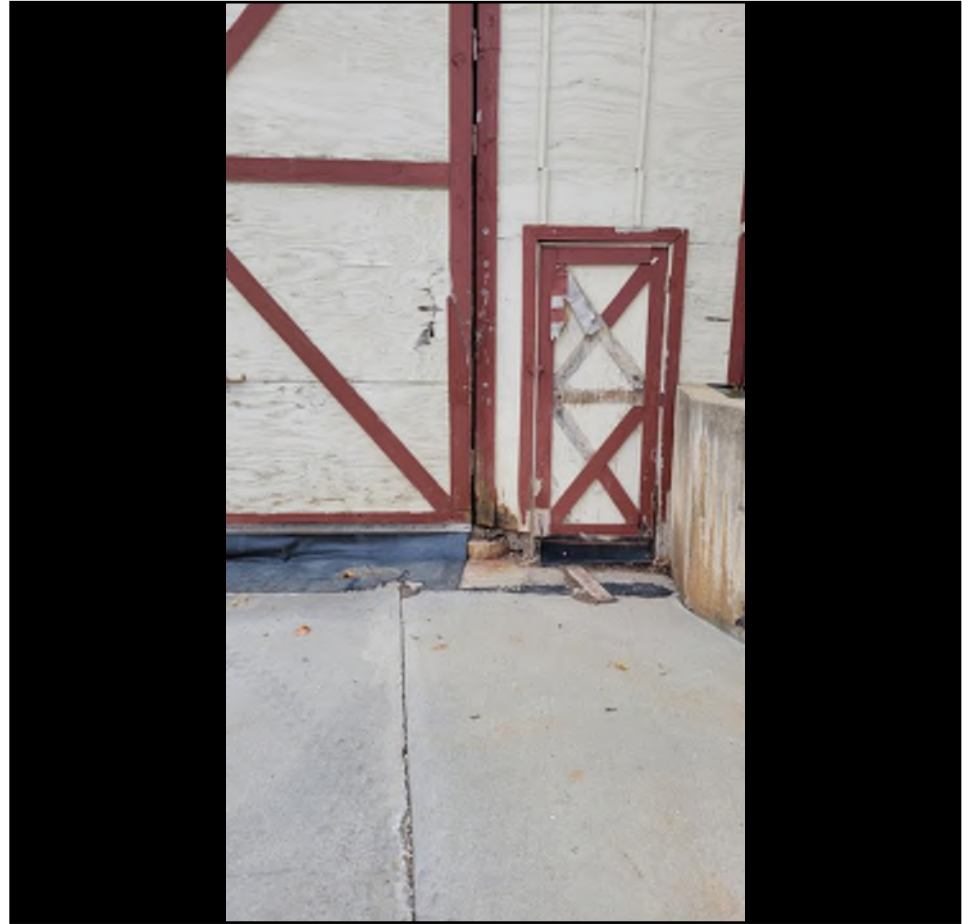
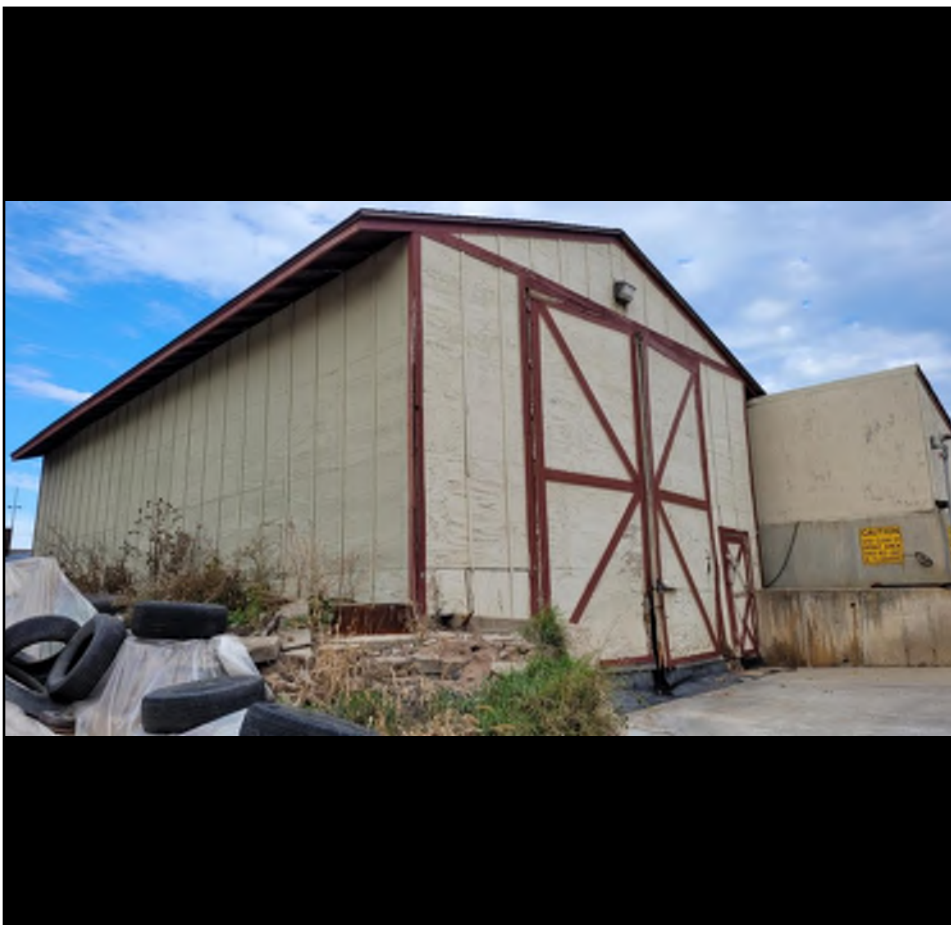
0

Exterior

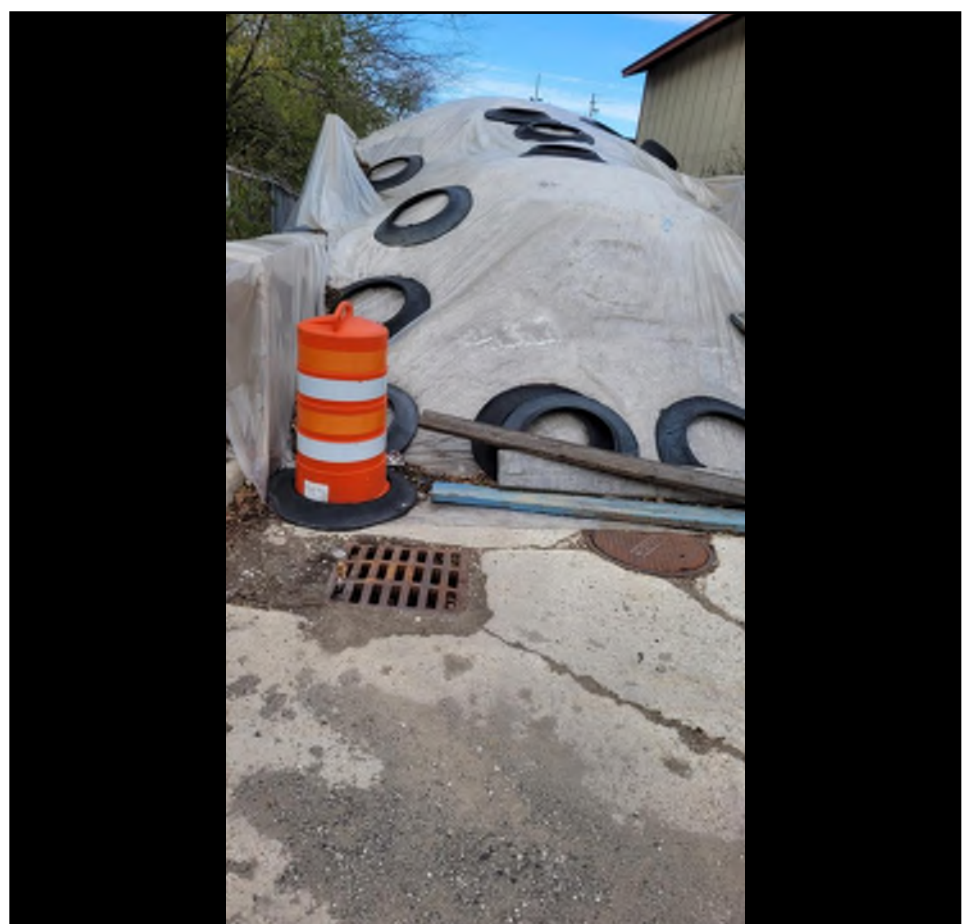
57

Roadways

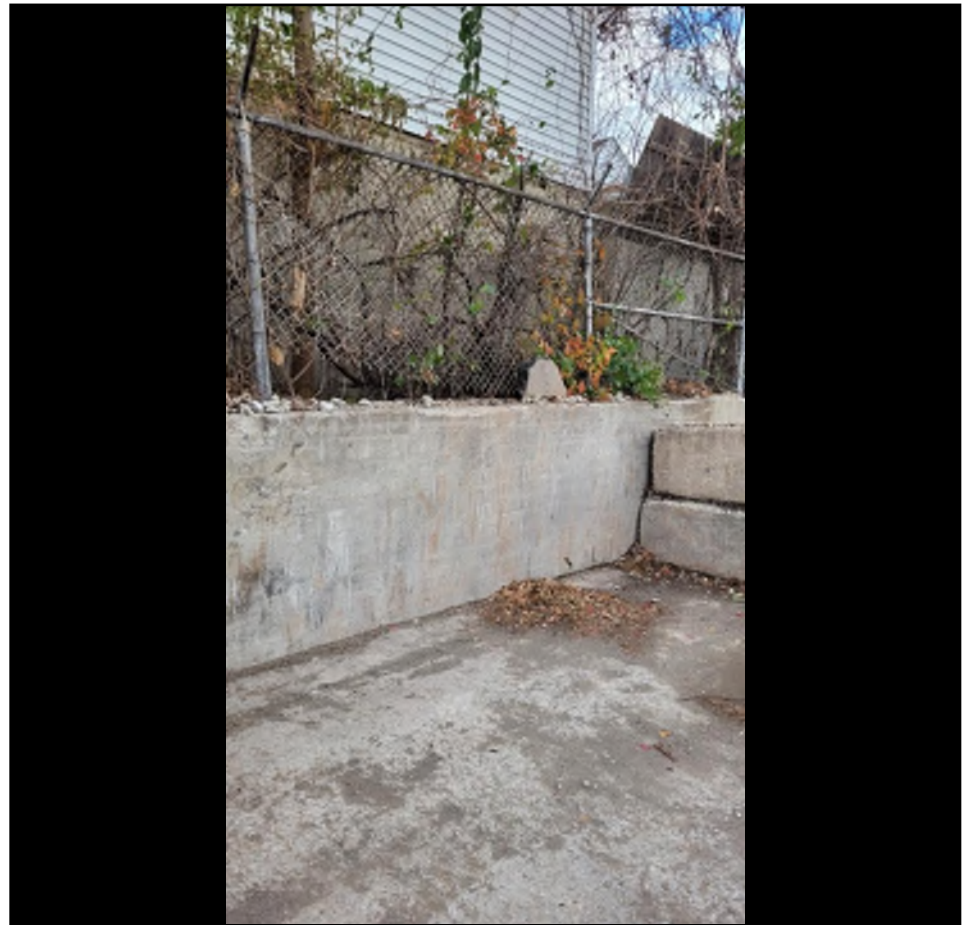
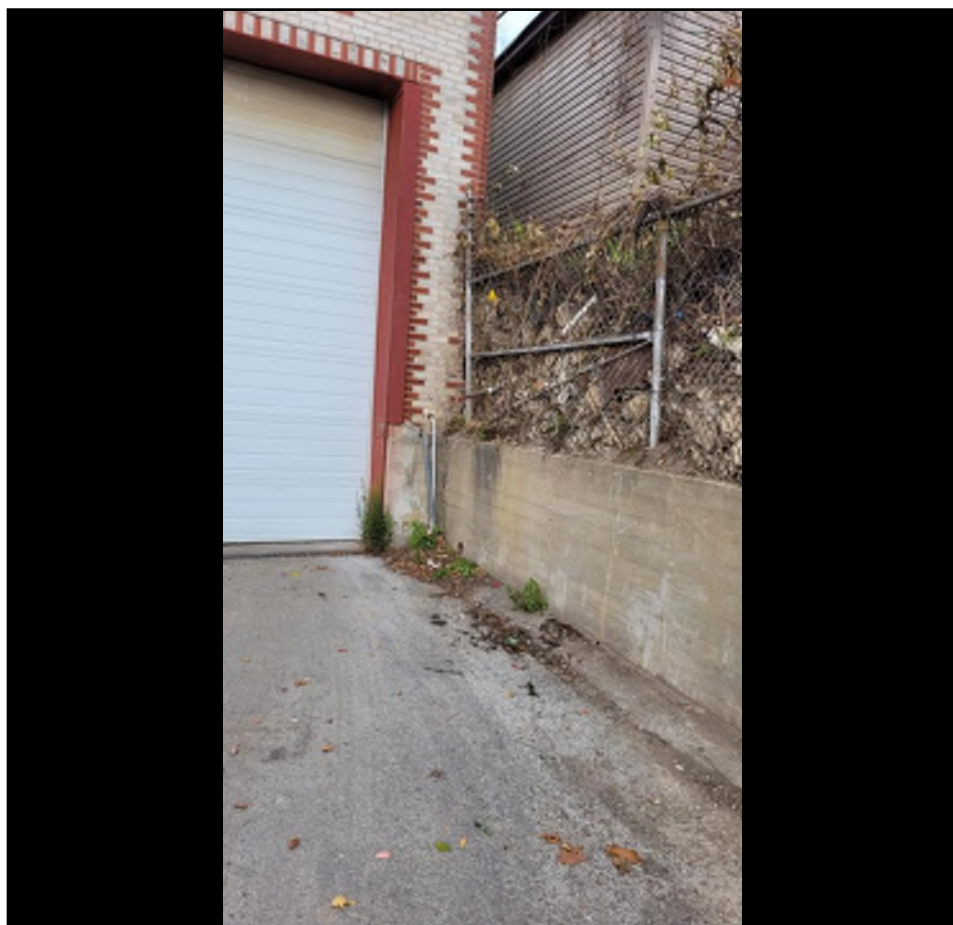
47

Parking Lots
