Village of Shorewood

Village Hall and Public Works Department
Facilities Condition Assessment

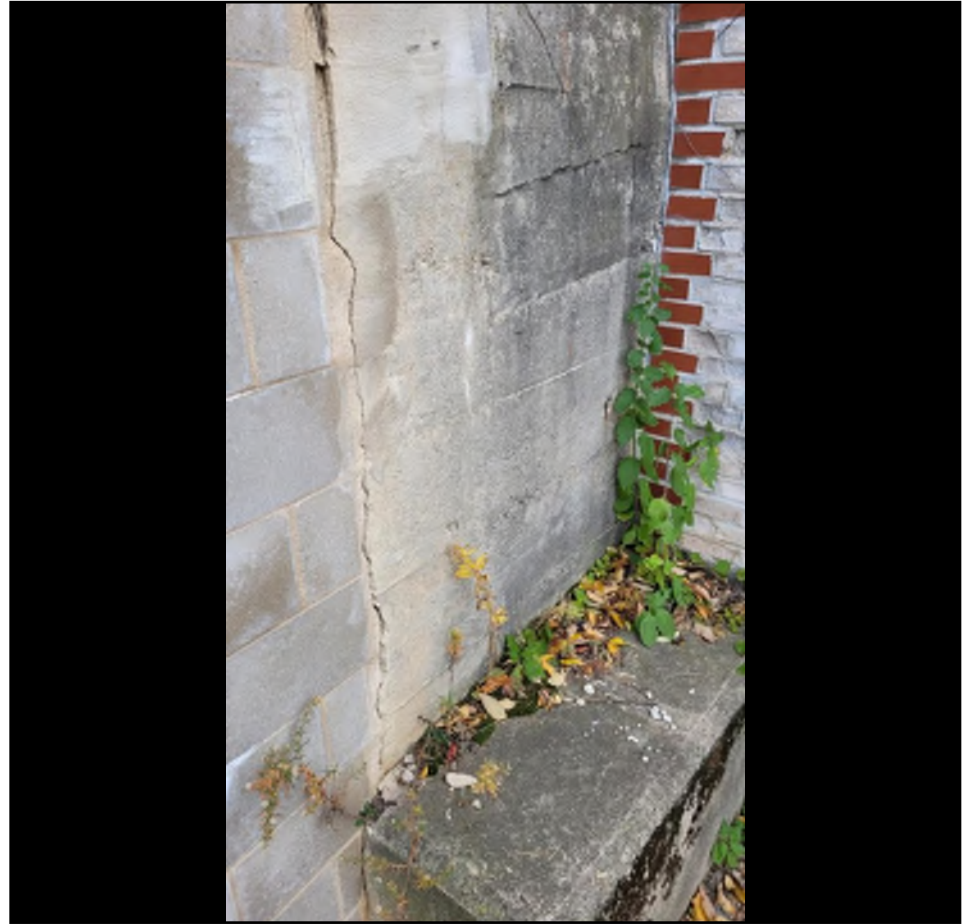
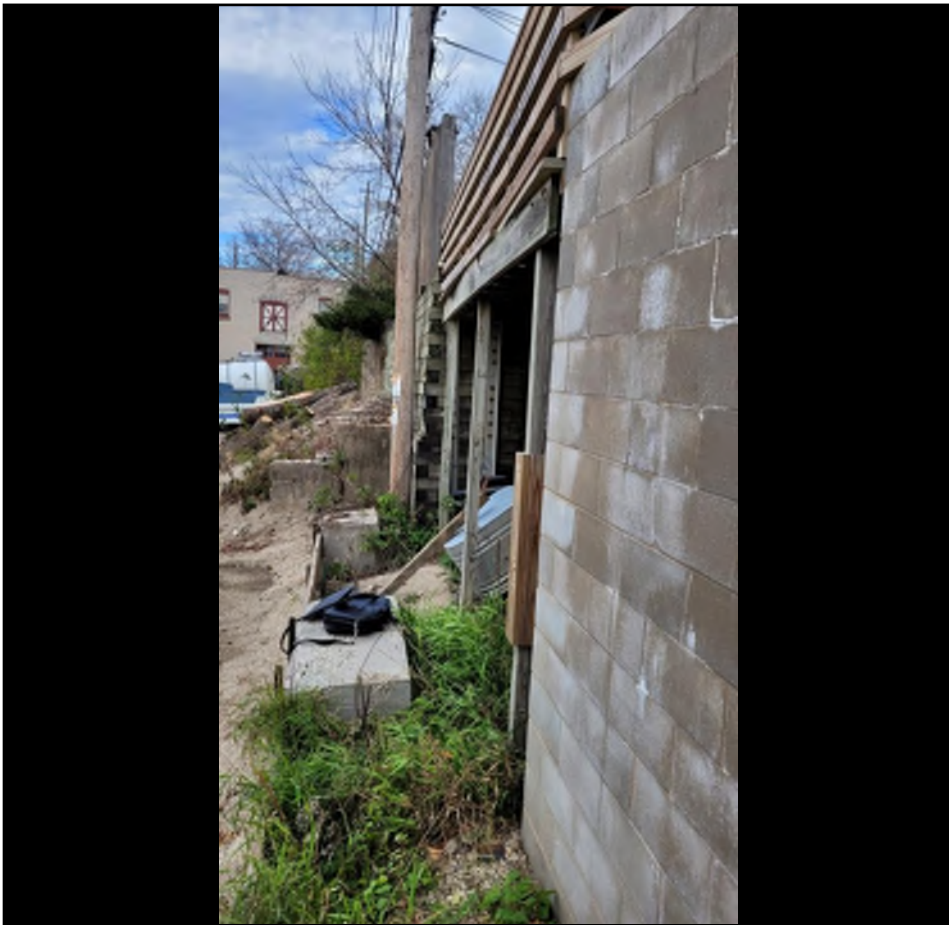
58

Foundation

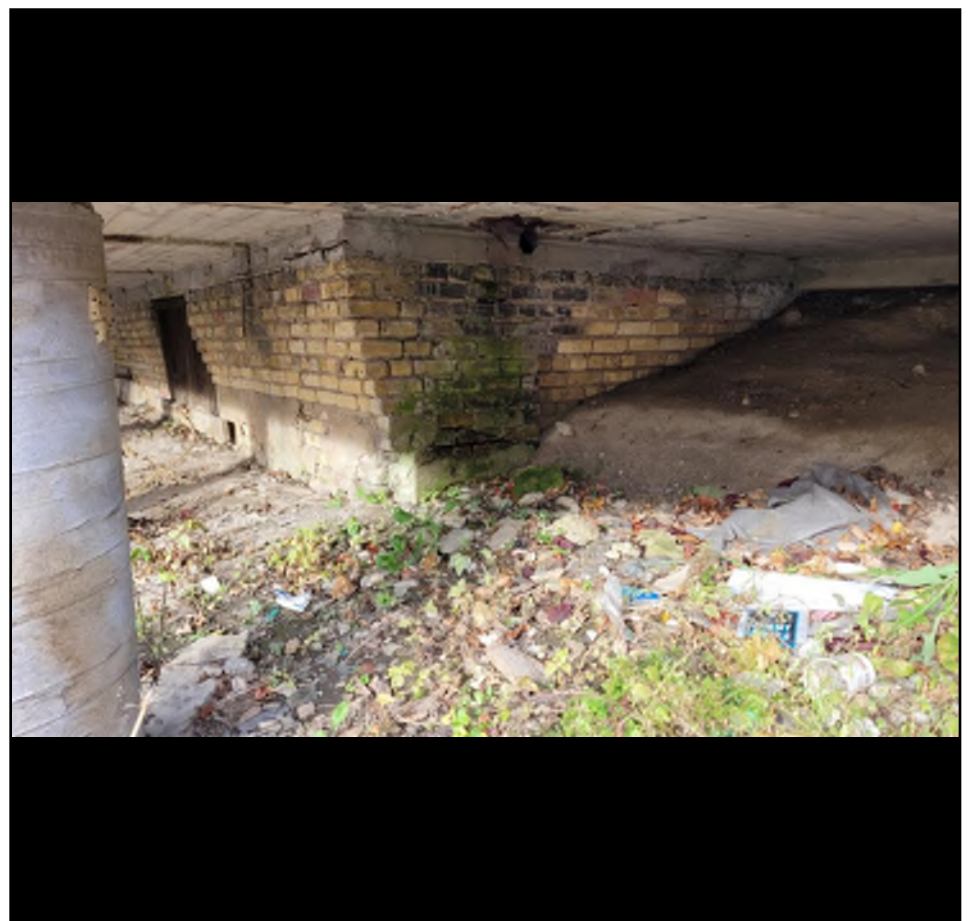
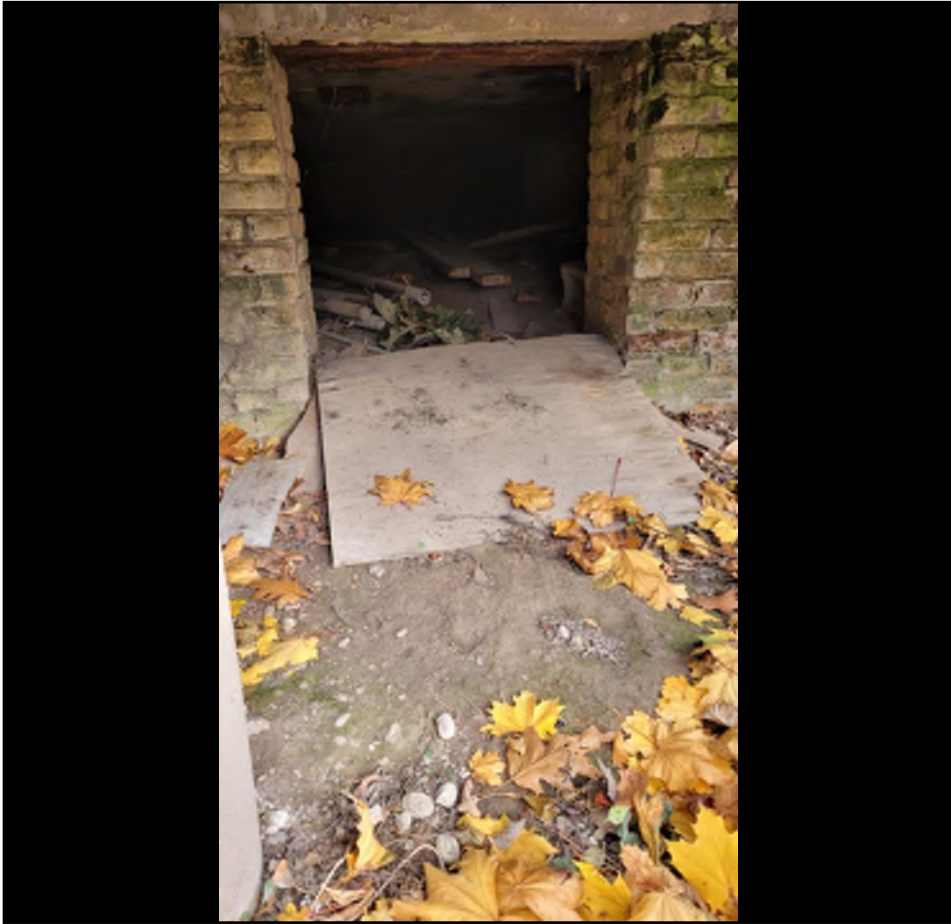
60

Foundation

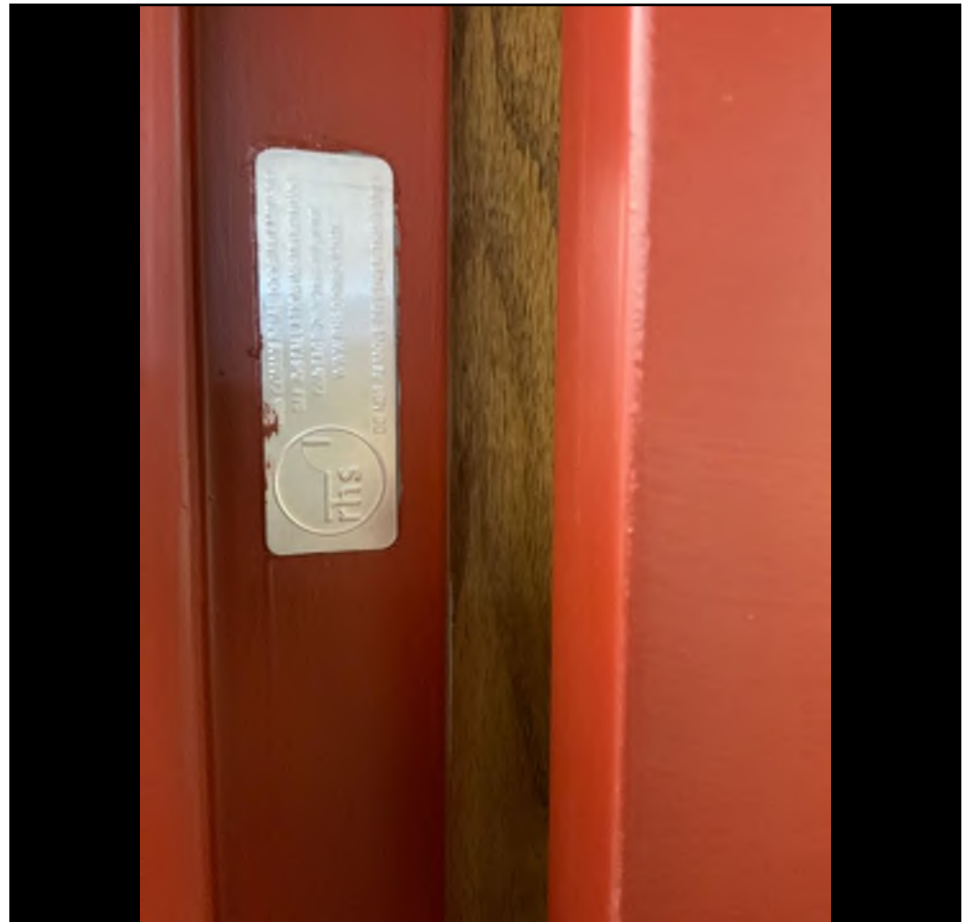
5

Doors

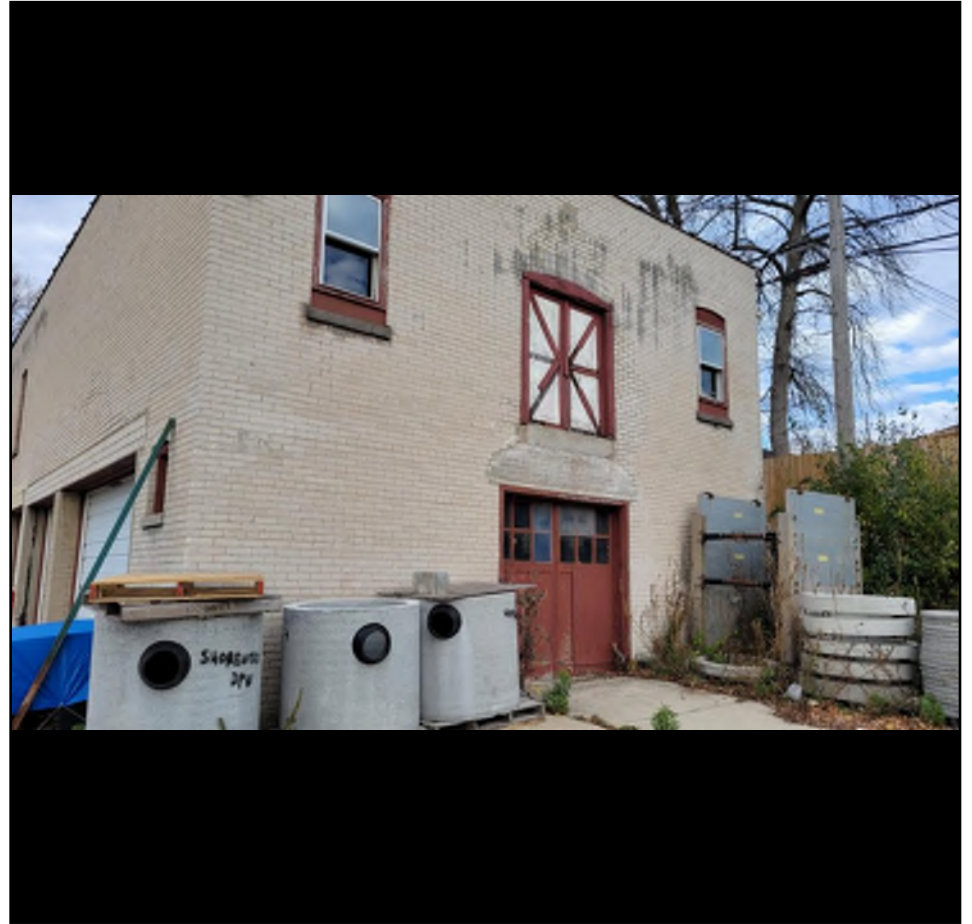
68

Exterior Doors

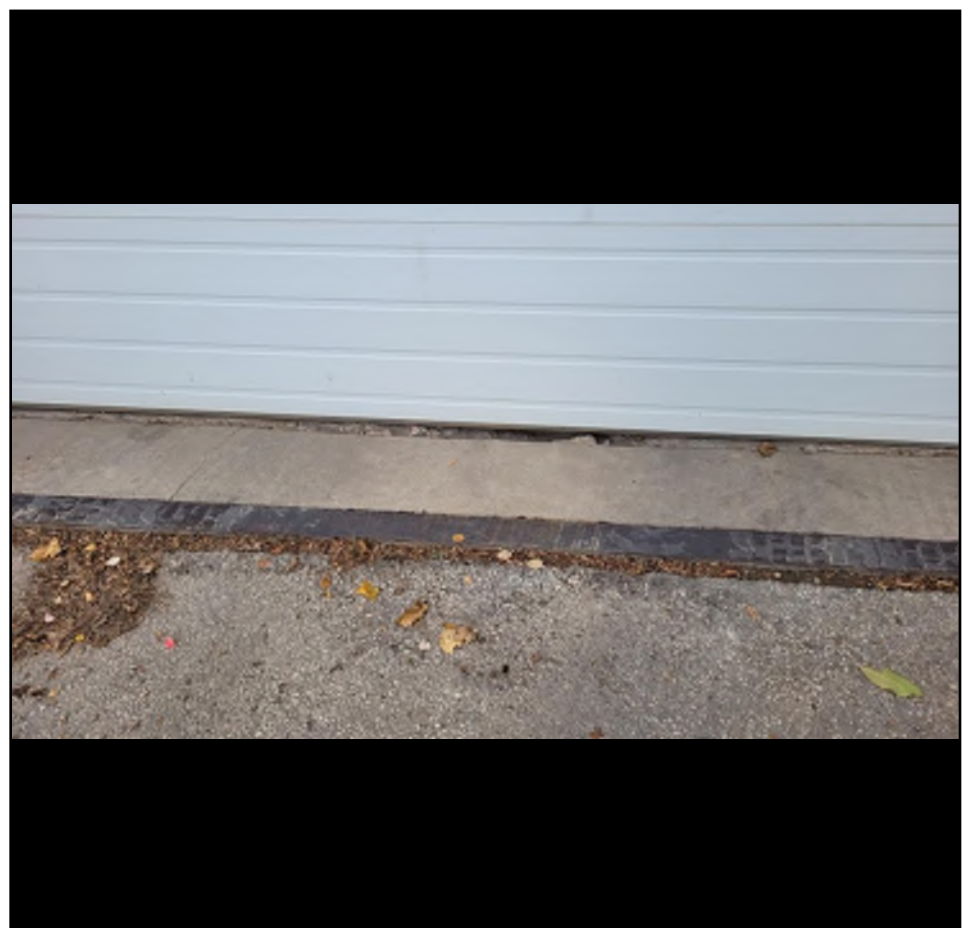
37

Exterior Doors

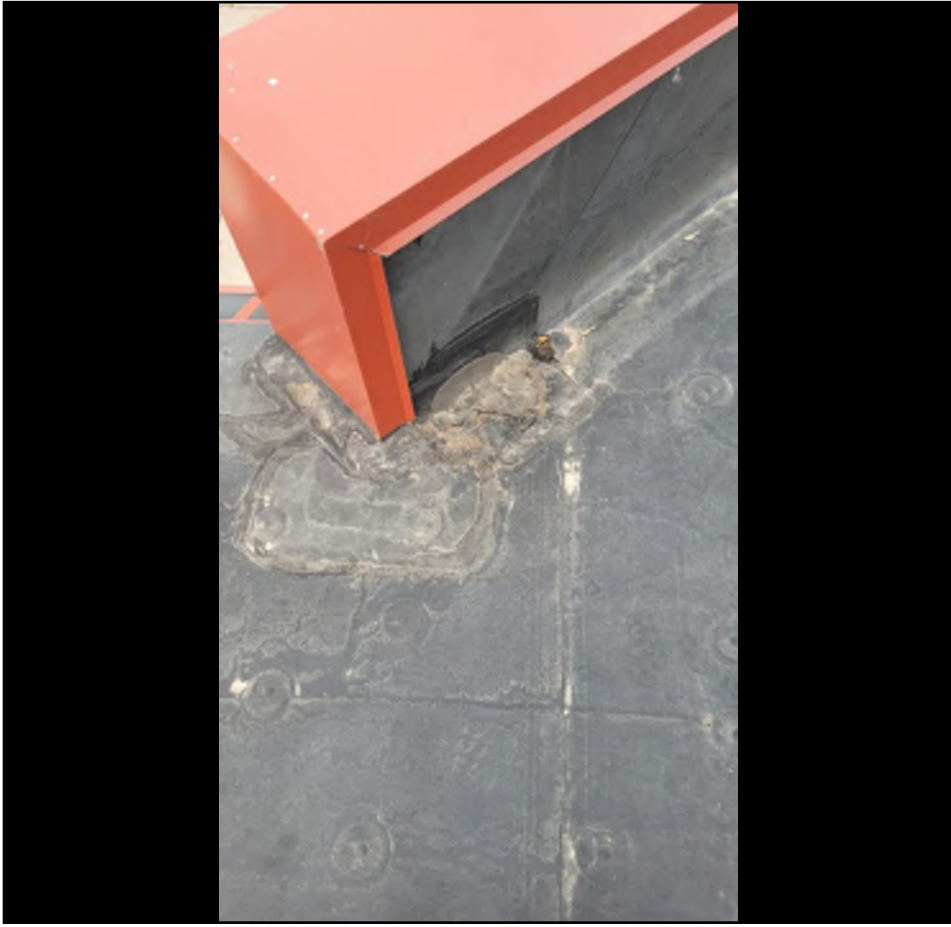
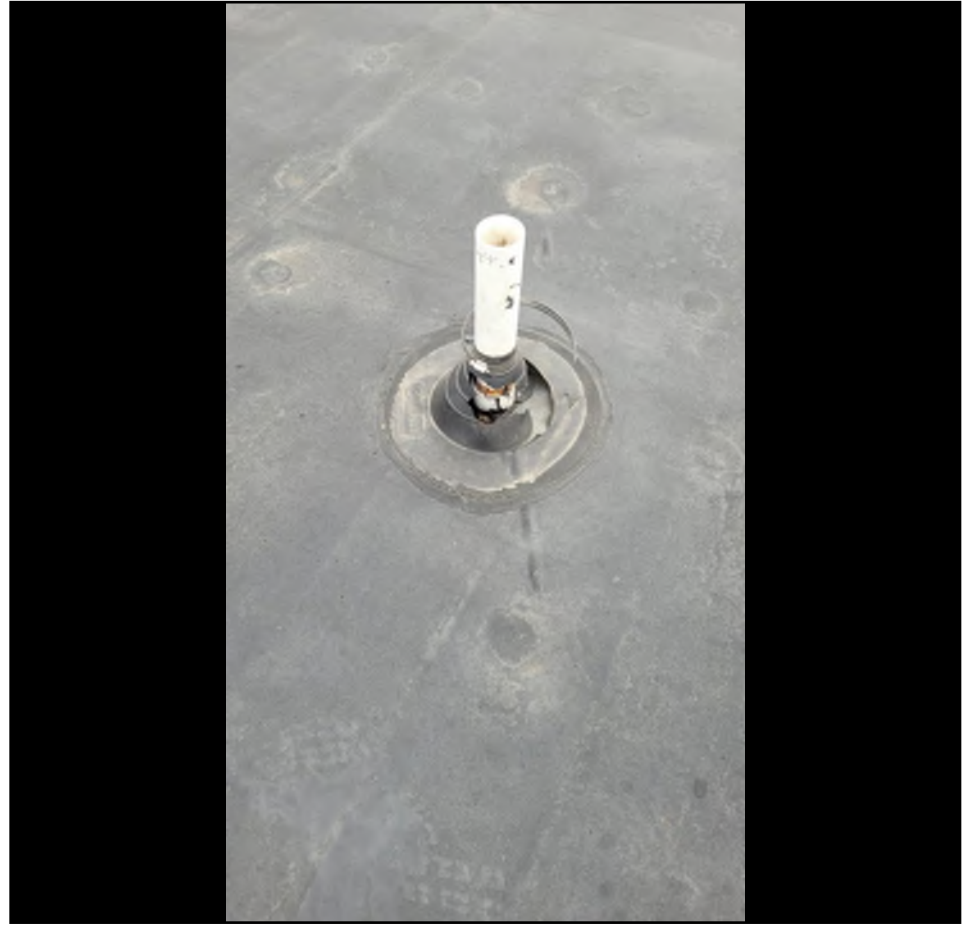
26

Roof

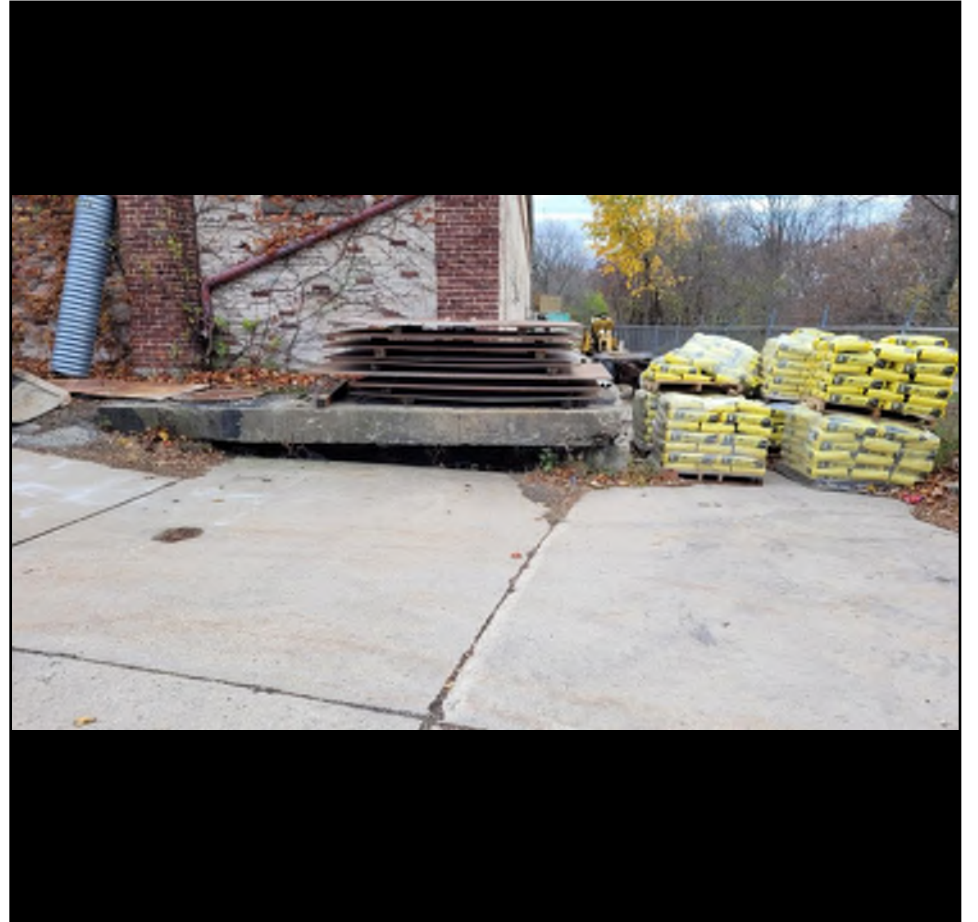
67

Foundation

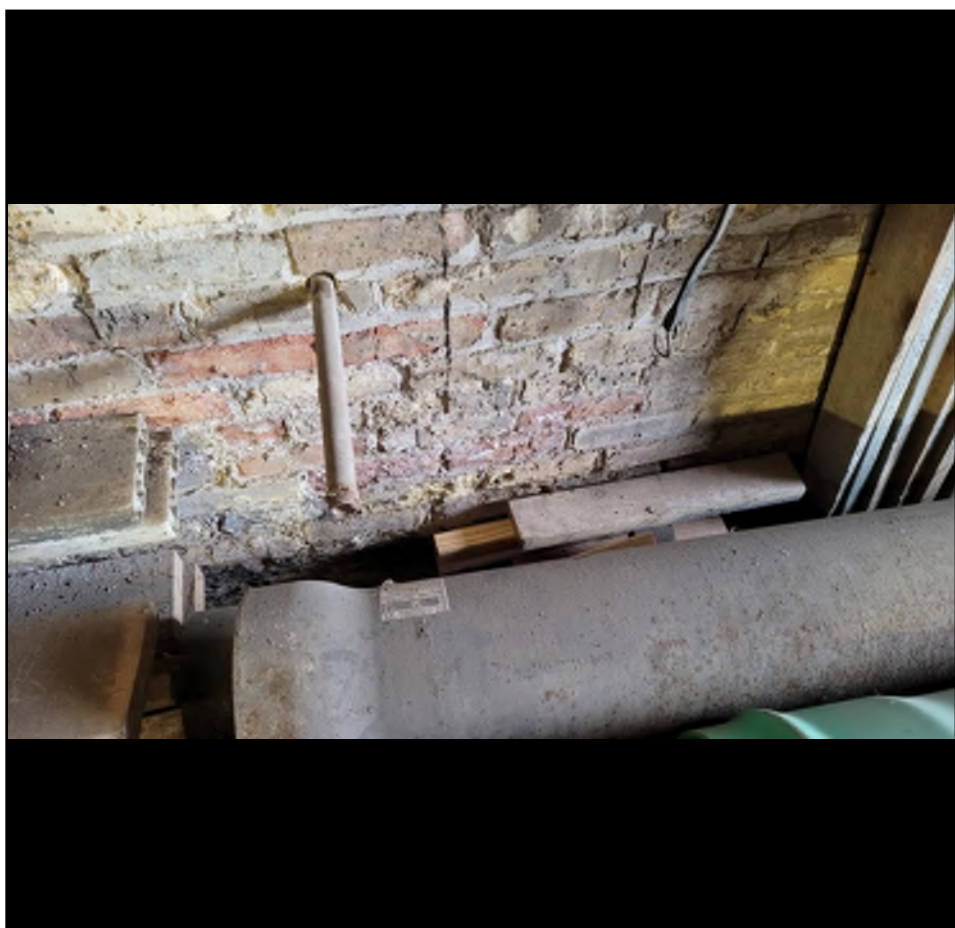
33

Foundation

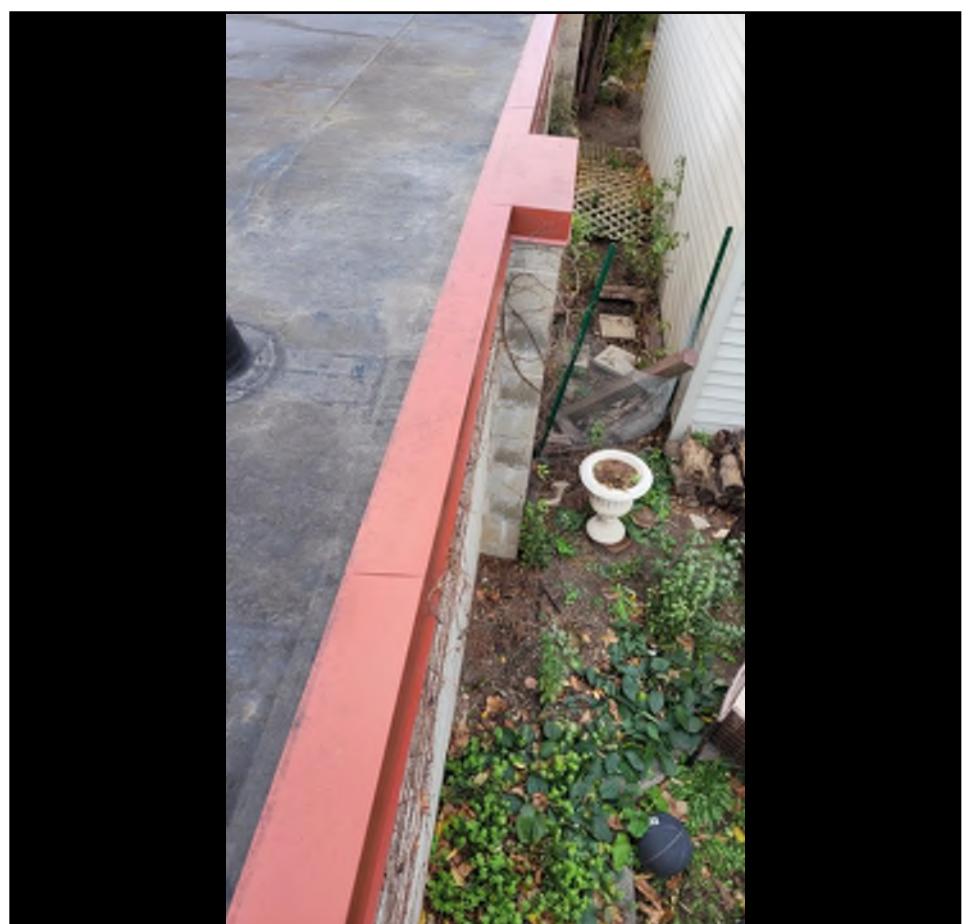
Foundation
72

72	Foundation	Priority 2	Category 3	the common wall of the building and the property line has a CMU exterior wall construction, which is subject to moisture infiltration, and therfore damage. This is contributing to the deterioration of the foundation wall, building, etc.	\$100,000

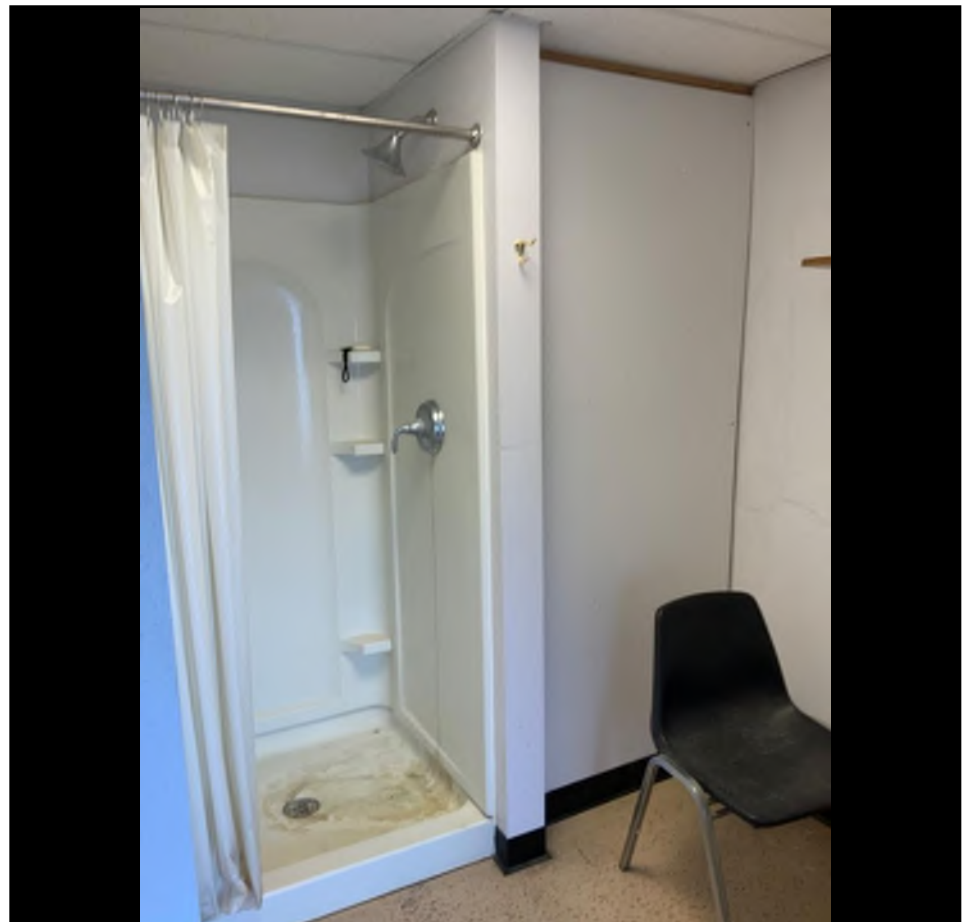
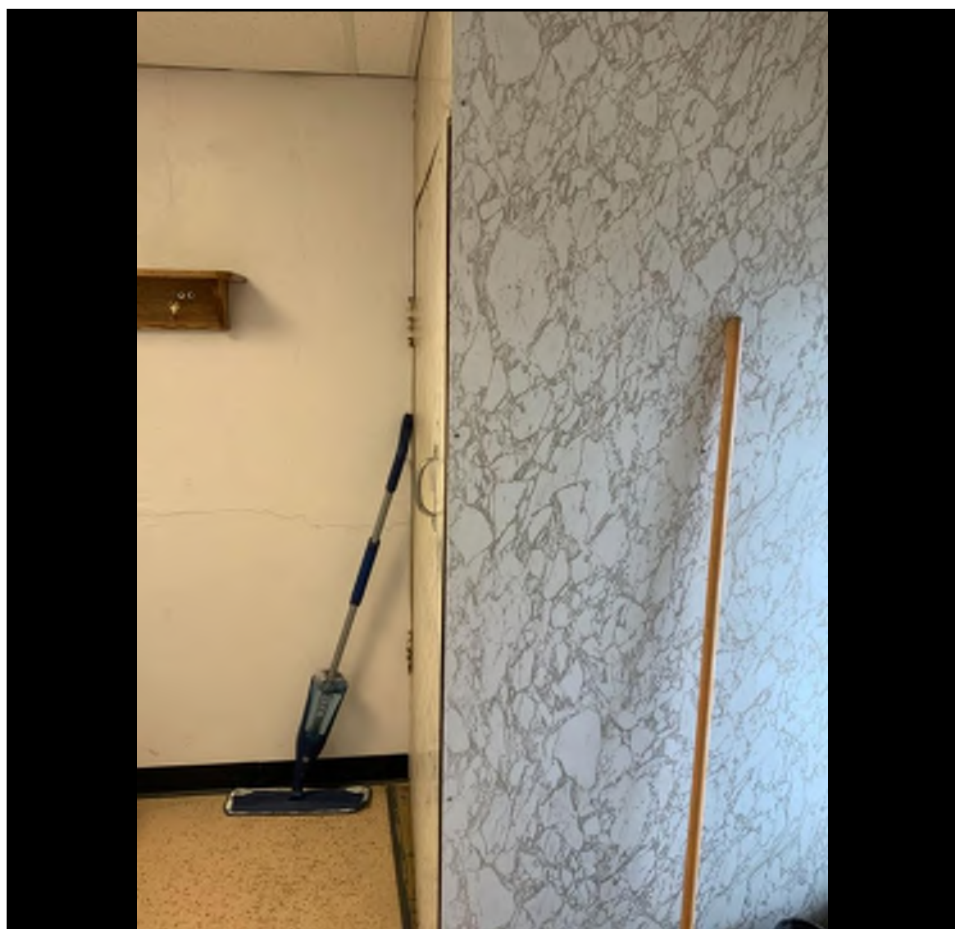
17	Plumbing	Priority 3	Category 2	Shower stall in fair condition	\$3,500

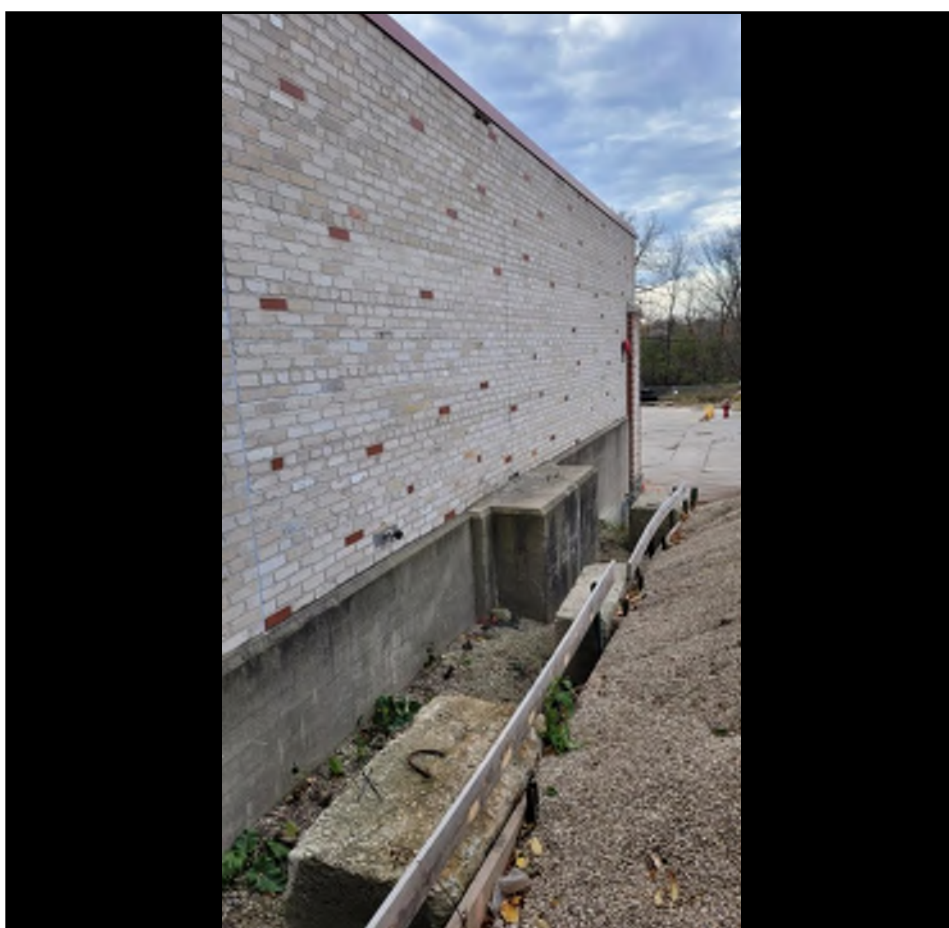
Exterior
38

38	Exterior	Priority 3	Category 3	The light colored brick is deteriorating due to its softness. any movement in the building results in the soft brick cracking or chipping away. evidence of the damage is present next to the wall.	\$10,000

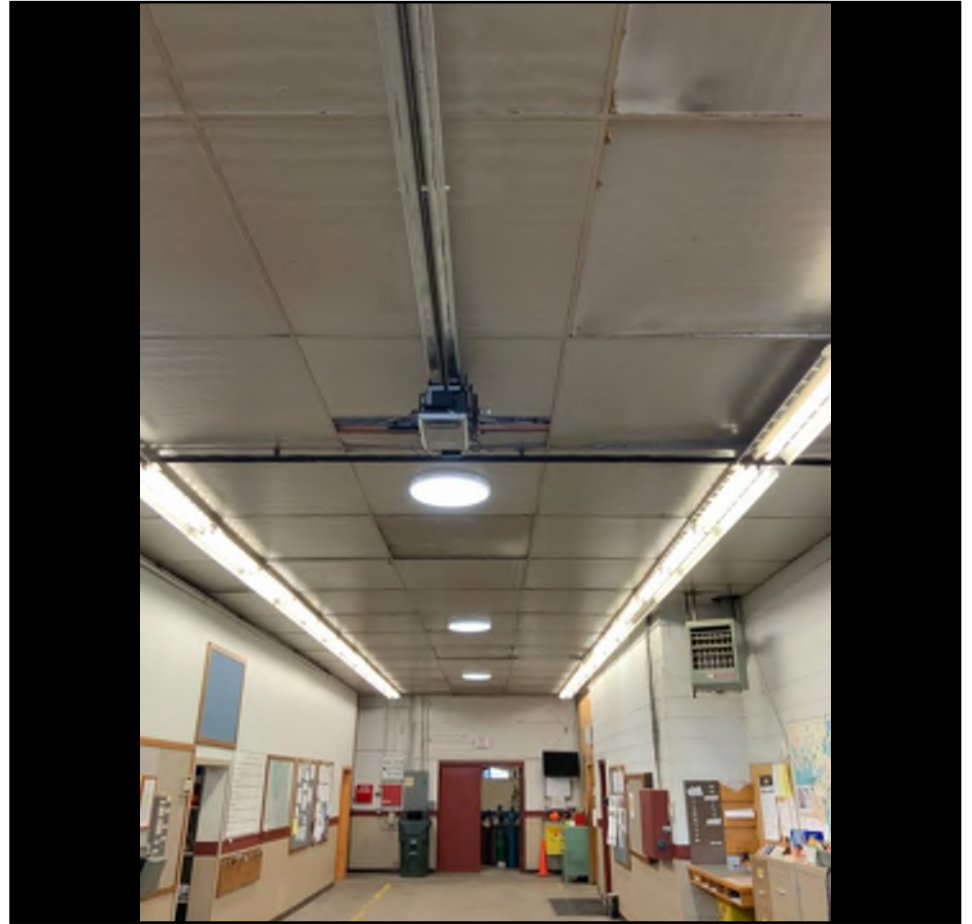
22	Ceilings	Priority 4	Category 3	Ceiling tiles are showing signs of age and deterioration.	\$5,000

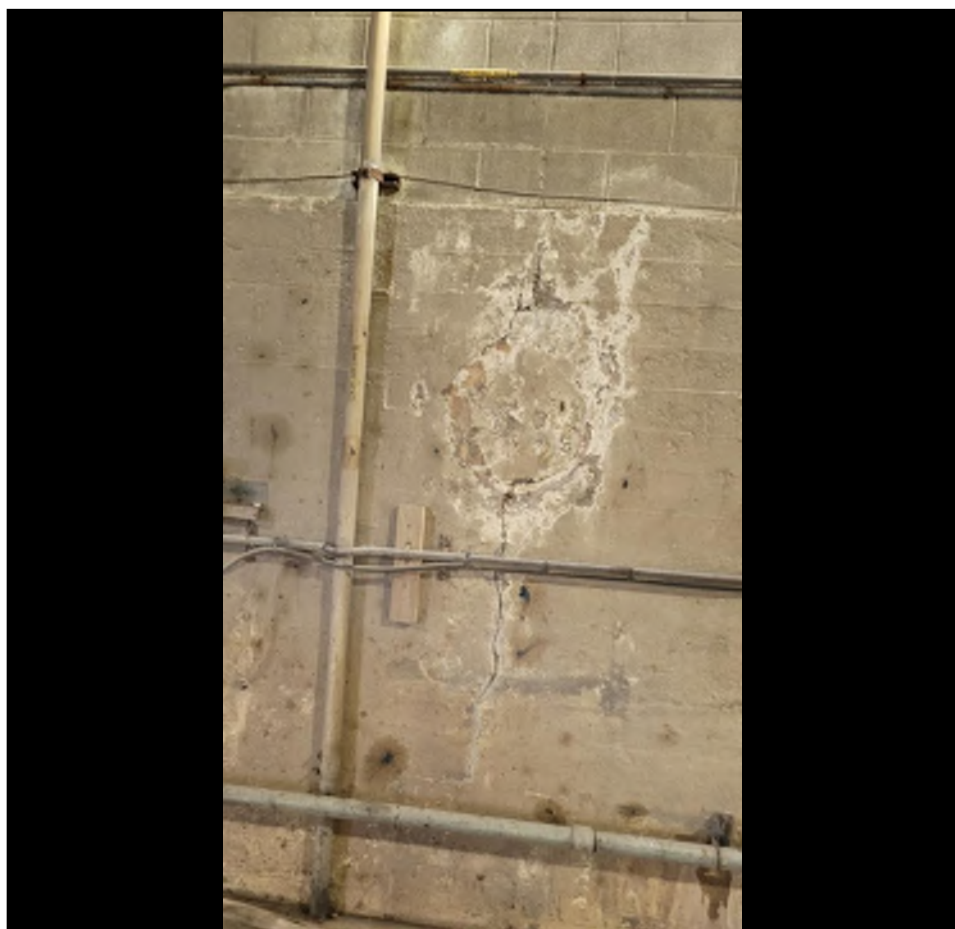
12	Exterior	Priority 4	Category 3	water damage to walls from letting water infiltrate the walls through stone caps. needs to be repaired. cracks resulting from the infiltration should be repaired once the water has been corrected.	\$2,500

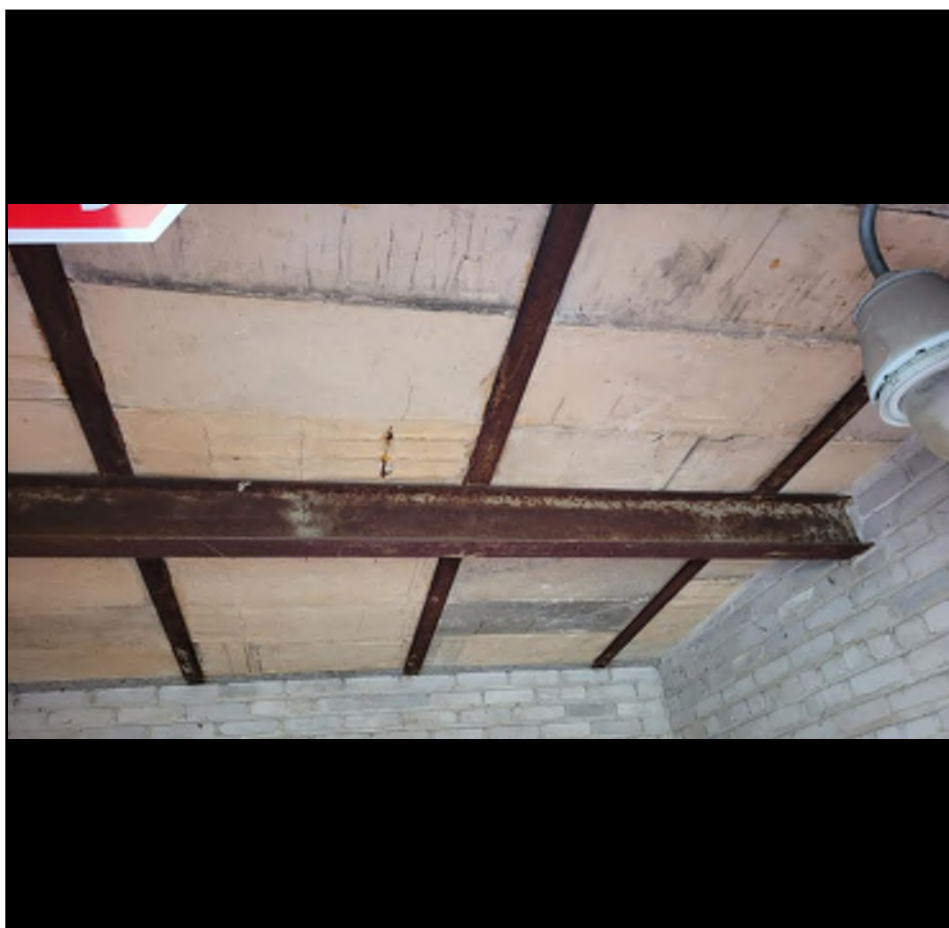
0	ADA requirements	Priority 4	Category 3	facility is not accesible, but it is long term storage, and therefore not typically required to meet code.	\$0							
 	40	Foundation	Priority 4	Category 3	concrete ceiling/ roof is damaged and spalling.	\$10,000

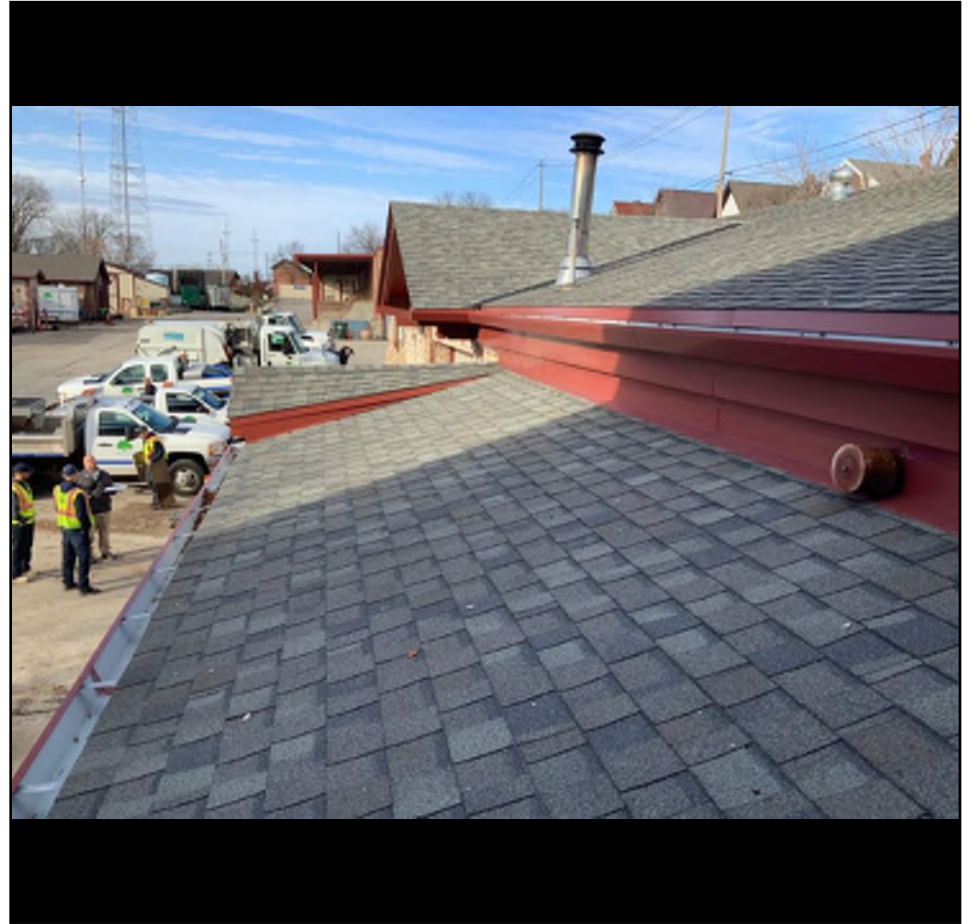
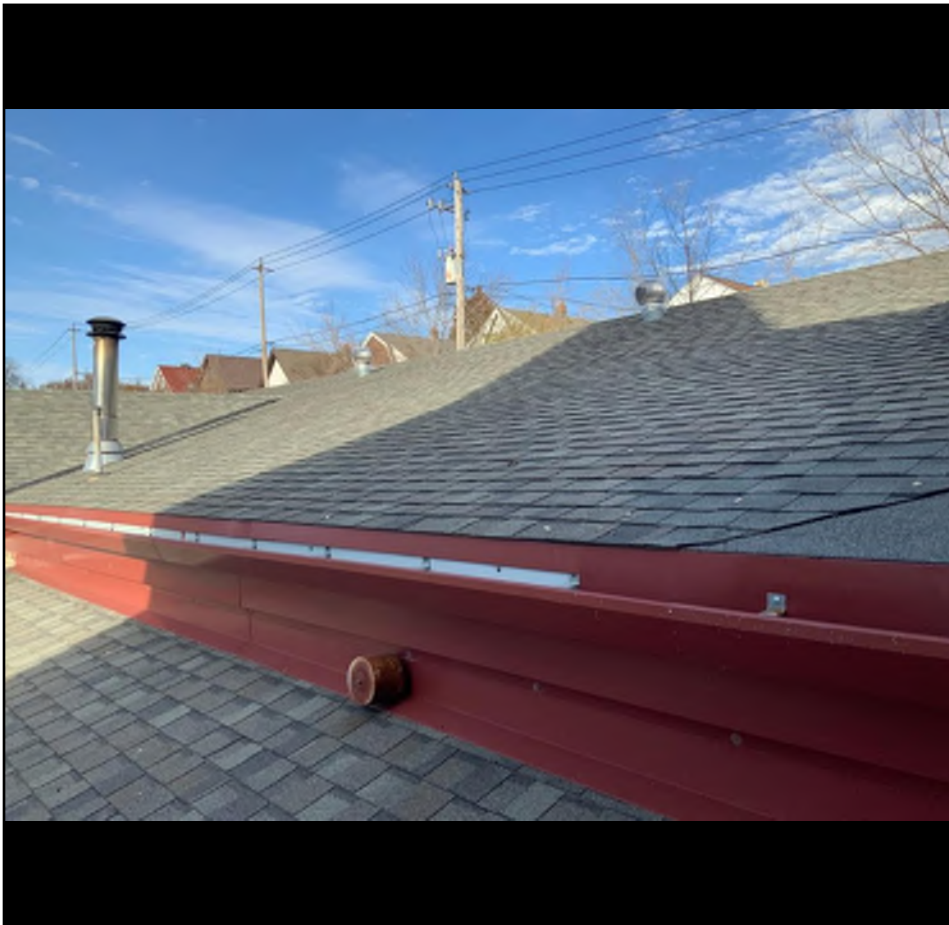
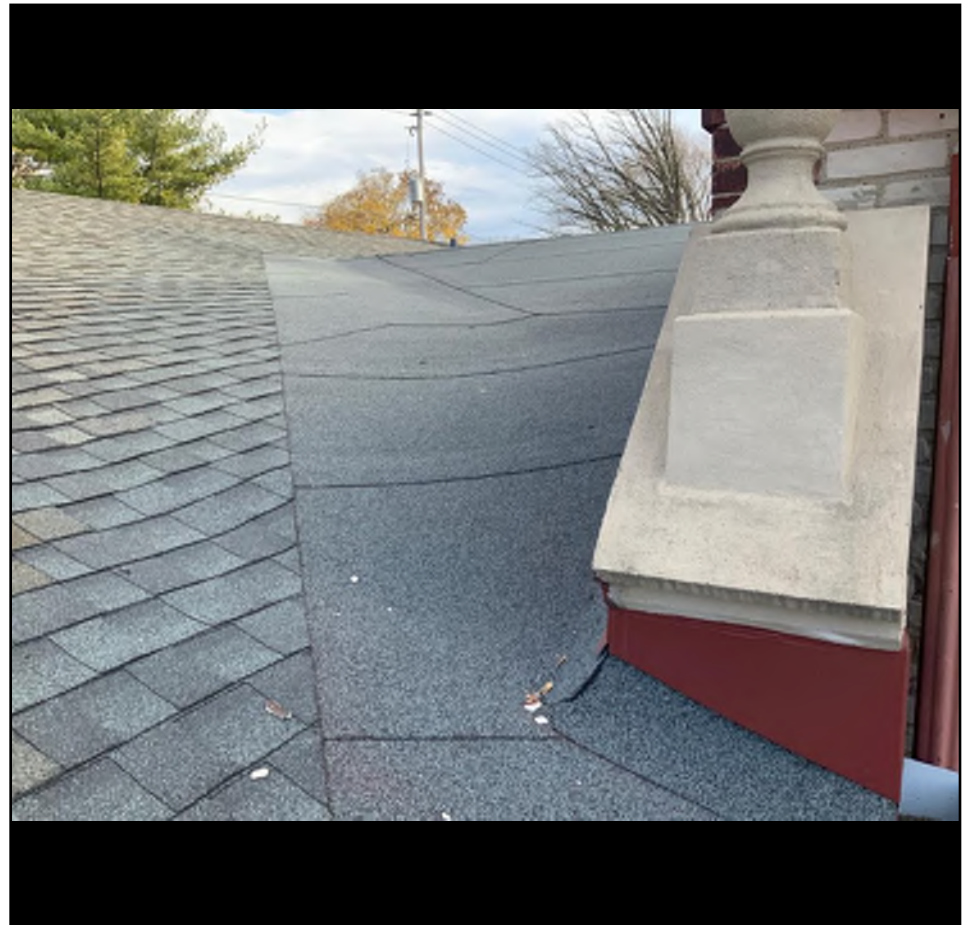
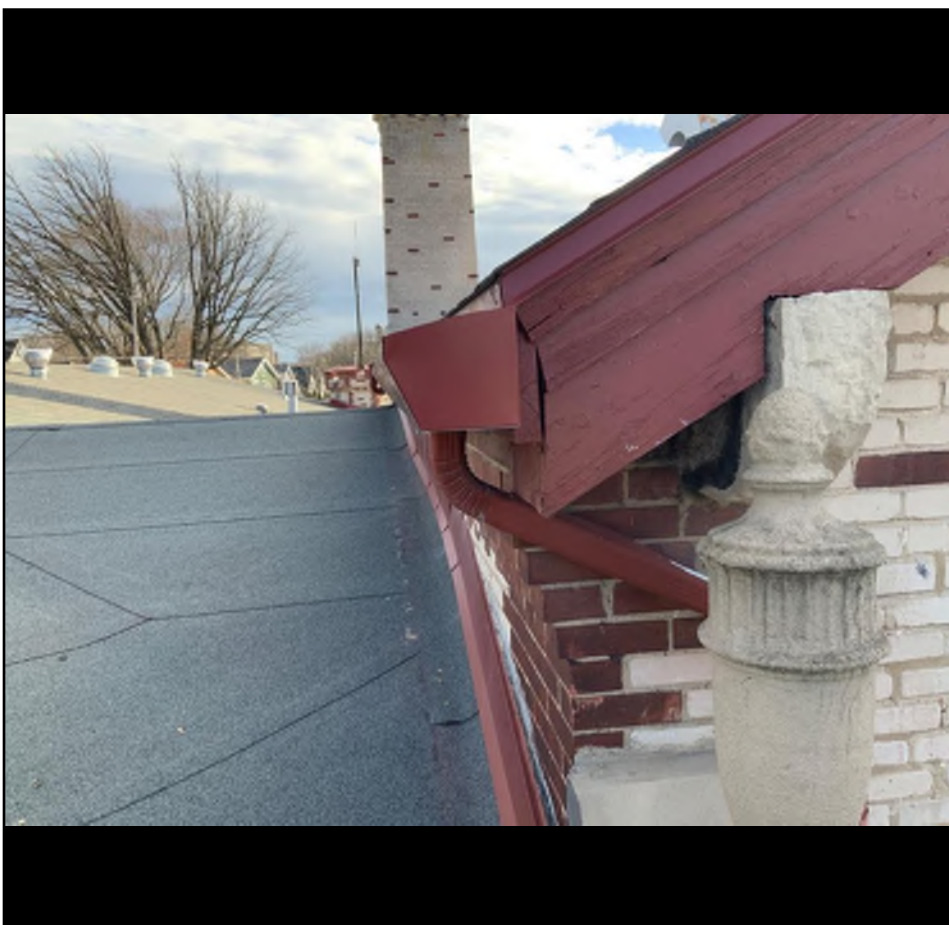
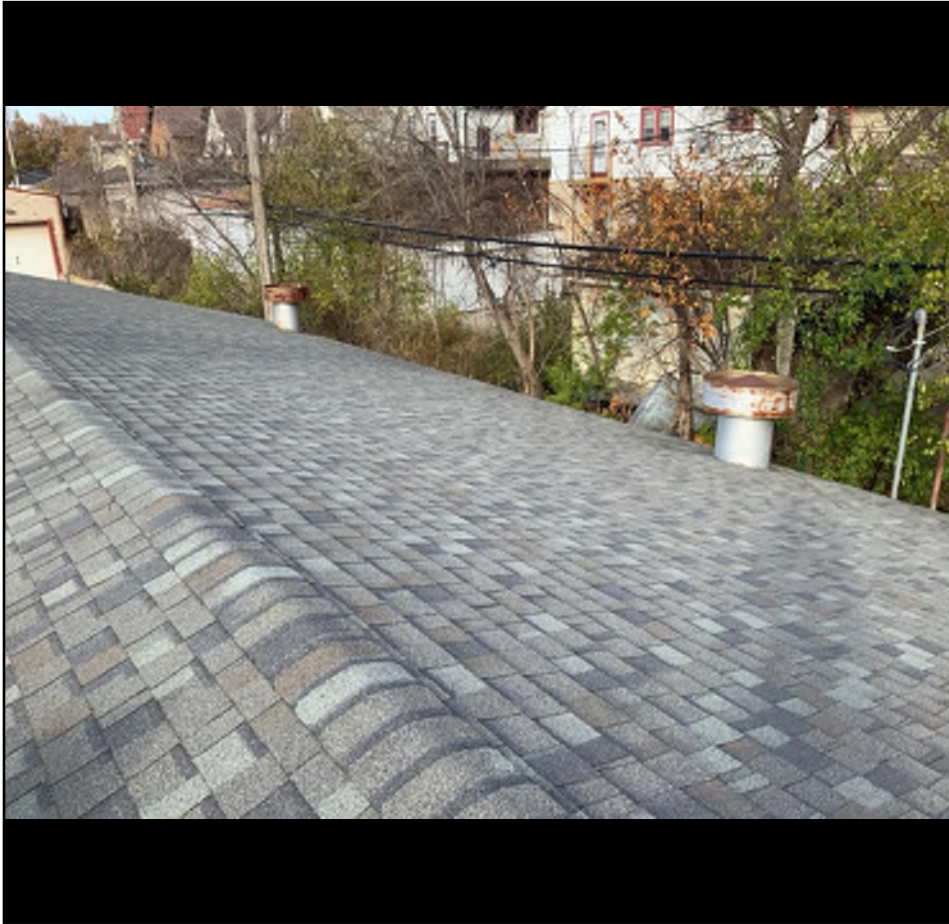
23	Ceilings	Priority 4	Category 4	Roof in good condition. Consider routine maintenance to roof vent projections, so showing signs of deterioration.	\$5,000

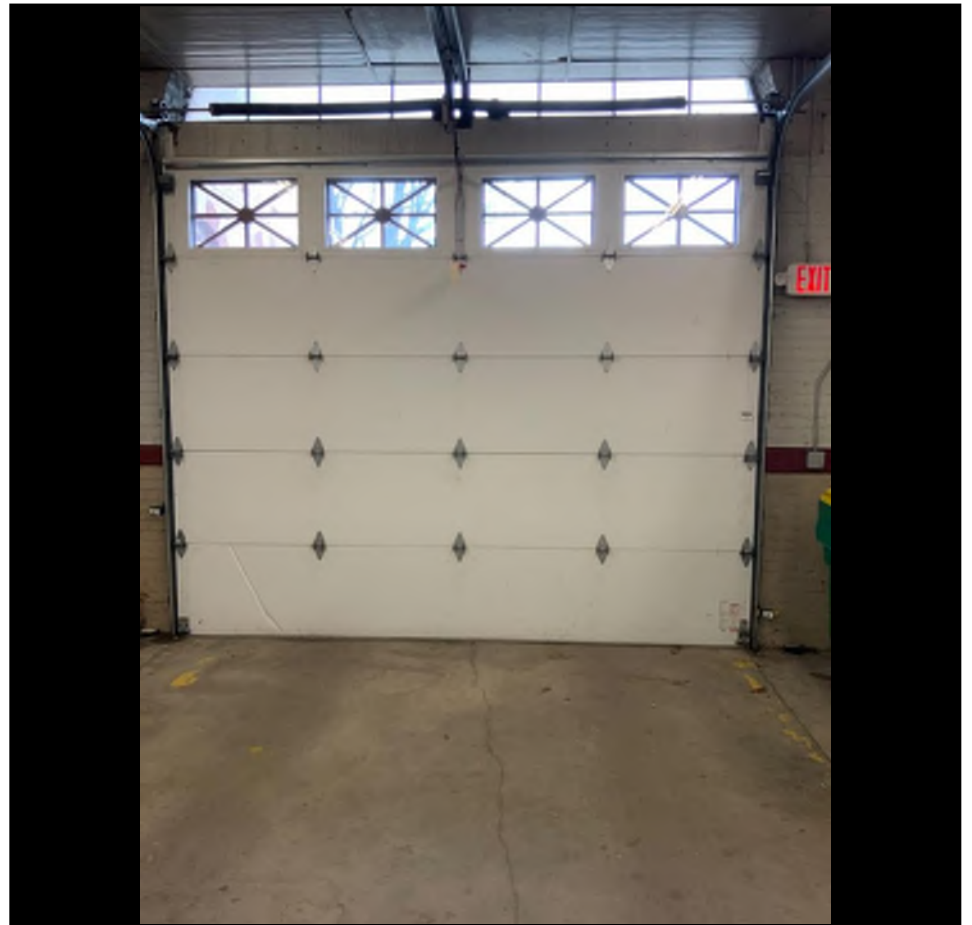
Floor
35

35	Floor	Priority 5	Category 5	Existing slab settlement / expansion cracks	\$8,000
